Instream & Riparian Enhancement of Mainstem McGarvey Creek (Phase I)

Daniel B. Gale
Yurok Tribal Fisheries Program
P.O. Box 339
Klamath, CA 95548

March 01, 2009

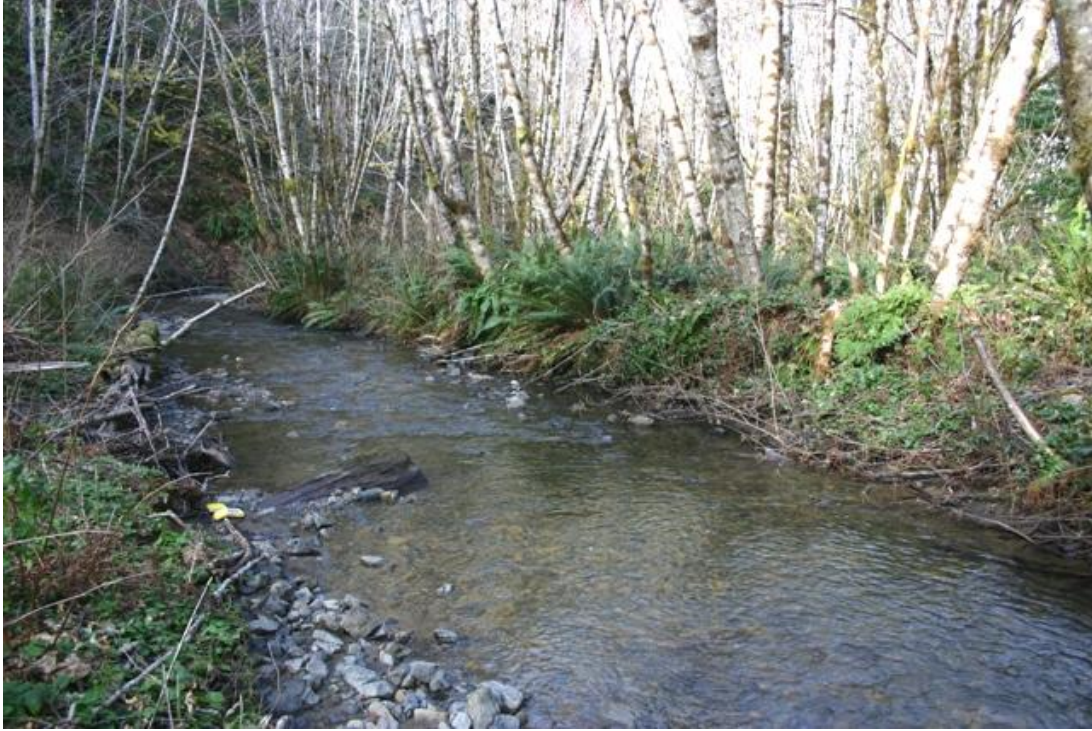
Figure 13. Shallow run at top of project reach before installation of structures #1-2, Mainstem McGarvey Creek, Lower Klamath River, California, February 2007.

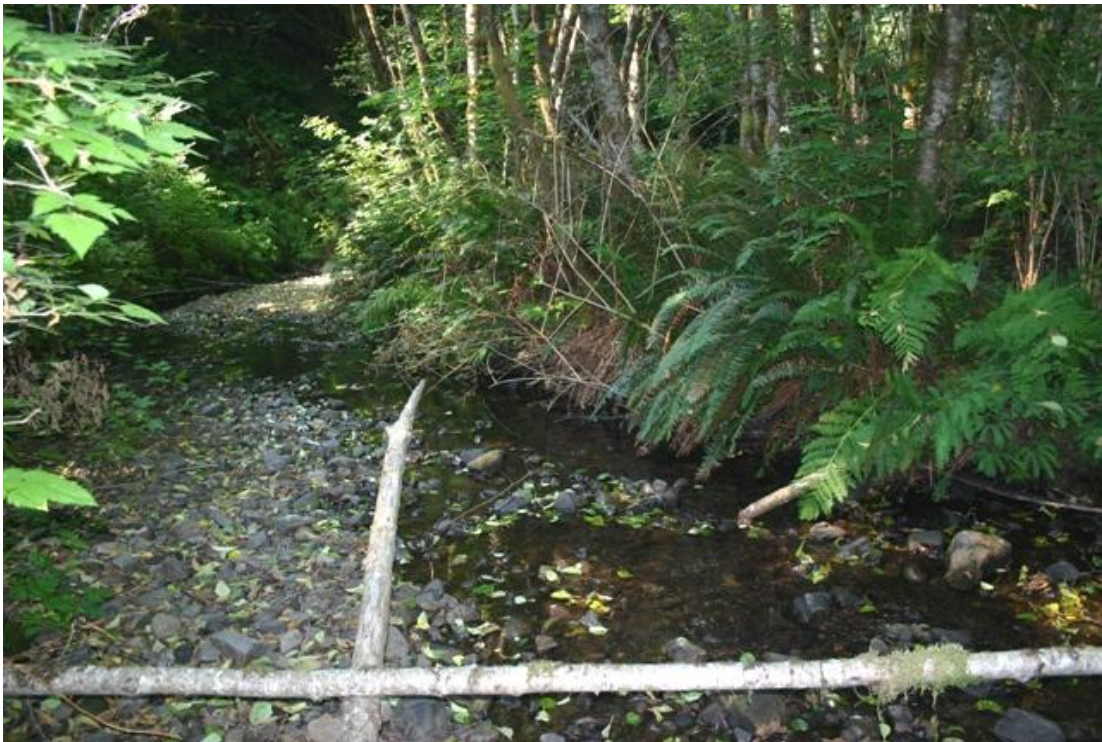
Figure 14. Shallow run at top of project reach before installation of structures #1-2, Mainstem McGarvey Creek, Lower Klamath River, California, September 2008.

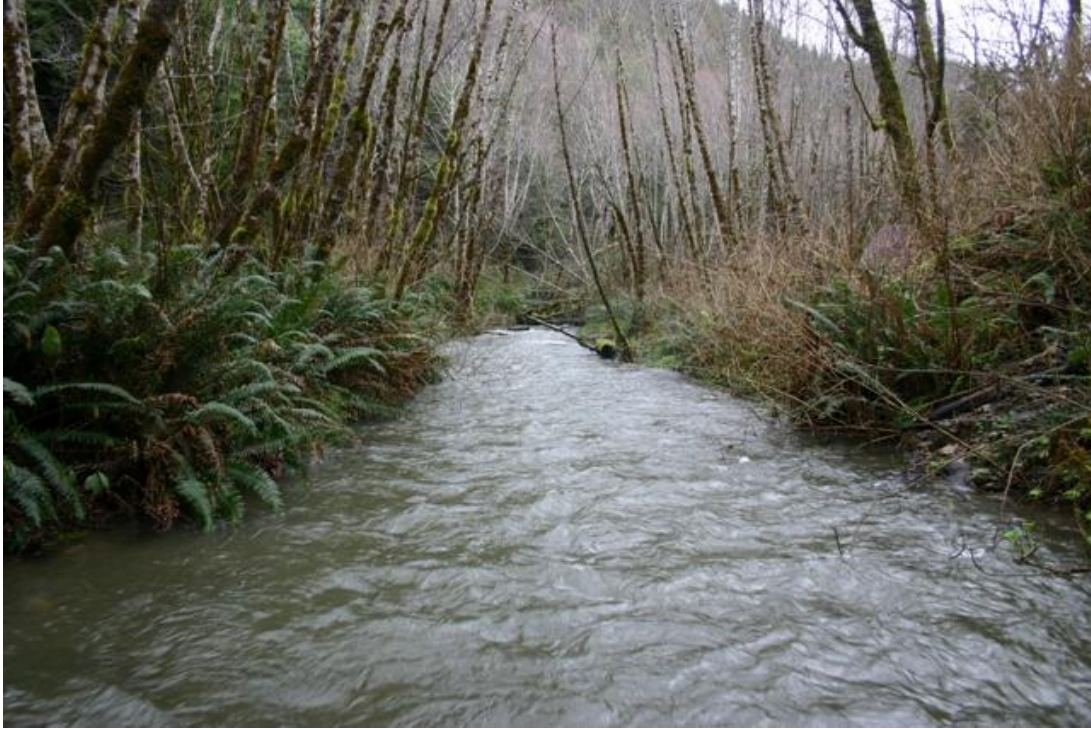
Figure 15. Shallow run at top of project reach before installation of structures #1-2, Mainstem McGarvey Creek, Lower Klamath River, California, February 2007.

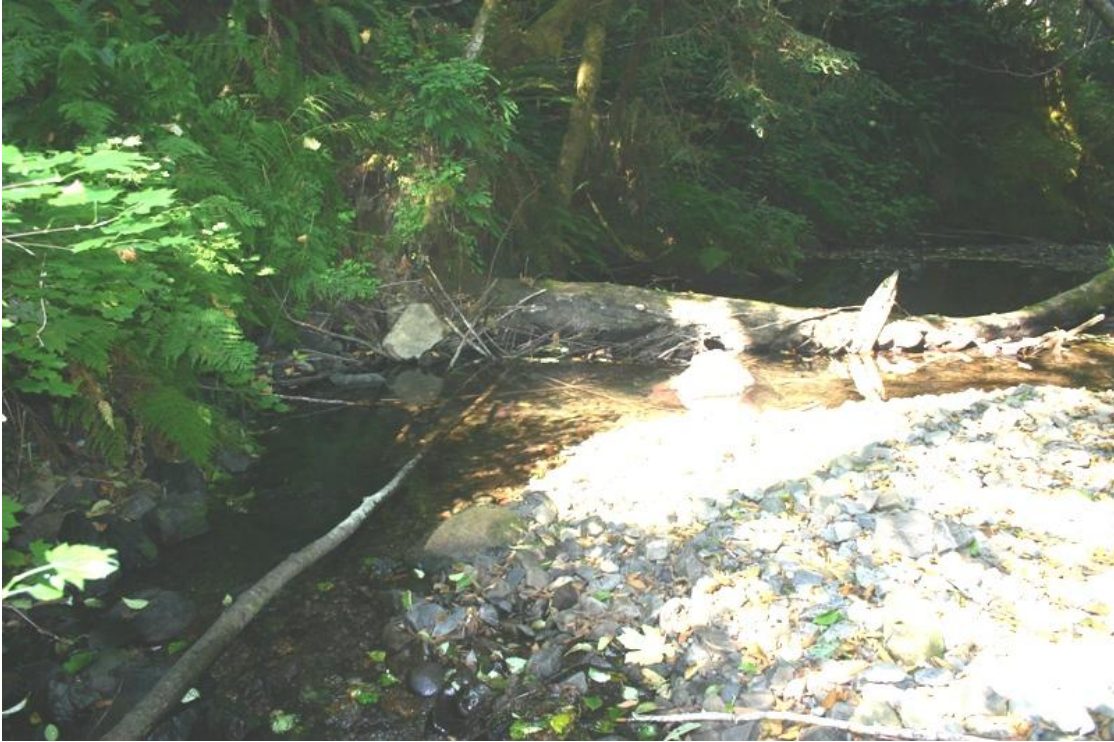
Figure 21. Shallow pool near top of project reach prior to installation of structure #3, Mainstem McGarvey Creek, Lower Klamath River, California, February 2007.

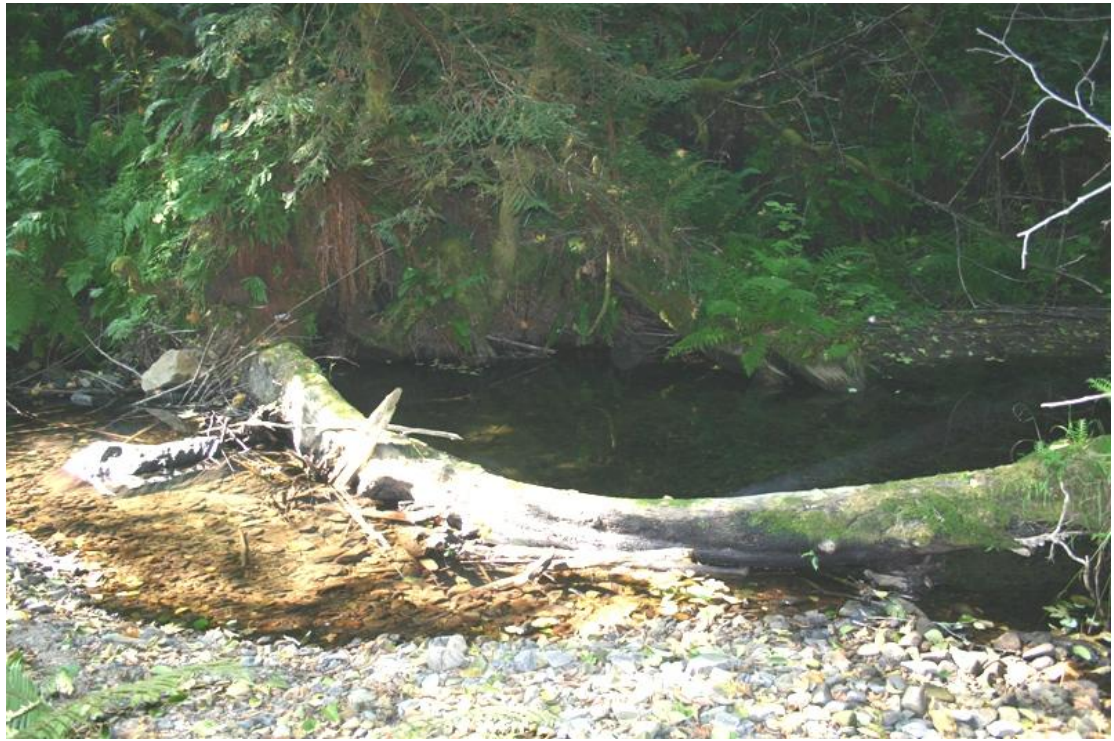
Figure 22. Shallow pool near top of project reach prior to installation of structure #3, Mainstem McGarvey Creek, Lower Klamath River, California, February 2007.

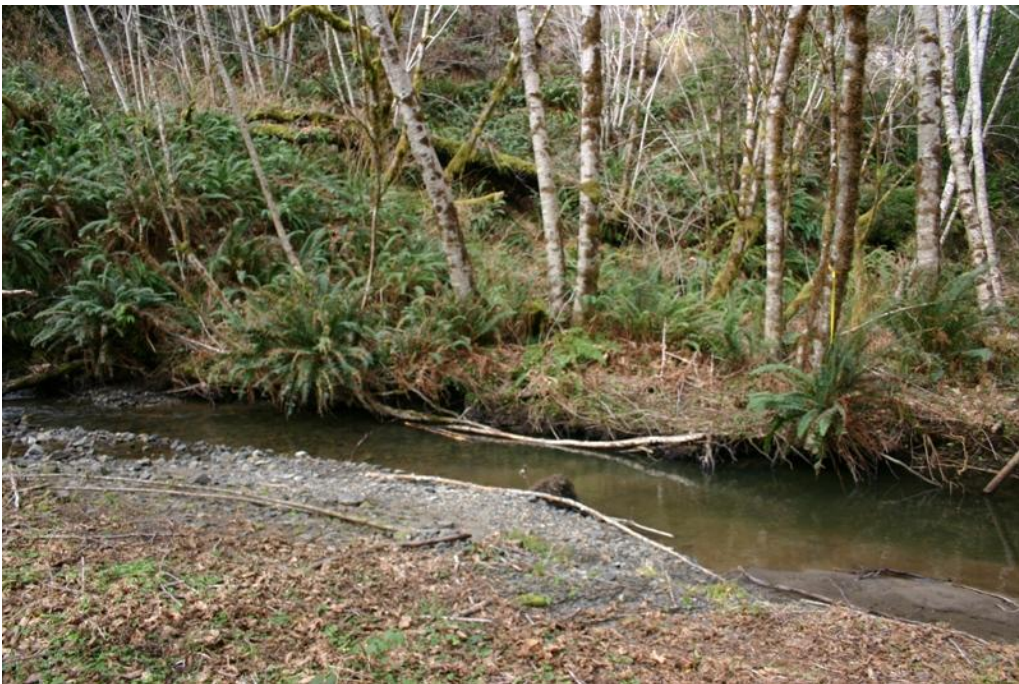
Figure 28. Shallow pool near top of project reach prior to installation of structure #4, Mainstem McGarvey Creek, Lower Klamath River, California, February 2007.

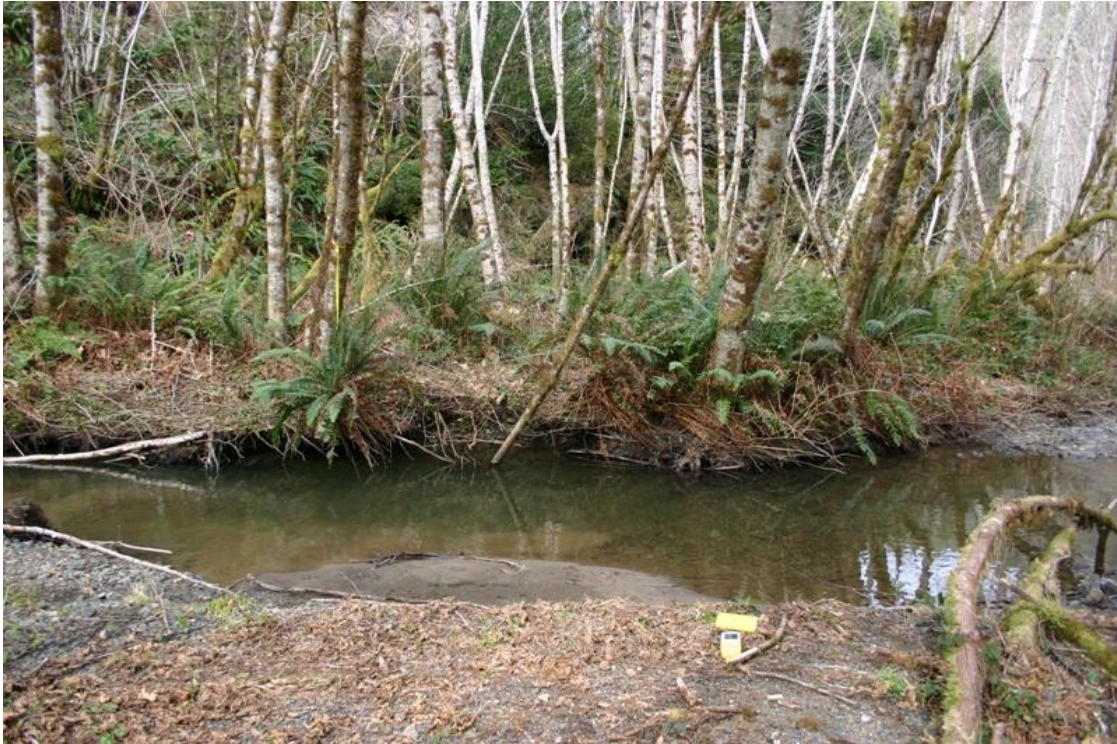
Figure 29. Shallow pool near top of project reach prior to installation of structure #4, Mainstem McGarvey Creek, Lower Klamath River, California, February 2007.

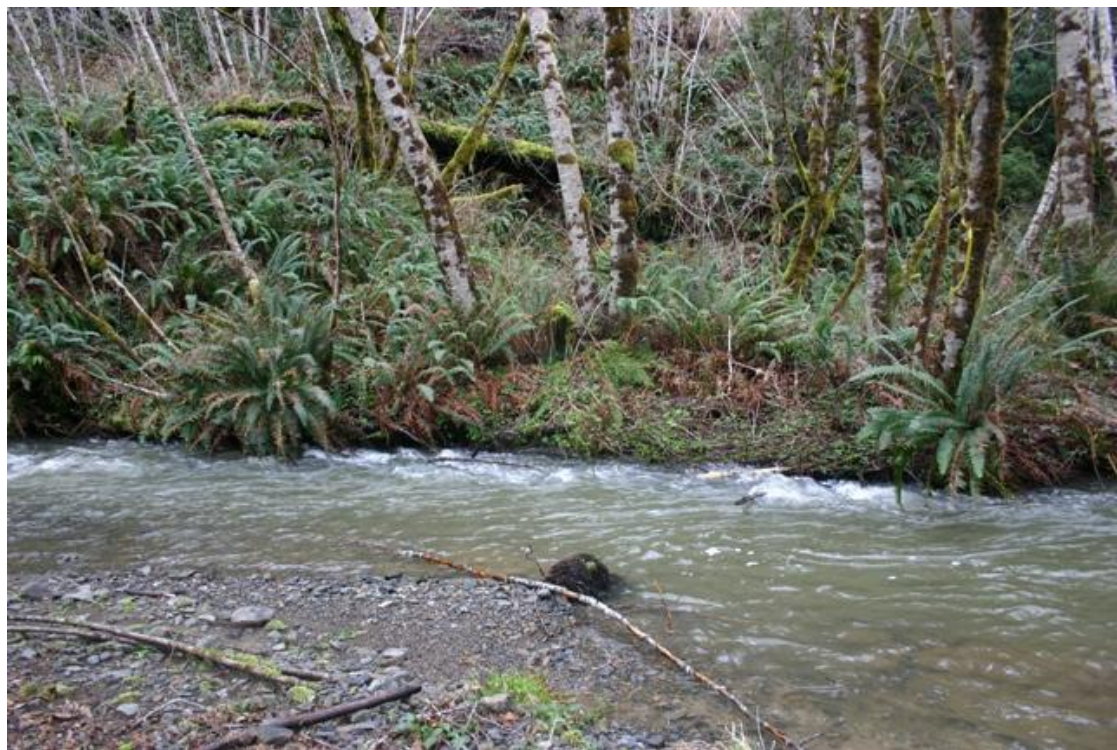
Figure 30. Shallow pool near top of project reach prior to installation of structure #4, Mainstem McGarvey Creek, Lower Klamath River, California, February 2007.

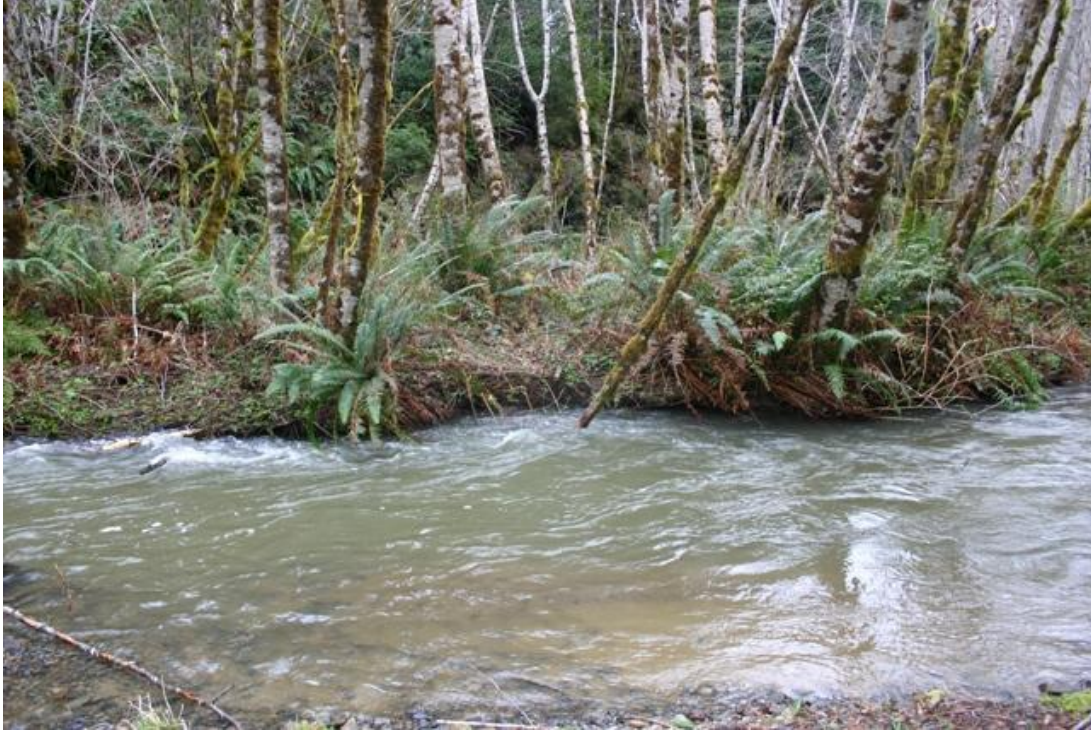
Figure 31. Shallow pool near top of project reach prior to installation of structure #4, Mainstem McGarvey Creek, Lower Klamath River, California, February 2007.

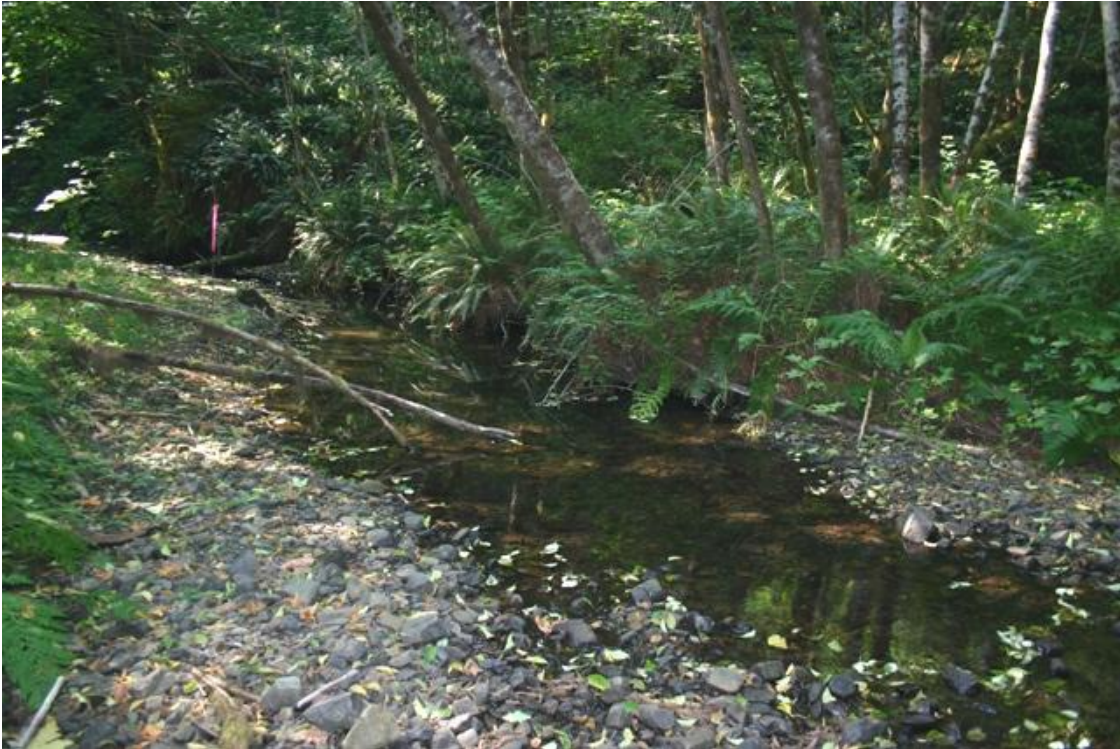
Figure 32. Shallow pool near top of project reach prior to installation of structure #4, Mainstem McGarvey Creek, Lower Klamath River, California, September 2008.

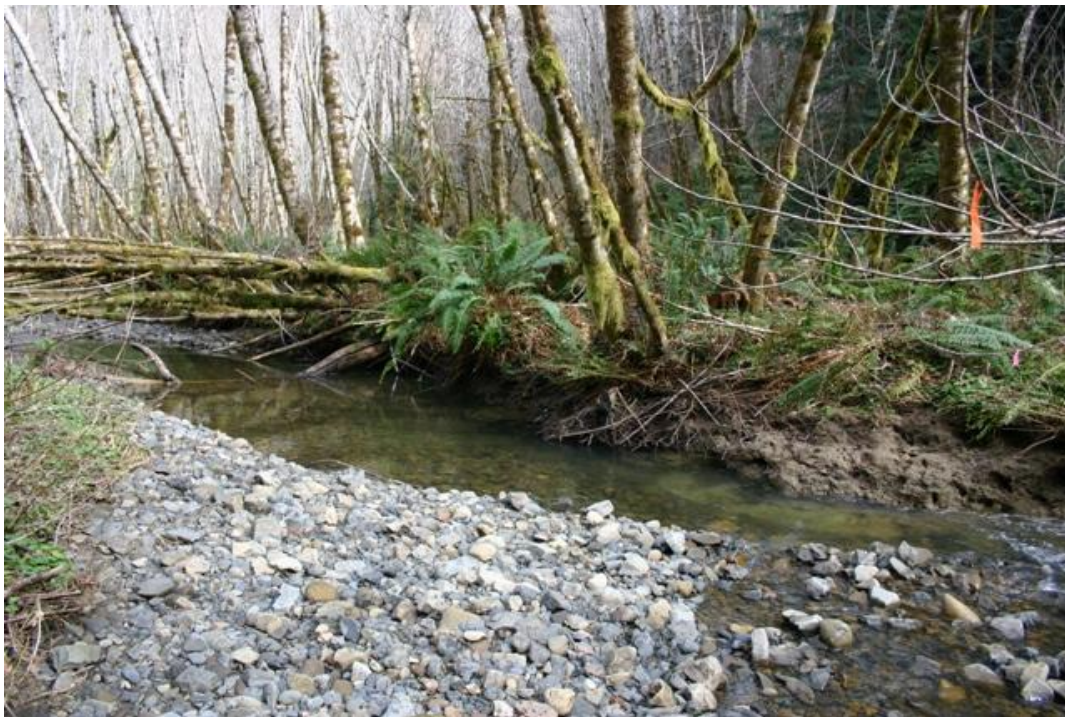
Figure 40. Shallow pool in upper portion of reach prior to installation of structure #5, Mainstem McGarvey Creek, Lower Klamath River, California, February 2007.

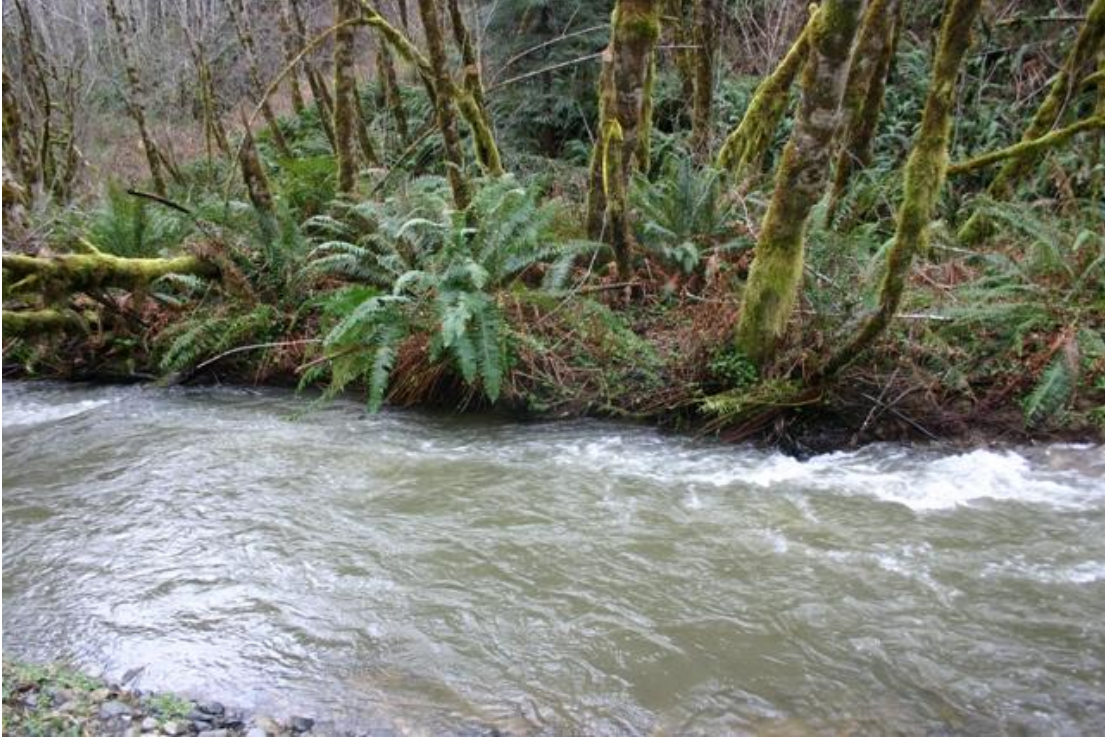
Figure 40. Shallow pool in upper portion of reach prior to installation of structure #5, Mainstem McGarvey Creek, Lower Klamath River, California, February 2007.

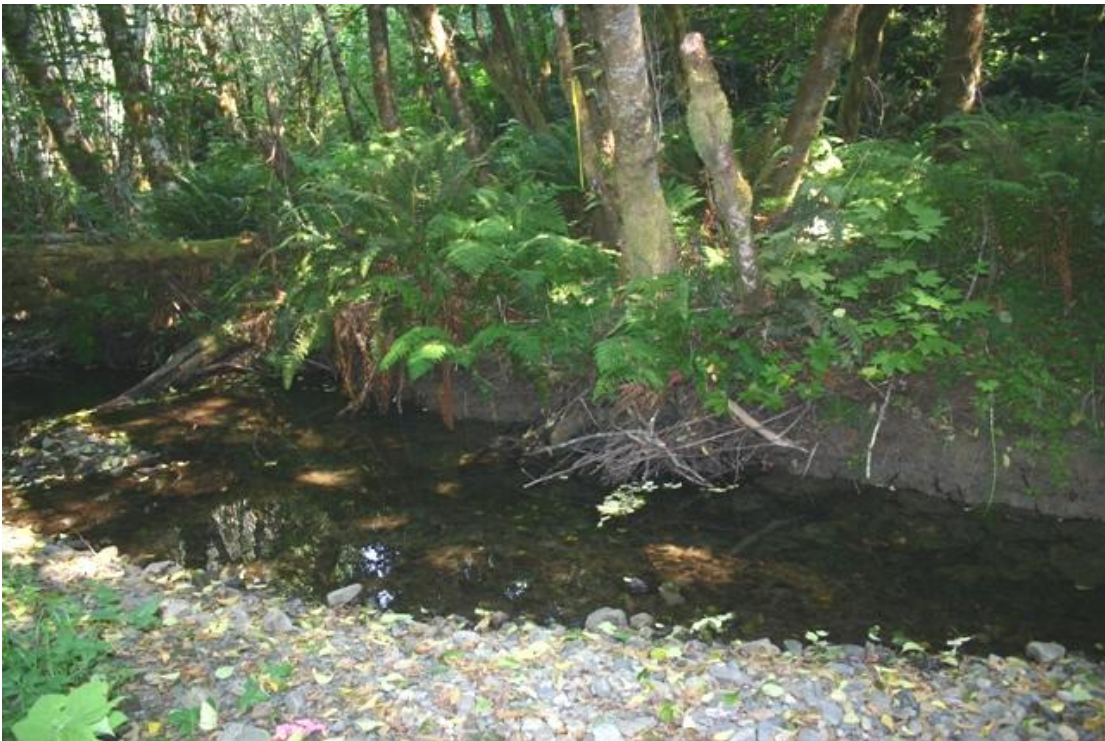
Figure 41. Shallow pool in upper portion of reach prior to installation of structure #5, Mainstem McGarvey Creek, Lower Klamath River, California, September 2008.

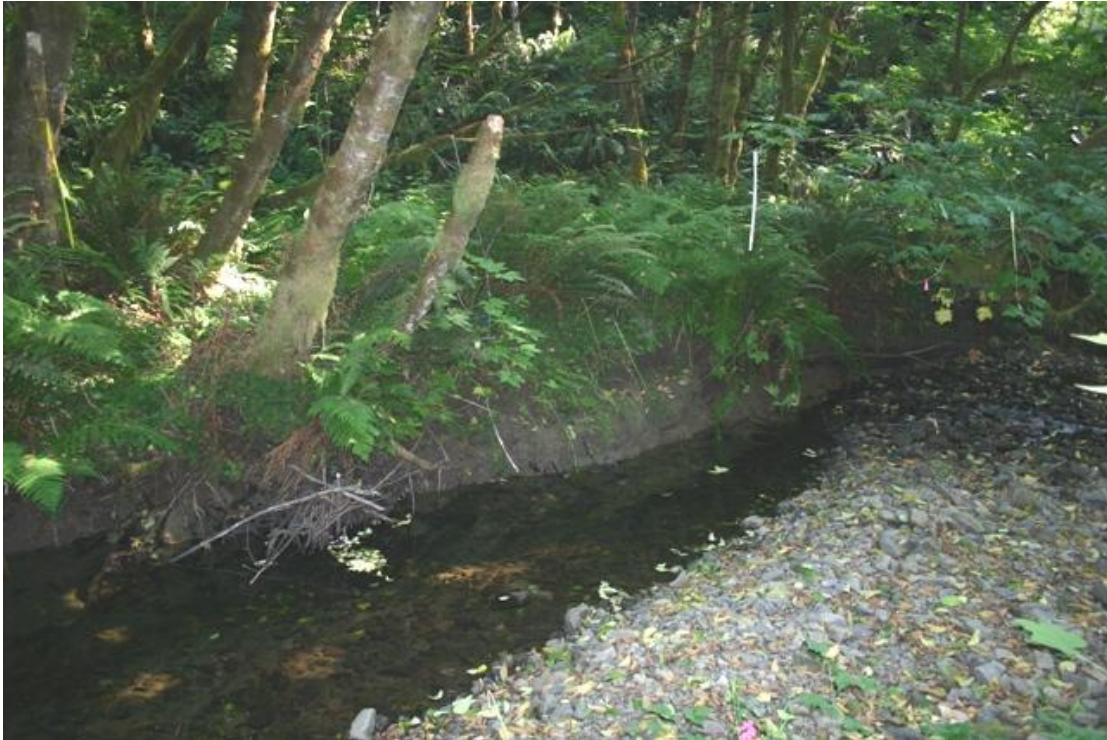
Figure 42. Shallow pool in upper portion of reach prior to installation of structure #5, Mainstem McGarvey Creek, Lower Klamath River, California, September 2008.

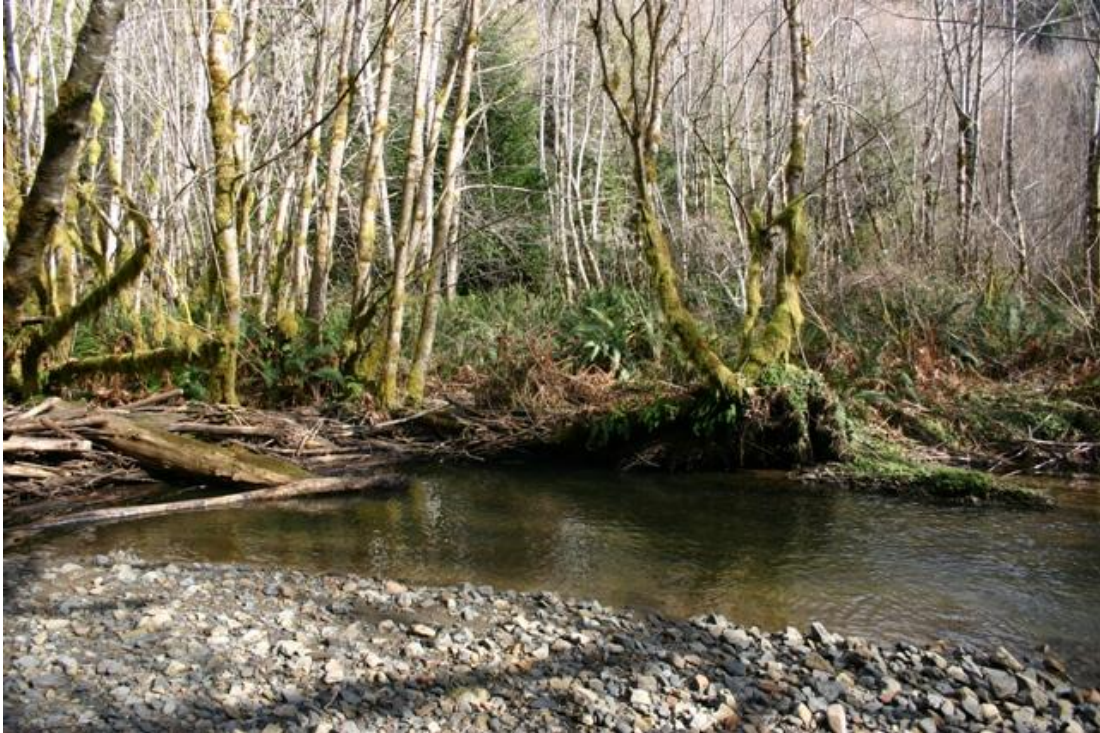
Figure 53. Confluence pool in upper portion of reach prior to installation of structure #6, Mainstem McGarvey Creek, Lower Klamath River, California, February 2007.

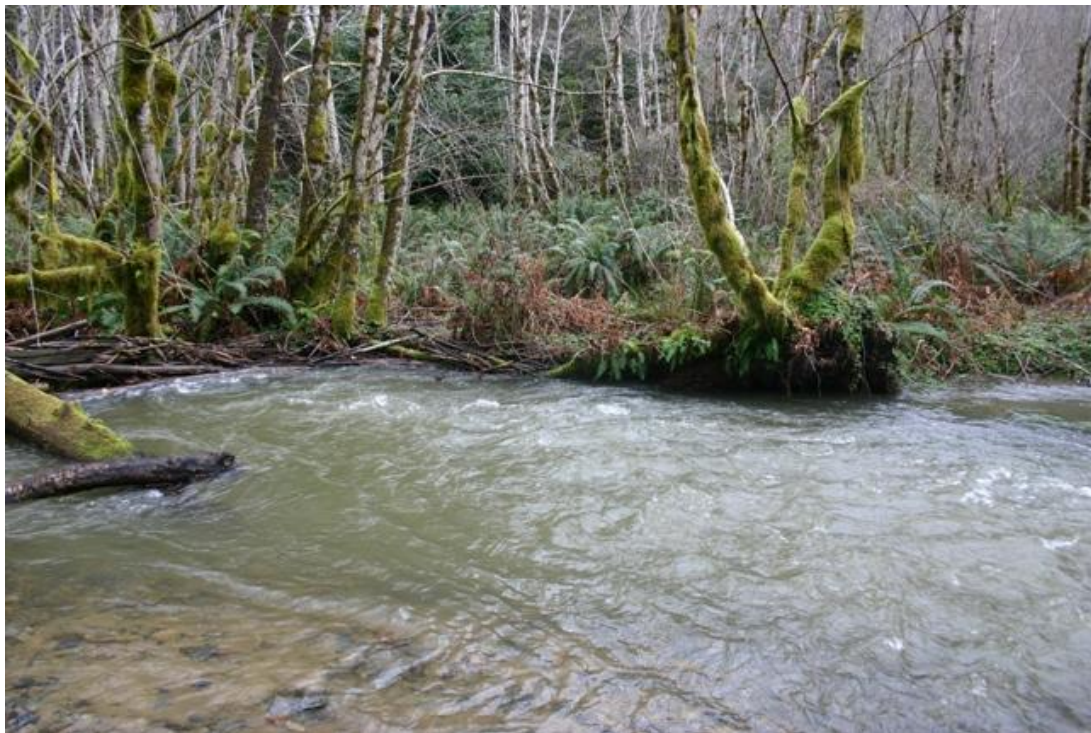
Figure 54. Confluence pool in upper portion of reach prior to installation of structure #6, Mainstem McGarvey Creek, Lower Klamath River, California, February 2007.

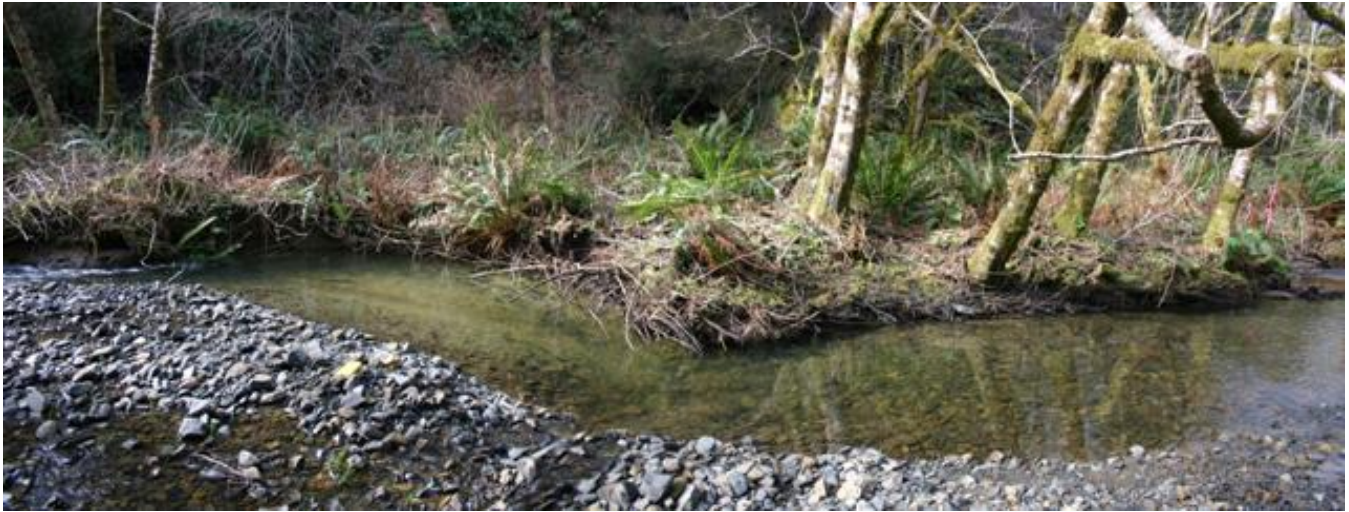
Figure 60. Backwater pool in upper portion of reach prior to installation of structure #7, Mainstem McGarvey Creek, Lower Klamath River, California, February 2007.

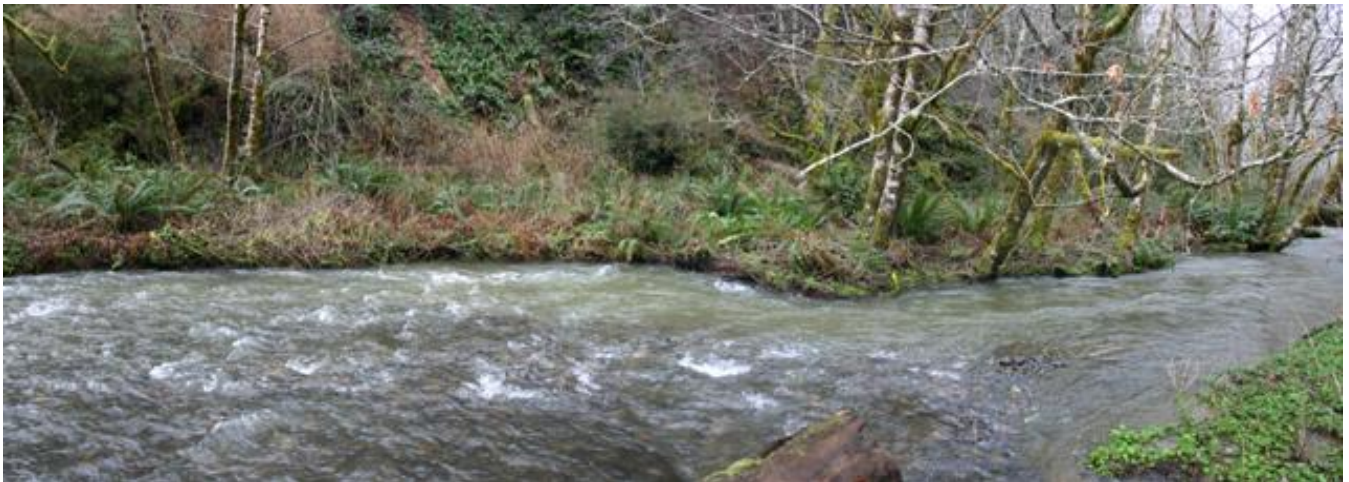
Figure 61. Backwater pool in upper portion of reach prior to installation of structure #7, Mainstem McGarvey Creek, Lower Klamath River, California, February 2007.

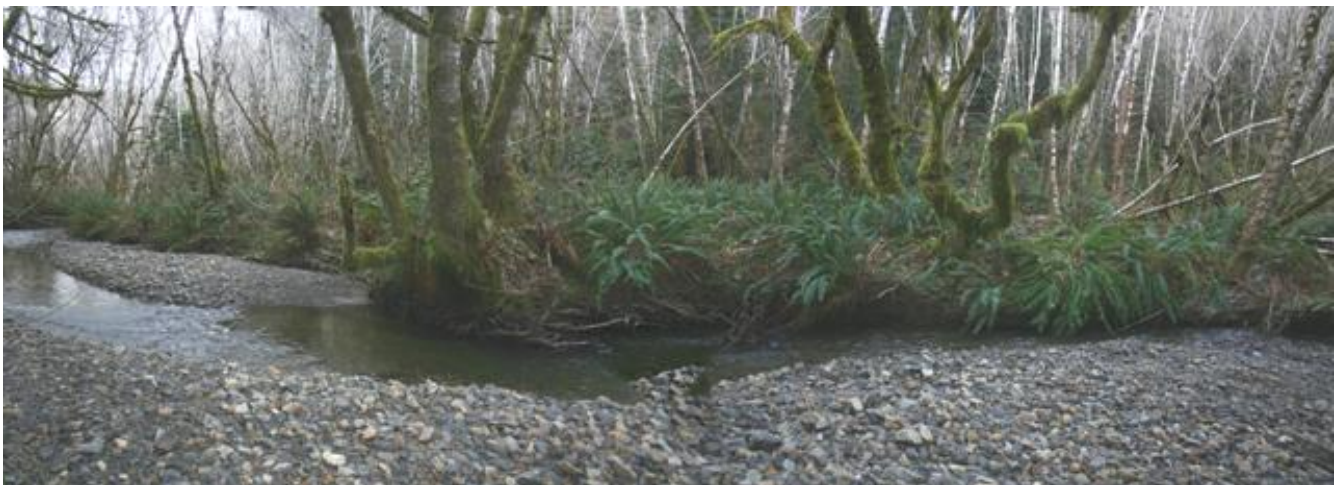
Figure 65. Lateral scour pool in middle portion of reach prior to installation of structures #8-9, Mainstem McGarvey Creek, Lower Klamath River, California, February 2007.
