Lower Klamath Sub-Basin Riparian Restoration Project
Project Completion Report – FY 2002

Yurok Tribal Fisheries Program
15900 Highway 101 North
Klamath, CA 95548

Submitted To:
Klamath River Basin Fisheries Task Force
December 2003

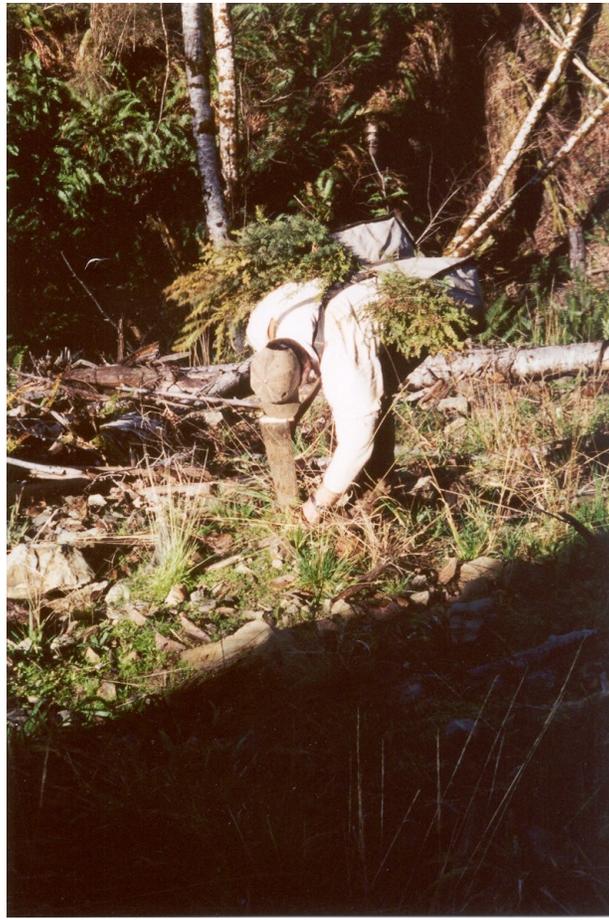
Figure 1. YTFFP crewmember planting bare-root conifers on the decommissioned M-800 road, West Fork McGarvey Creek, lower Klamath River, California, 2002.

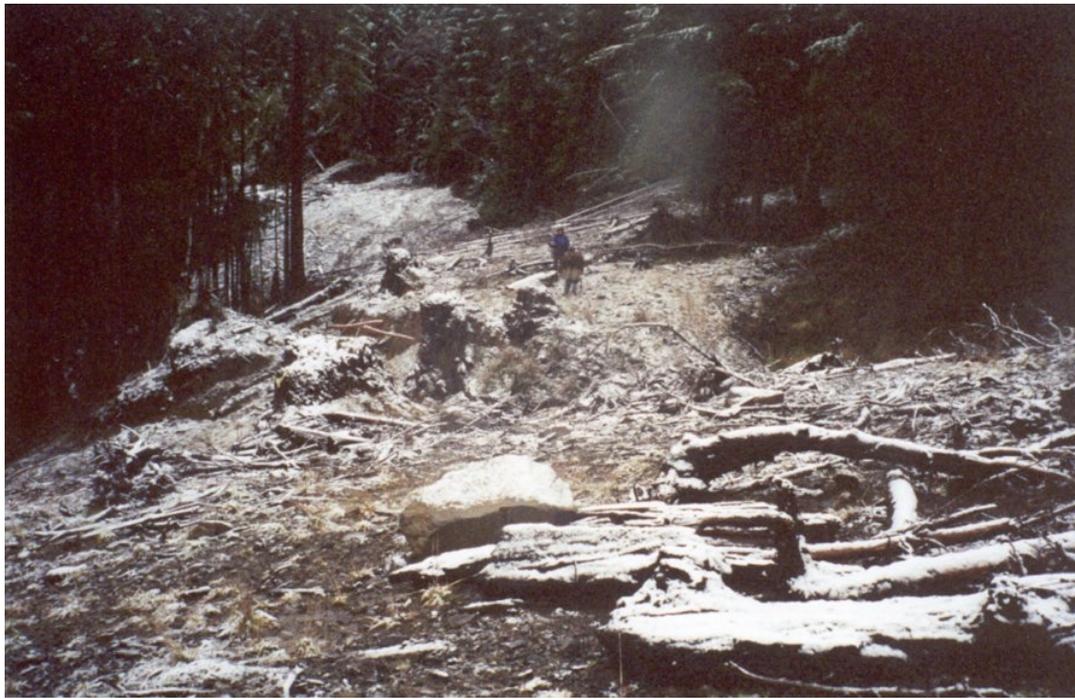
Figure 2. YTFP crewmembers planting trees on the decommissioned T-140 road, Tectah Creek, lower Klamath River, California, 2002.

A decommissioned road network in upper South Fork Ah Pah was planted with approximately 2,000 trees, consisting of 50 % redwood and 50% Douglas fir trees (Table 1, Figure 4). Approximately 3,500 trees were planted along 2 miles of decommissioned roads in upper Tectah Creek, consisting of 75% (n=2,625) Douglas fir and 25% (n=875) redwood (Table 1, Figure 5).

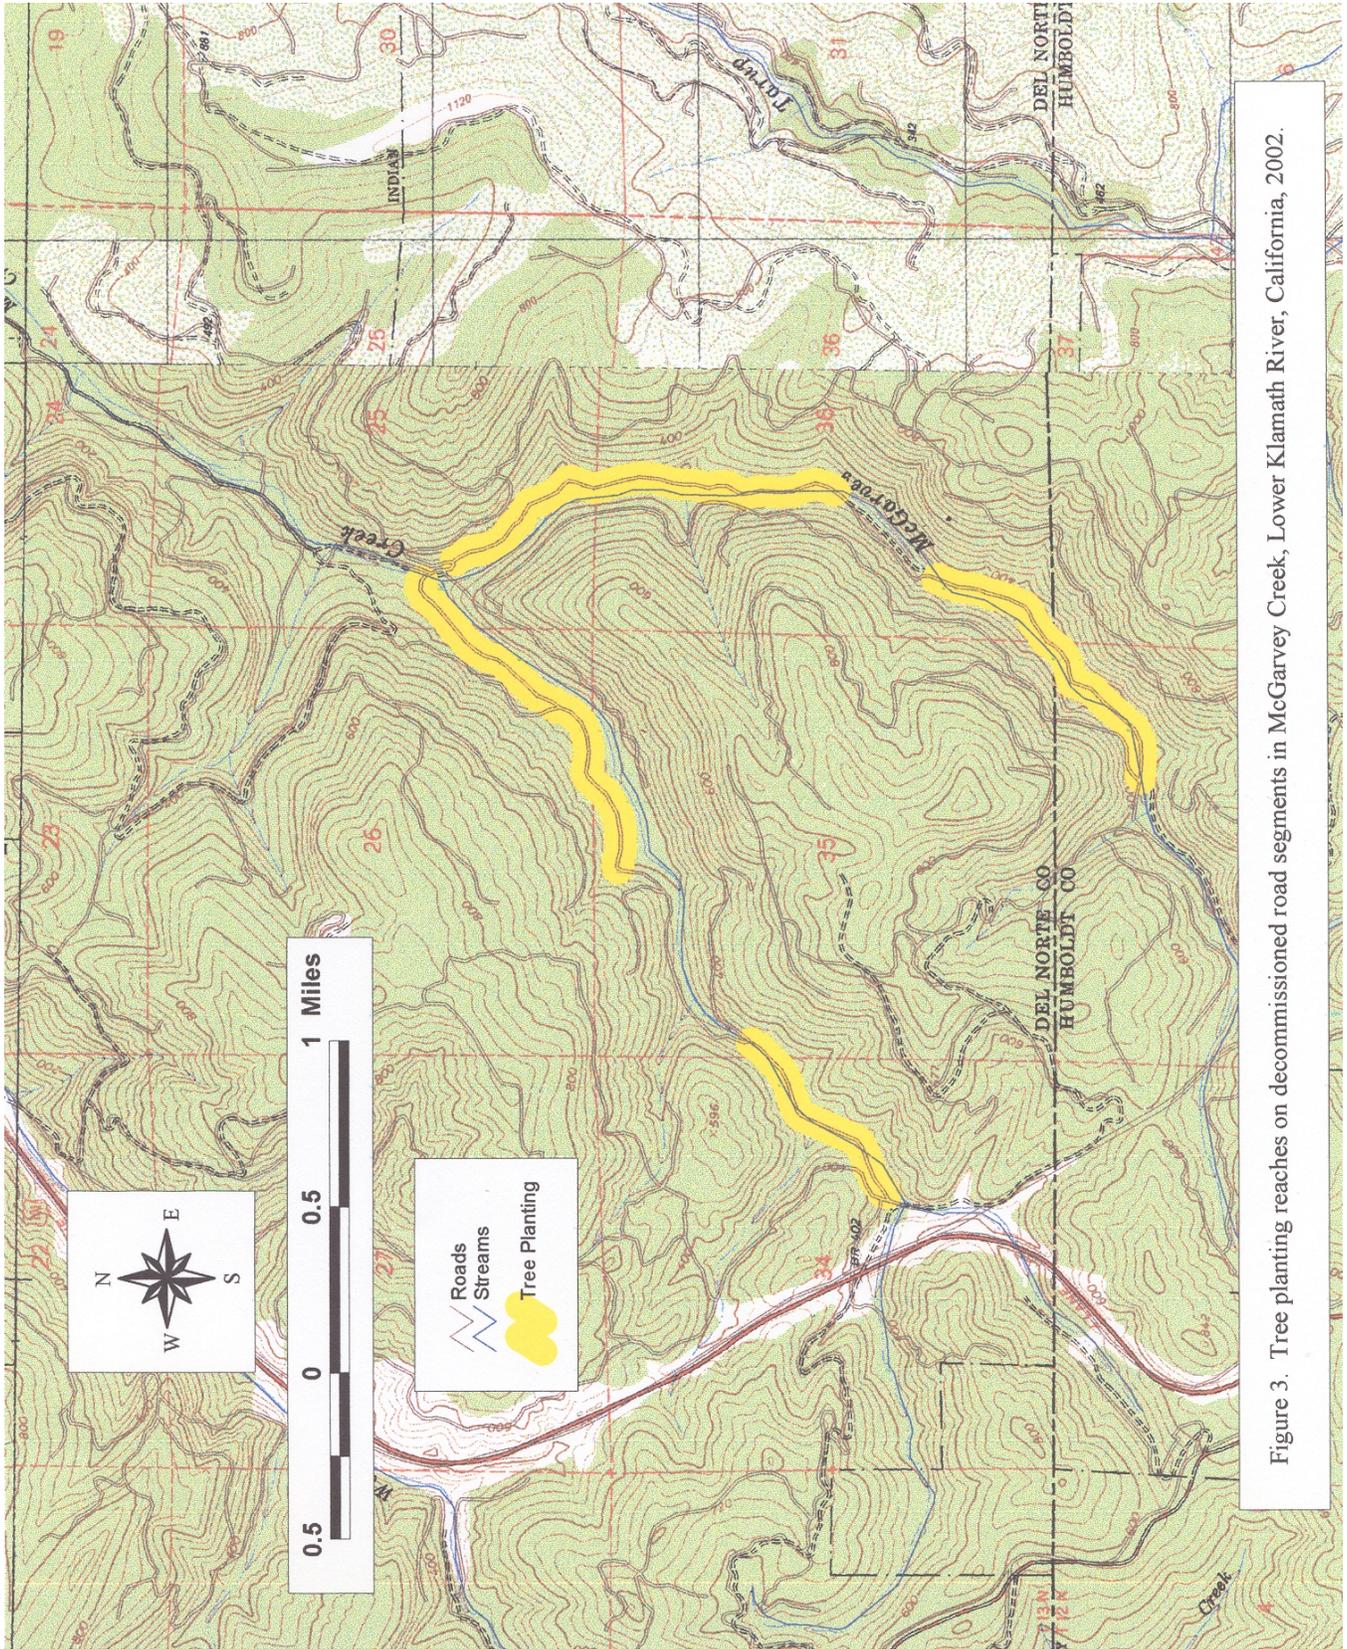
Figure 3. Tree planting reaches on decommissioned road segments in McGarvey Creek, Lower Klamath River, California, 2002.

Redwood and Douglas fir trees were planted along approximately 5 miles of decommissioned roads within the riparian area of mainstem and West Fork McGarvey Creek (Figure 3). A total of 2,500 trees were planted along the mainstem, with approximately 75% (n=1,875) redwood and 25% (n=625) Douglas fir (Table 1). 2,000 conifers were planted along West Fork McGarvey Creek, comprised of approximately 75% (n=1,500) redwood and 25 % (n=500) Douglas fir.

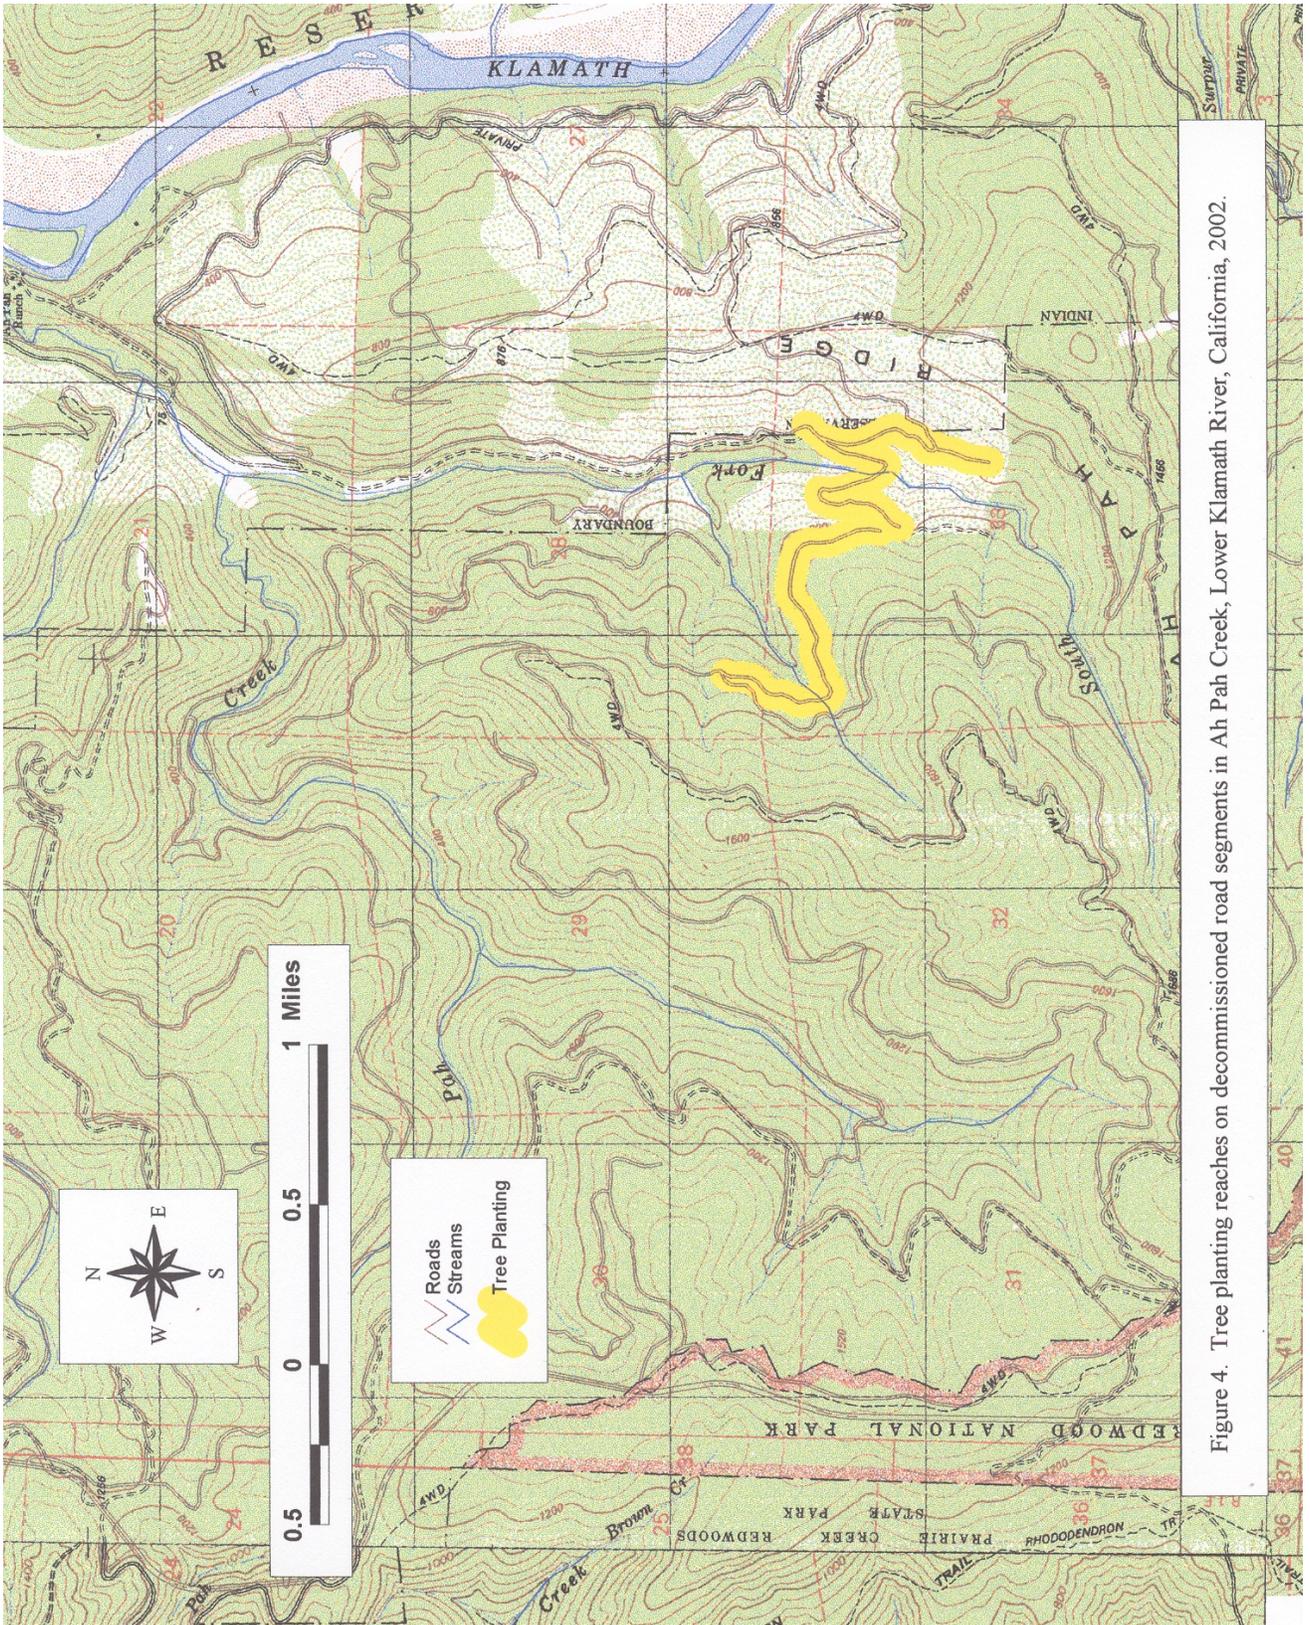
Figure 4. Tree planting reaches on decommissioned road segments in Ah Pah Creek, Lower Klamath River, California, 2002.

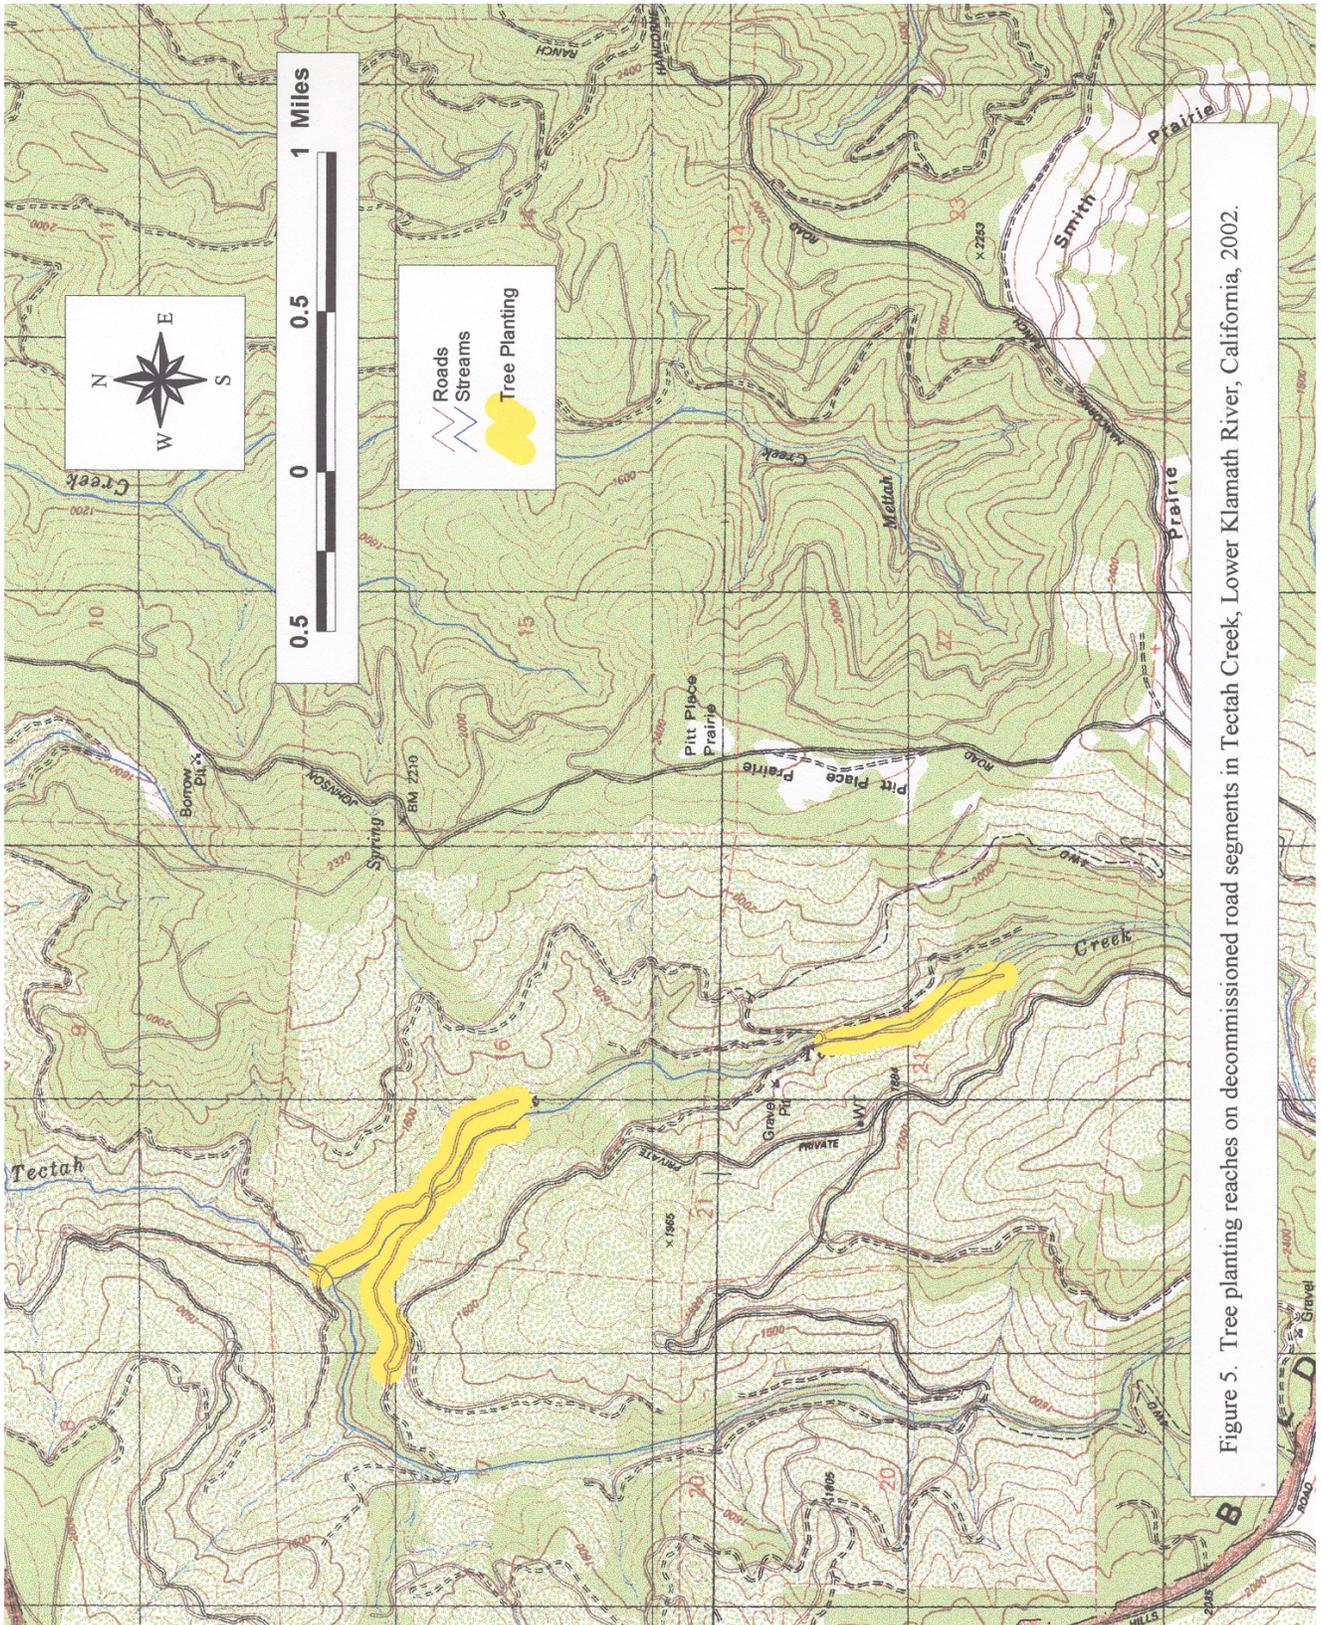
Figure 5. Tree planting reaches on decommissioned road segments in Tectah Creek, Lower Klamath River, California, 2002.

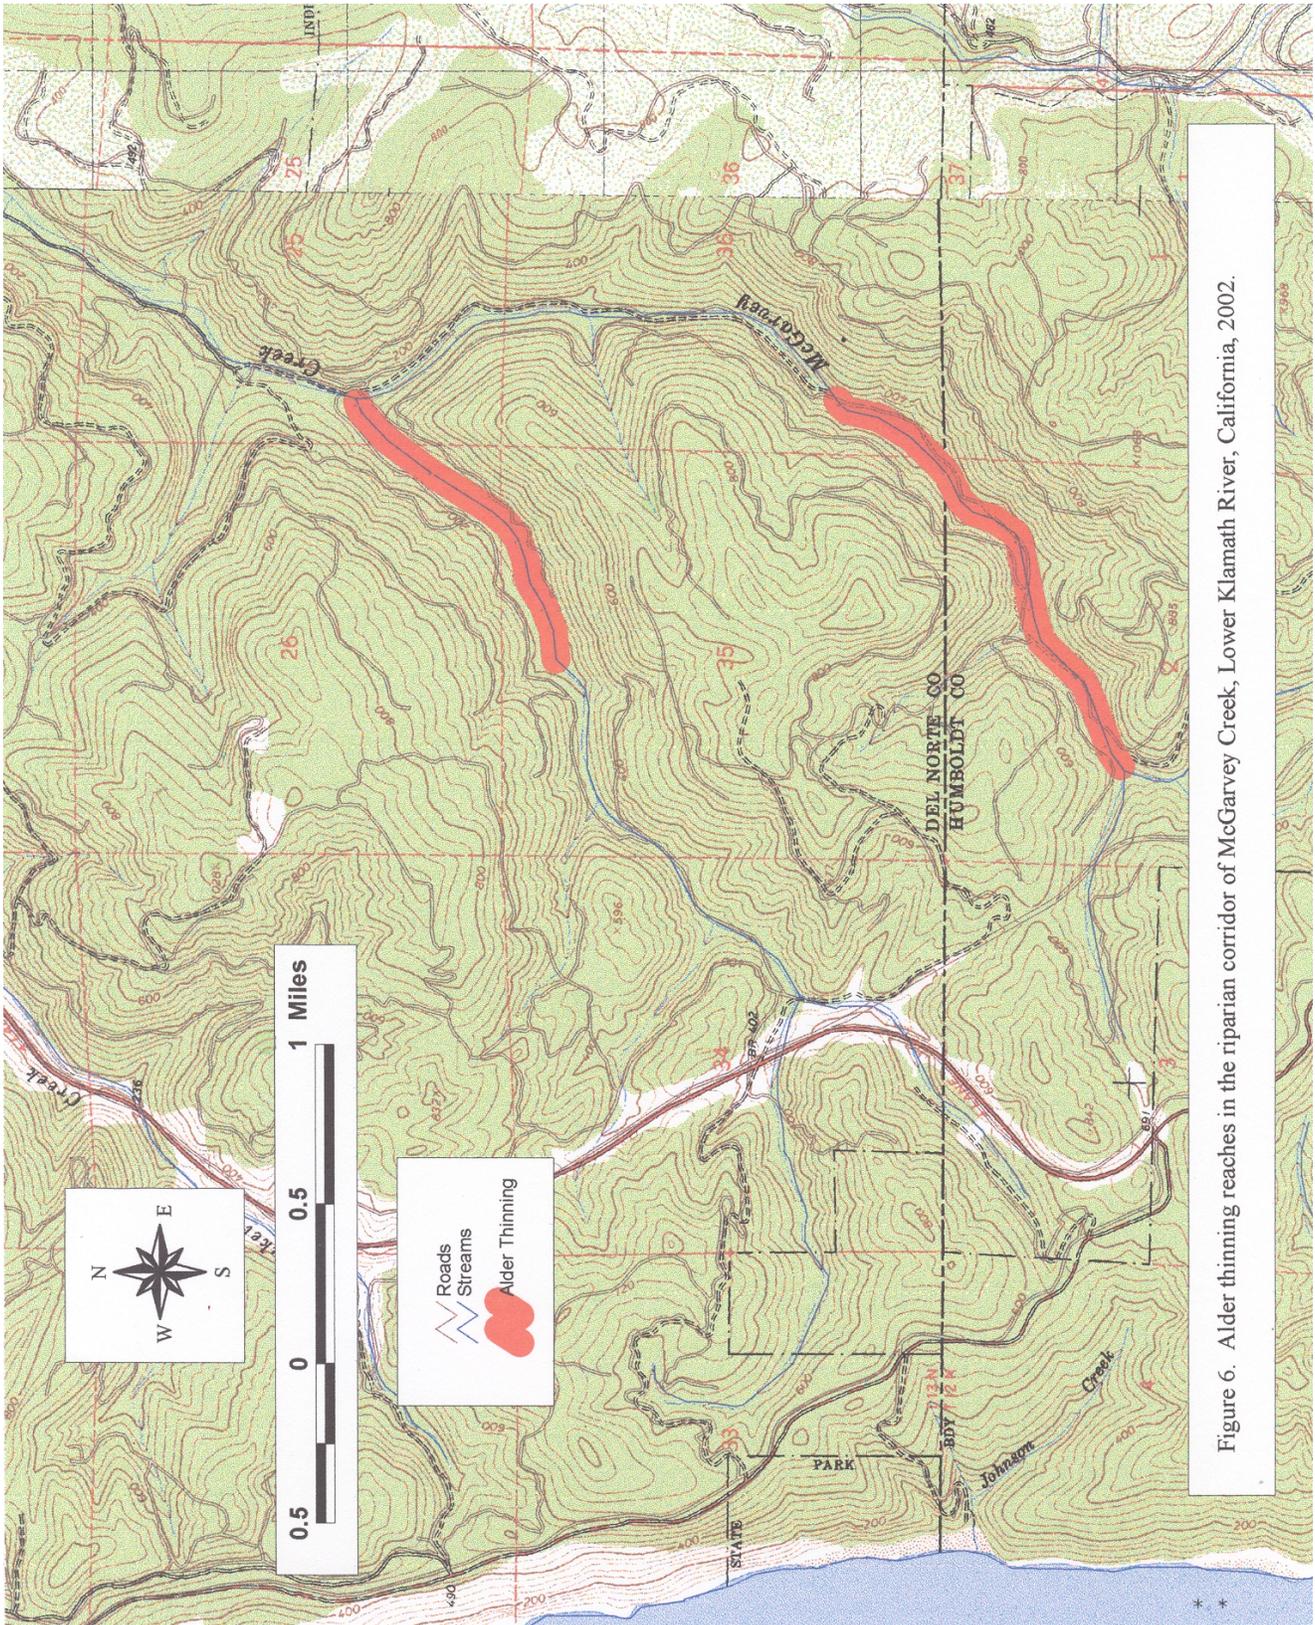
Figure 6. Alder thinning reaches in the riparian corridor of McGarvey Creek, Lower Klamath River, California, 2002.

Twenty clusters of conifers were thinned within the mainstem McGarvey Creek reach (Figure 6). A total of 72 redwood and 19 Douglas fir trees were released in this reach (Table 2). The diameter of Douglas fir trees ranged from 0.6-8.0 inches (dbh) with an average diameter of 3.3 inches, while the diameter of redwood trees ranged from 1.4-13.1 inches with an average diameter of 5.3 inches (Tables 2-3). The average height of the Douglas fir trees was 24 feet, while the average height of the released redwood trees was 30 feet. The conifers ranged from 15-95 feet from the creek, with an average distance of 42 feet. A total of 108 alders were thinned while releasing these conifers along mainstem McGarvey Creek.

Twenty-eight clusters of conifers were thinned in West fork McGarvey Creek (Figure 6). A total of 78 redwood and 6 Douglas fir trees were released in this reach (Table 2). The diameter of Douglas fir trees ranged from 2.2-5.1 inches, with an average diameter of 3.4 inches, while the diameter of redwood trees ranged from 1.4-15.9 inches, with an average of 5.9 inches (Tables 2, 4). Douglas fir tree heights ranged from 15-40 feet with an average height of 23 feet, while the average height of redwood trees was ranged from 10-100 feet, with an average of 25 feet. A total of 94 alders were thinned from both redwood and Douglas fir trees along the West Fork McGarvey Creek.

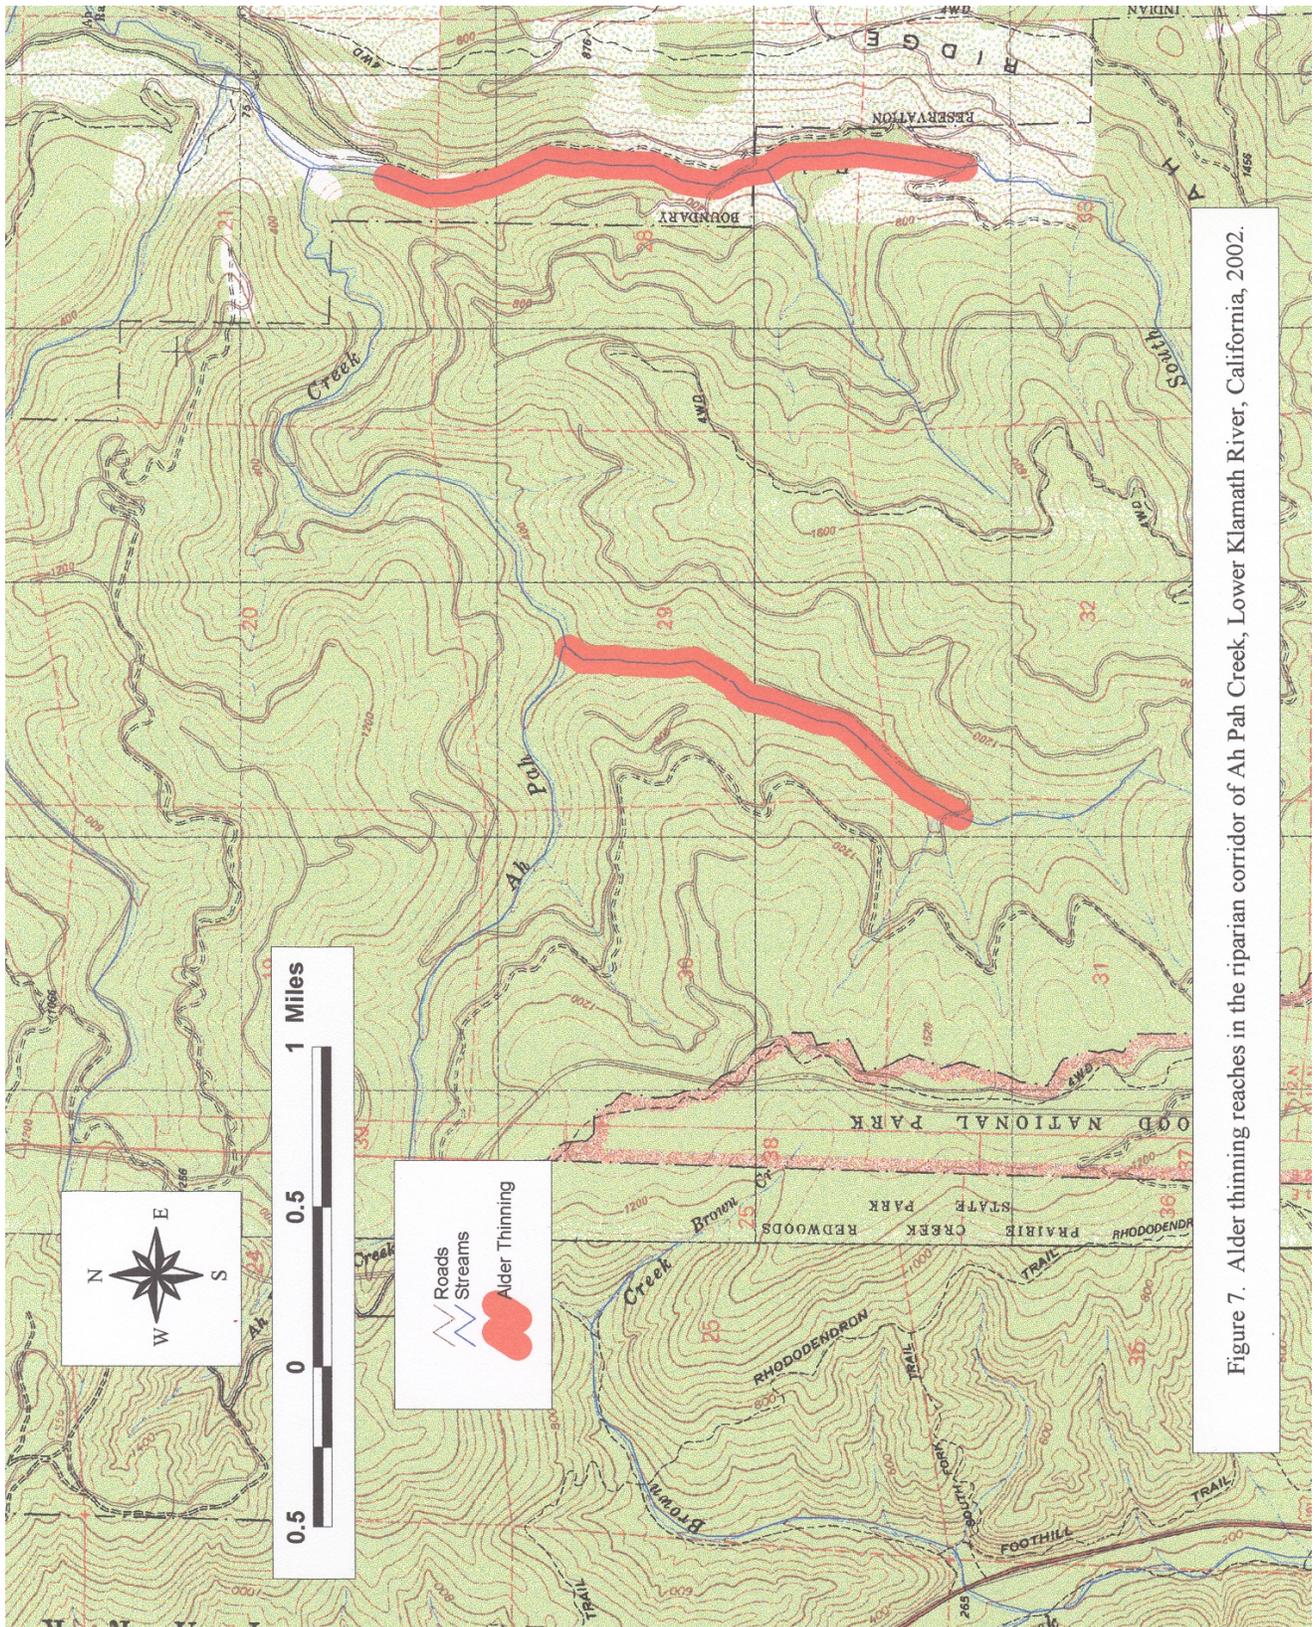
Figure 7. Alder thinning reaches in the riparian corridor of Ah Pah Creek, Lower Klamath River, California, 2002.

Twenty clusters of conifers were thinned in upper mainstem Ah Pah Creek (Figure 7). A total 50 redwood and 7 Douglas fir trees were released in this reach (Table 2). Douglas fir trees ranged from 1.6-10.2 inches in diameter, with an average of 4.7 inches, while the diameter of redwood trees ranged from 1.3-22.9 inches, with an average diameter of 6.6 inches (Tables 2, 5). Douglas fir tree ranged from 10-60 feet in height with an average height of 26 feet, while redwood trees ranged in height from 7-50 feet, with an average of 28 feet. A total of 92 alders were thinned from both redwood and Douglas fir trees along the South Fork Ah Pah Creek.

Nineteen clusters of conifers were thinned in South Fork Ah Pah Creek (Figure 7). A total of 28 redwood and 47 Douglas fir trees were released in this reach (Table 2). Douglas fir trees ranged from 1.6-12.1 inches in diameter, with an average of 3.9 inches, while the diameter of redwood trees ranged from 1.6-14.3 inches, averaging 5.7 inches (Tables 2, 6). Douglas fir tree ranged from 8-80 feet with an average height of 28 feet, while redwoods ranged in height from 10-70 feet, with an average of 29 feet. A total of 125 alders were thinned while releasing these conifers along South Fork Ah Pah Creek.

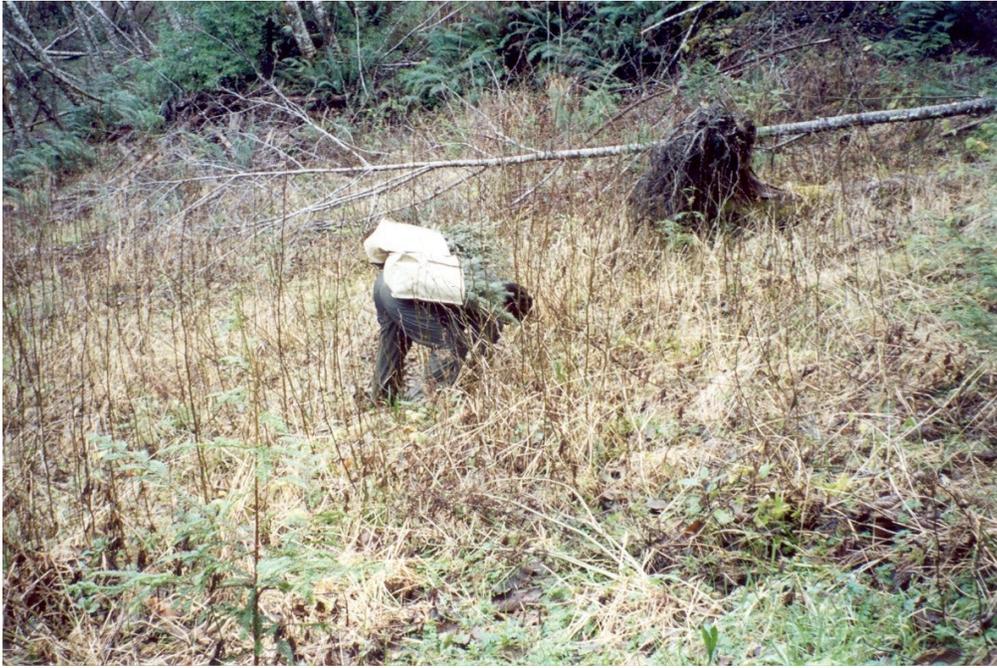
Figure 8. YTFP crewmember planting bareroot conifers on decommissioned M-10 road, McGarvey Creek, lower Klamath River, California, 2002.

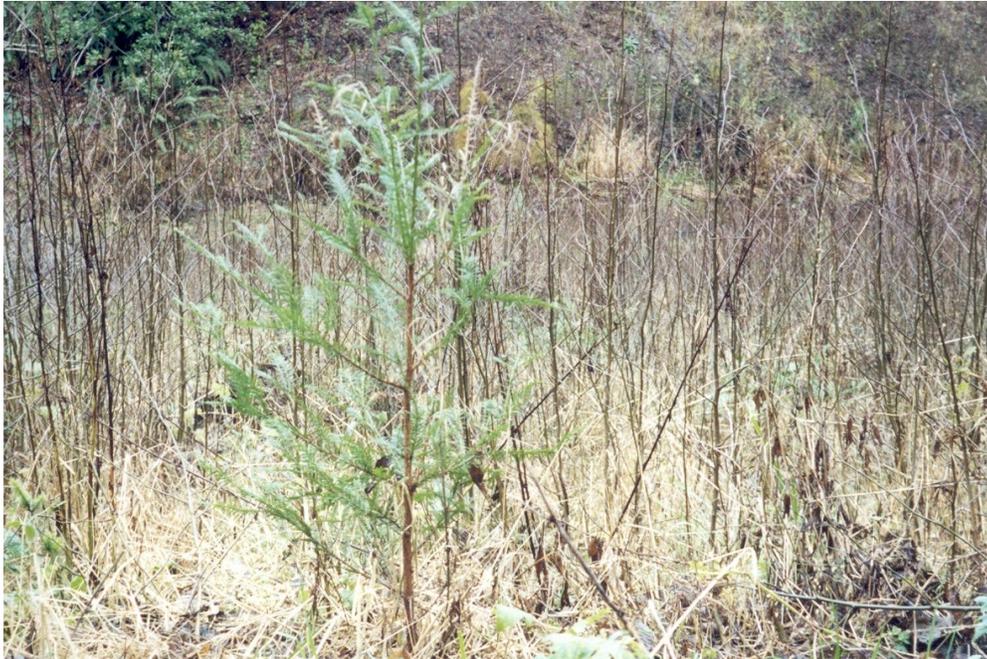
Figure 9. Coastal redwood tree two years after planting, decommissioned M-10 road, McGarvey Creek, lower Klamath River, California, 2003.

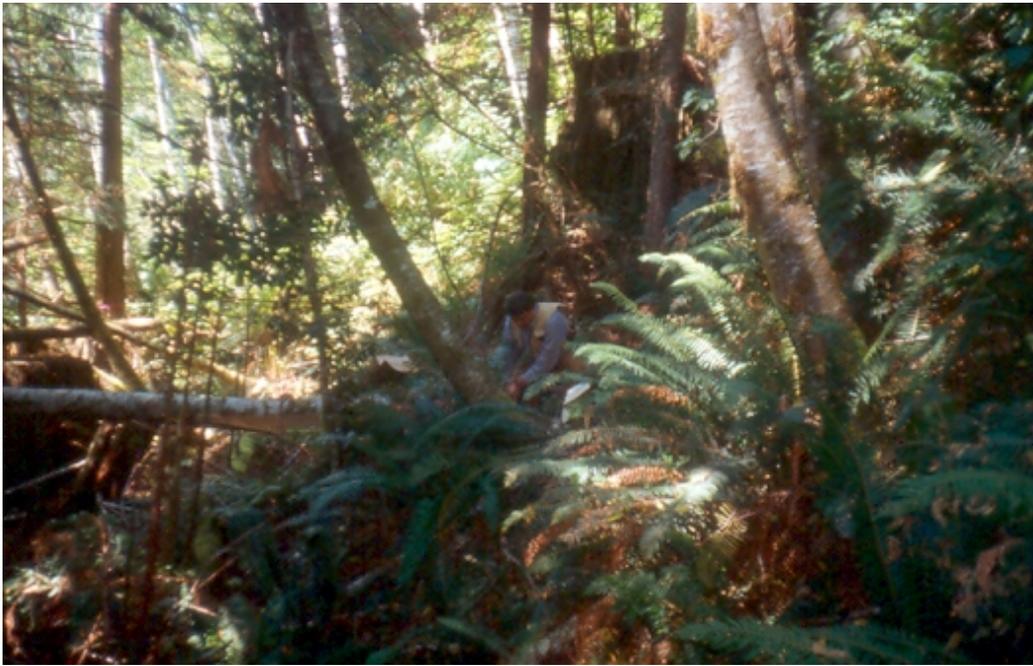
Figure 10. YTFP crewmember thinning alders to release adjacent conifer trees, West Fork McGarvey Creek, lower Klamath River, California, 2002.

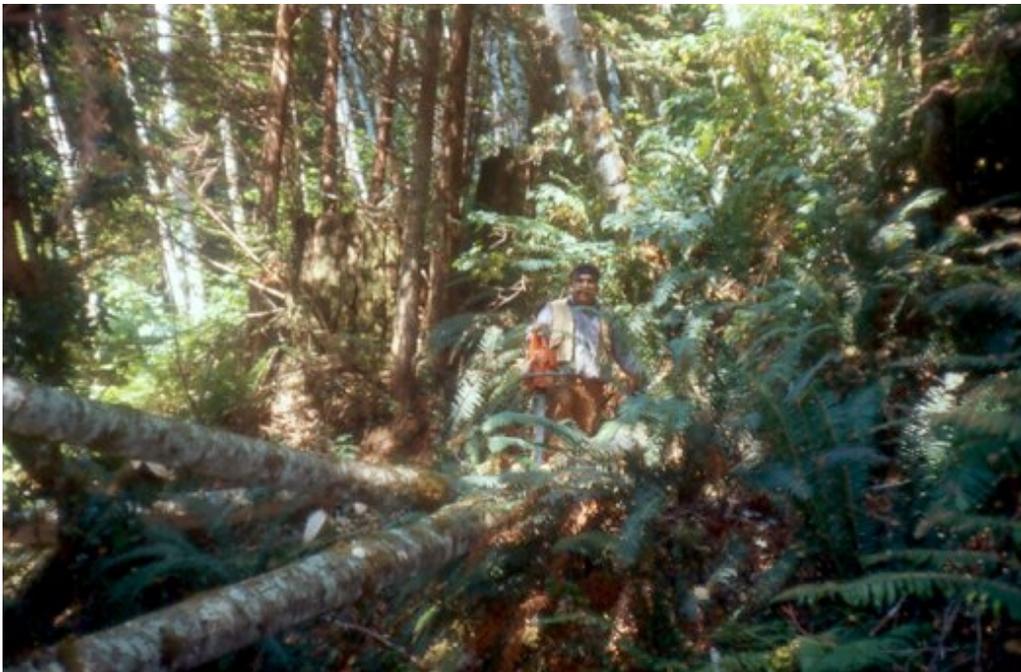
Figure 11. YTFP crewmember thinning alders to release adjacent conifer trees, West Fork McGarvey Creek, lower Klamath River, California, 2002.
