## Restoration Planning in Lower Blue Creek, Lower Klamath River: Phase I

Final Technical Report - 2008

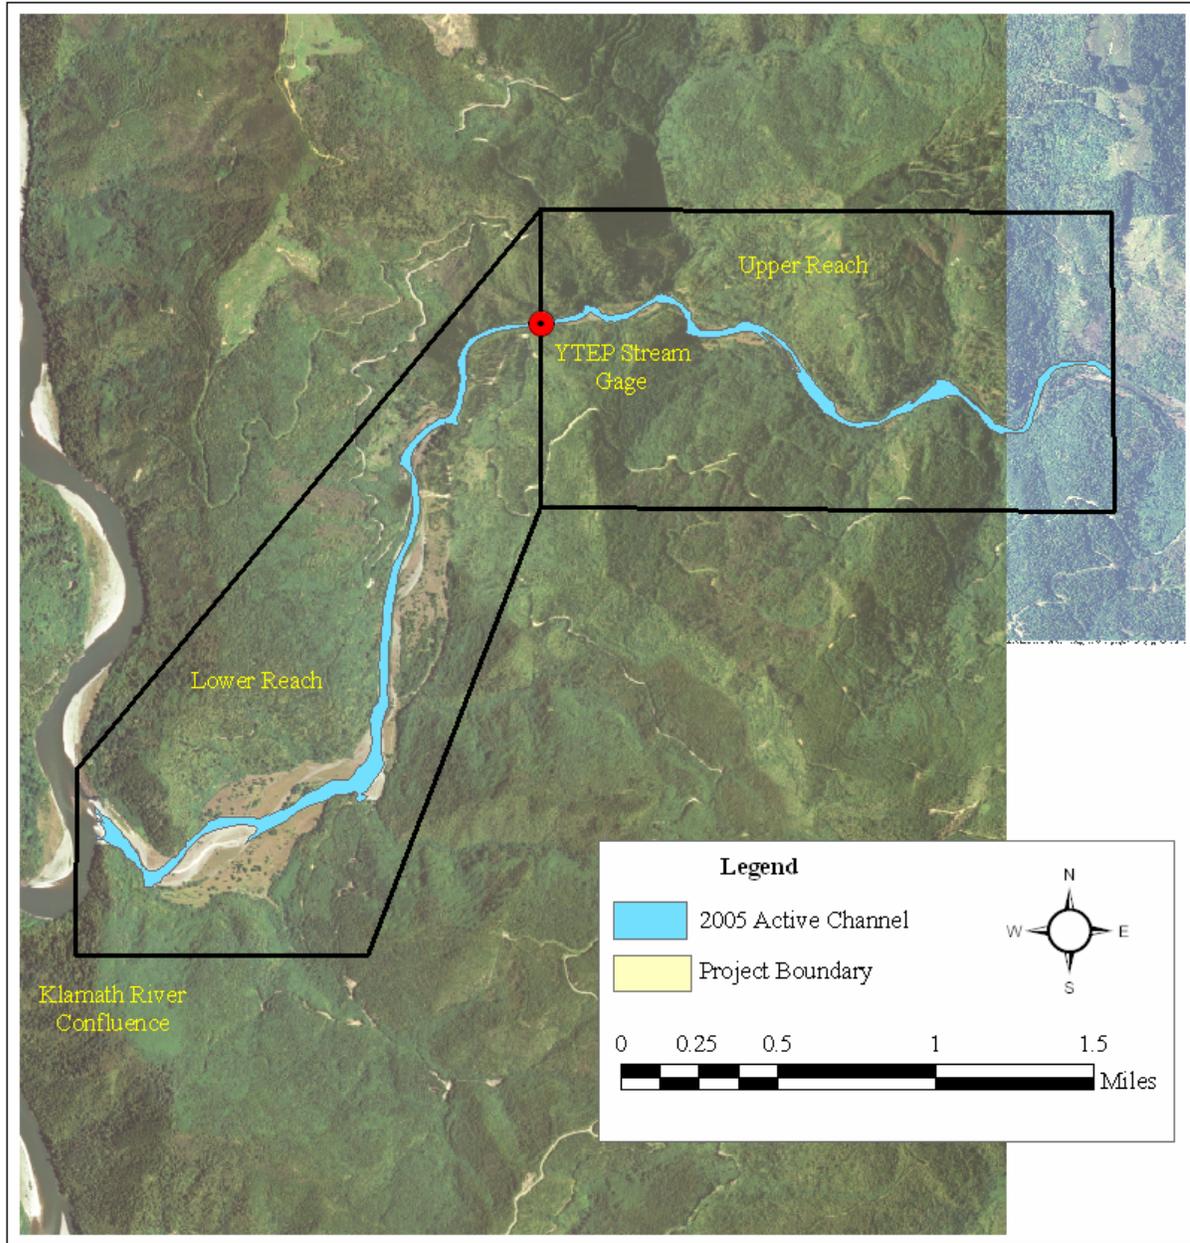
Figure 5. Map depicting two assessment areas in lower Blue Creek, Lower Klamath River Sub-basin, California. Base image: portions of the 2005 NAIP imagery, 1 meter resolution.

The project area consisted of riparian habitats and stream reaches located from the mouth of Blue Creek (41.426 Latitude; 123.928 Longitude) to approximately 2.1 miles upstream of the Yurok Tribe Environmental Program's stream gage (Figure 4). The study area was separated into an upper and lower reach, based on the degree of valley confinement (Jain et al. 2007). The upper reach is located within a steep narrow bedrock valley that limits lateral channel migration and the formation of extensive floodplains. The lower reach extended from where the valley widens and a series of discontinuous floodplains have formed, down to the confluence with the Klamath River (Figure 5).

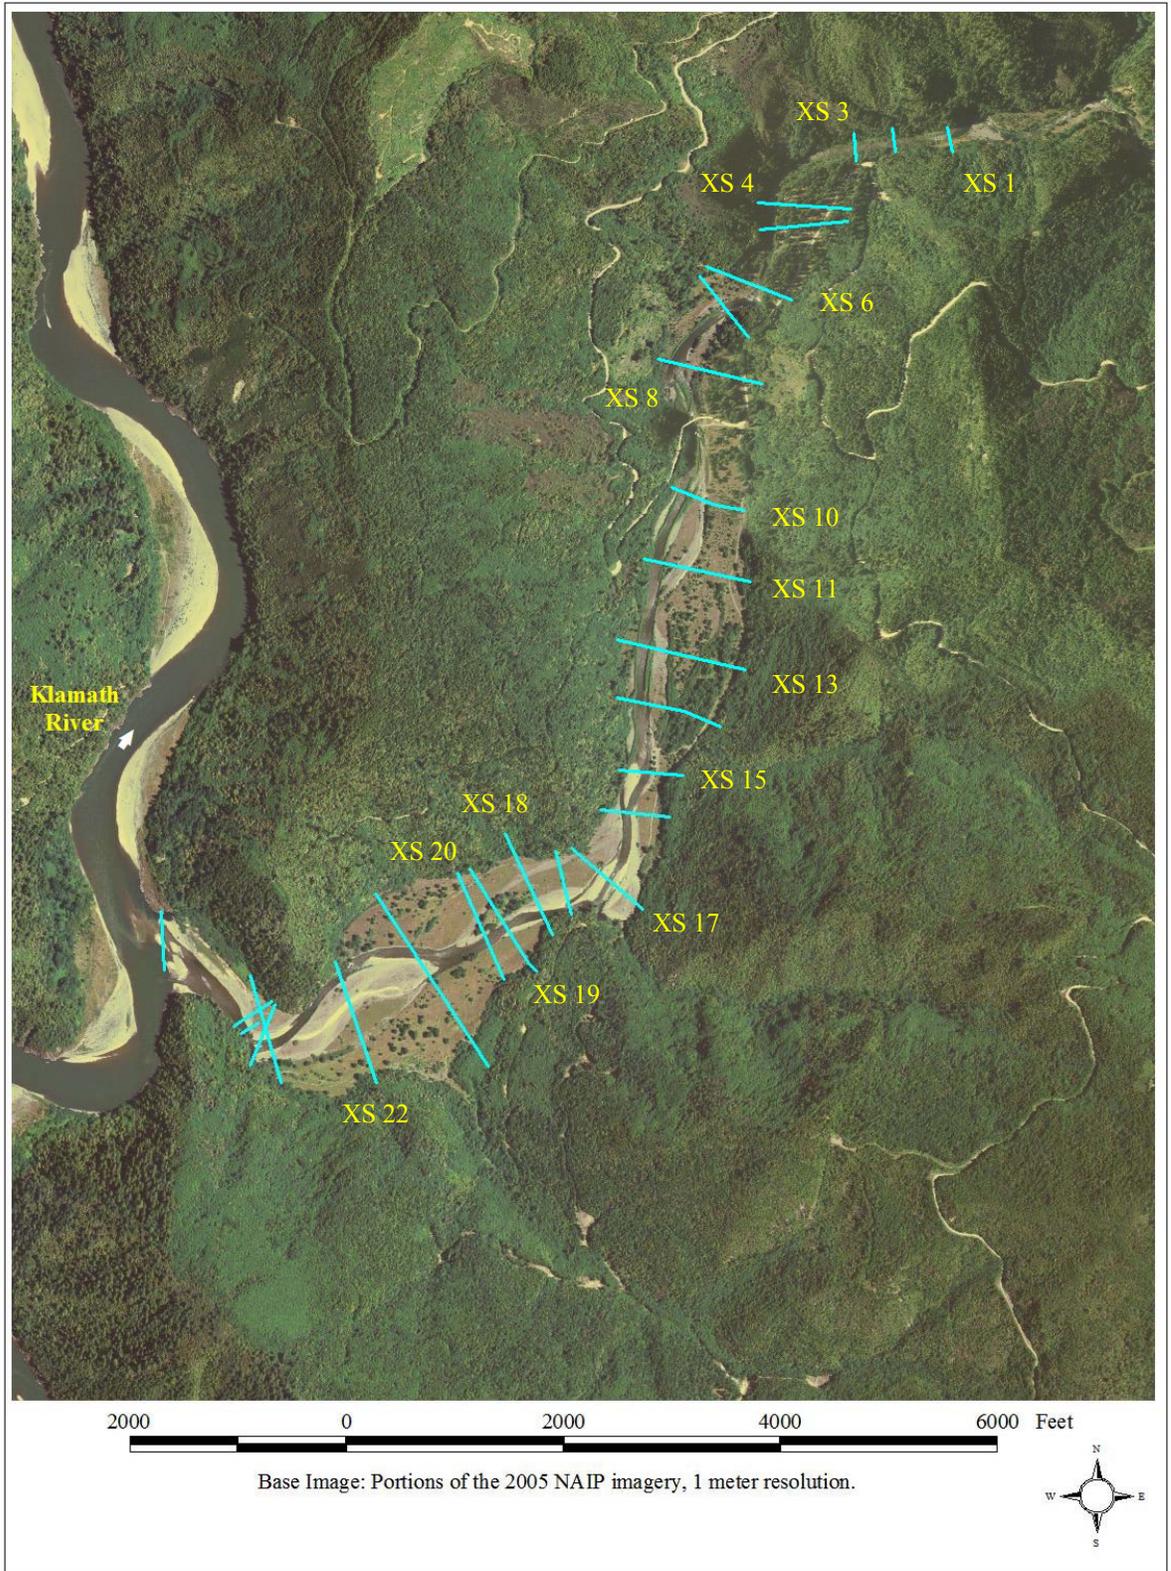
Figure 6. Map depicting permanent reference cross sections established in Blue Creek by the Yurok Tribal Fisheries Program, Lower Klamath River Sub-basin, California (2007 – 2008).

A total of 22 permanent and an additional four cross sections were established and surveyed in lower Blue Creek (Figure 6). Cross sections were established in various habitat types (i.e. pools, riffles, and runs) to better characterize the range of topographic conditions present in the lower valley. The Mature Conifer vegetation class was located on surfaces that were on average 29 feet above base flow elevations (Table 3; Figure 17). Both the Conifer Regeneration and Mature Cottonwood vegetation classes were located on surfaces that were on average 15 feet above base flow elevations (Table 3; Figure 17). The Upper Mesophytic vegetation class was present on surfaces that were on average 10 feet above base flow elevations; while the lower Mesophytic Class was located on surfaces that were on average 4.7 feet above base flow elevations (Table 3; Figure 17).

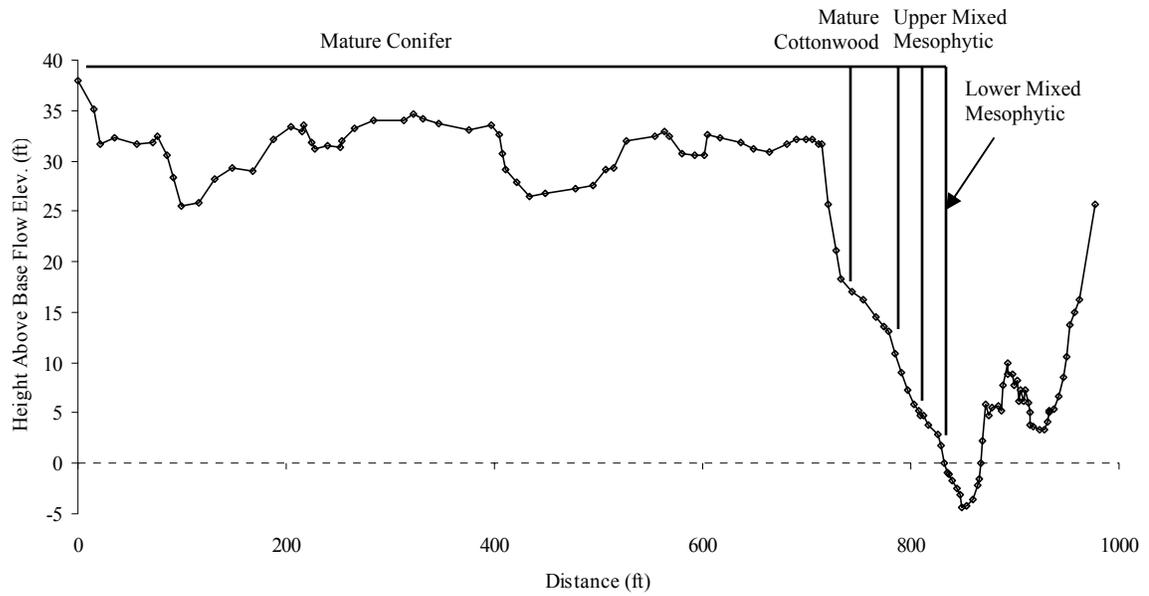
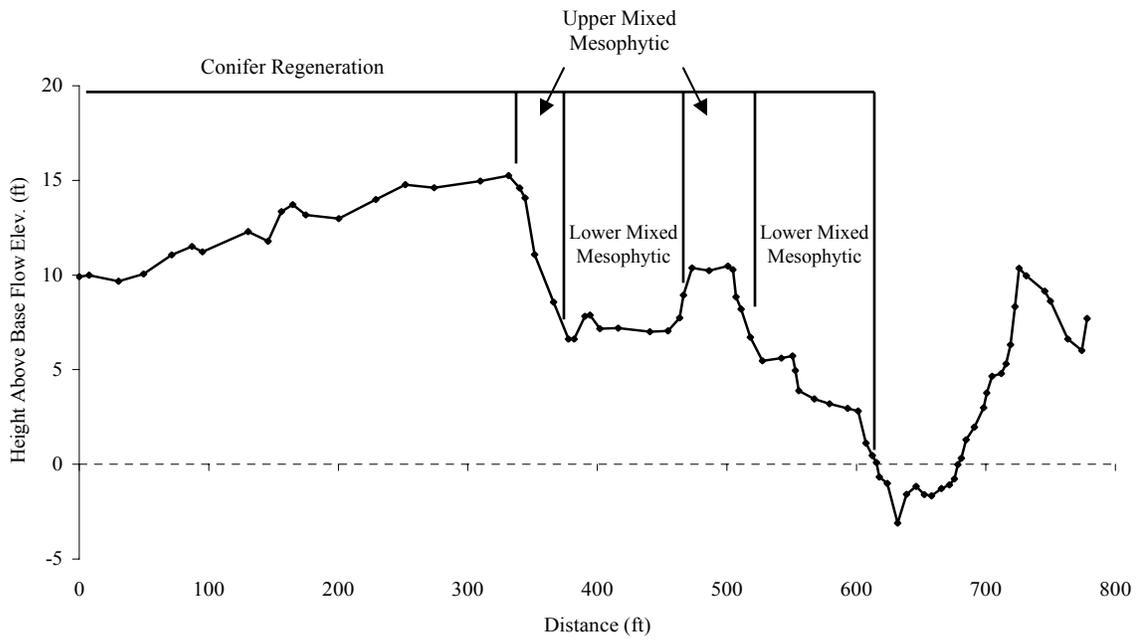
Figure 7. Cross section plots depicting riparian vegetation classes and elevations of riparian surfaces relative to base flow elevations in lower Blue Creek, Lower Klamath River Sub-basin, California (2007 – 2008).

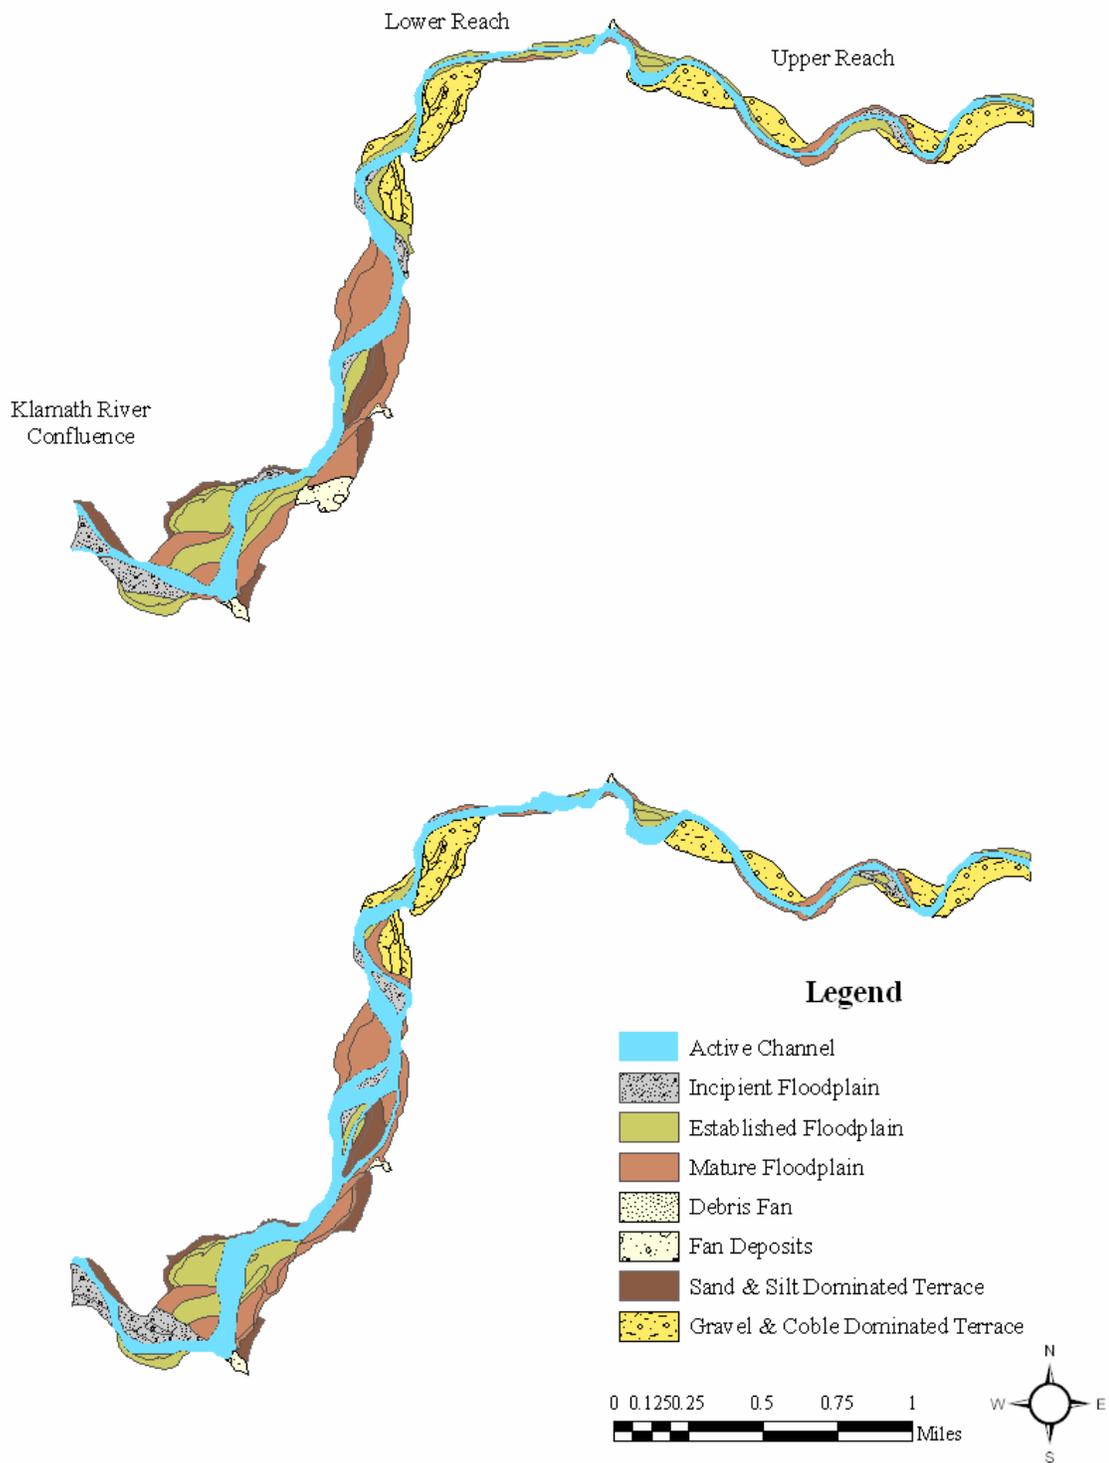
Figure 8. Geomorphic map of the Blue Creek valley floor for 1948 (top image) and 1958 (bottom image), Lower Klamath River Sub-basin, California.

The geomorphic map produced from the 1948 images show valley landforms in apparent equilibrium with the existing sediment and flood regime (Figure 8). The channel exhibited a sinuous planform and the majority of the valley landforms supported vegetation. Forested debris fan deposits were mapped at the mouths of Pularvasar Creek and at the un-named tributary at the Washout Pool (Figure 8). The gravel and cobble dominated terraces (type 5b) in the lower and upper reaches were covered by mature stands of mixed conifers, similar to the stands that remain at the campground flat and on the remnant patch terraces located upstream of West Fork Blue Creek.

The geomorphic map from the 1958 images includes details of the changes in channel and valley landforms two years following the large magnitude flood event in 1955 (Figure 8). This map shows a wider channel with a side channel that reoccupied an abandoned floodplain channel adjacent to One Mile Creek. Areas with incipient floodplains formed near where the bridge is now located and within the next downstream meander bend. Measurements of landform change in the lower reach show the proportional area of active channel planform and incipient floodplain increased by 30 and 24 percent, respectively compared to measurements from the 1948 images (Figure 9). Concurrent with an increase in the more active features, the proportional area of established and mature floodplains decreased by 10 and 24 percent, respectively (Figure 9).

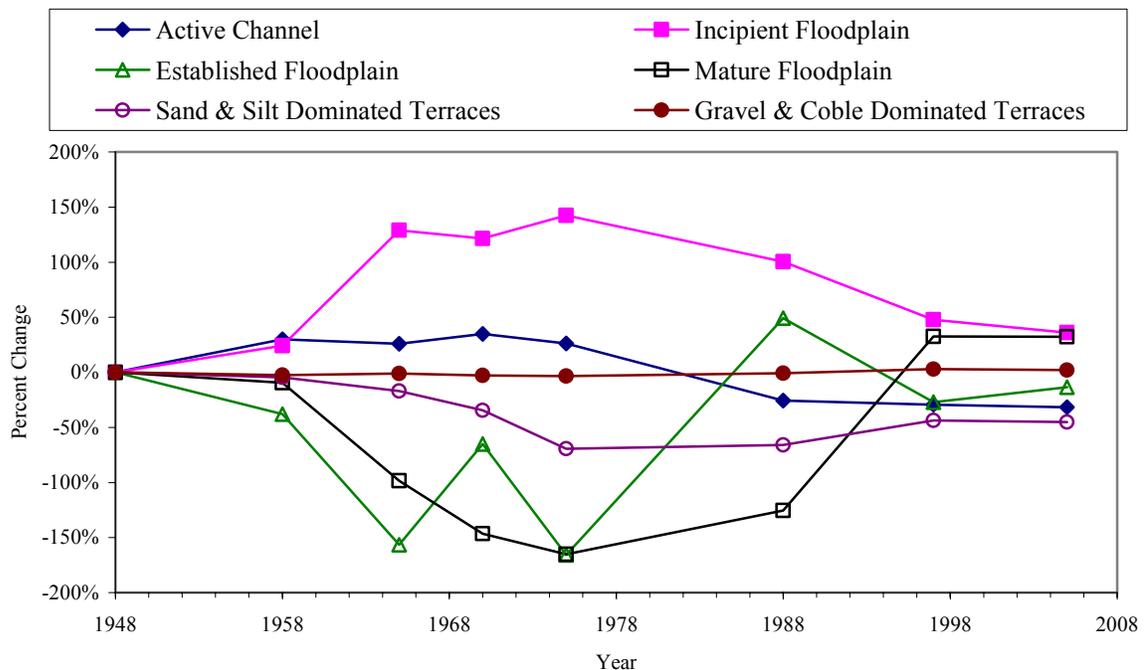
Figure 9. Measured percent change in valley landform area for the period 1948 - 2005, lower Blue Creek, Lower Klamath River Sub-basin, California. Percent change was calculated as the change in the landform area compared to its area mapped from 1948 images.

Since the 1988 map period the planform area of the active channel has dropped below the area mapped in 1948 (Figure 9). The area of incipient floodplain has also steadily decreased but has not yet reached levels mapped prior to 1958. The area of mature floodplain and type 5a terraces increased over the Phase IV period. However, the poor soil and vegetation development on the new 5a terrace deposits leaves them vulnerable to erosion.

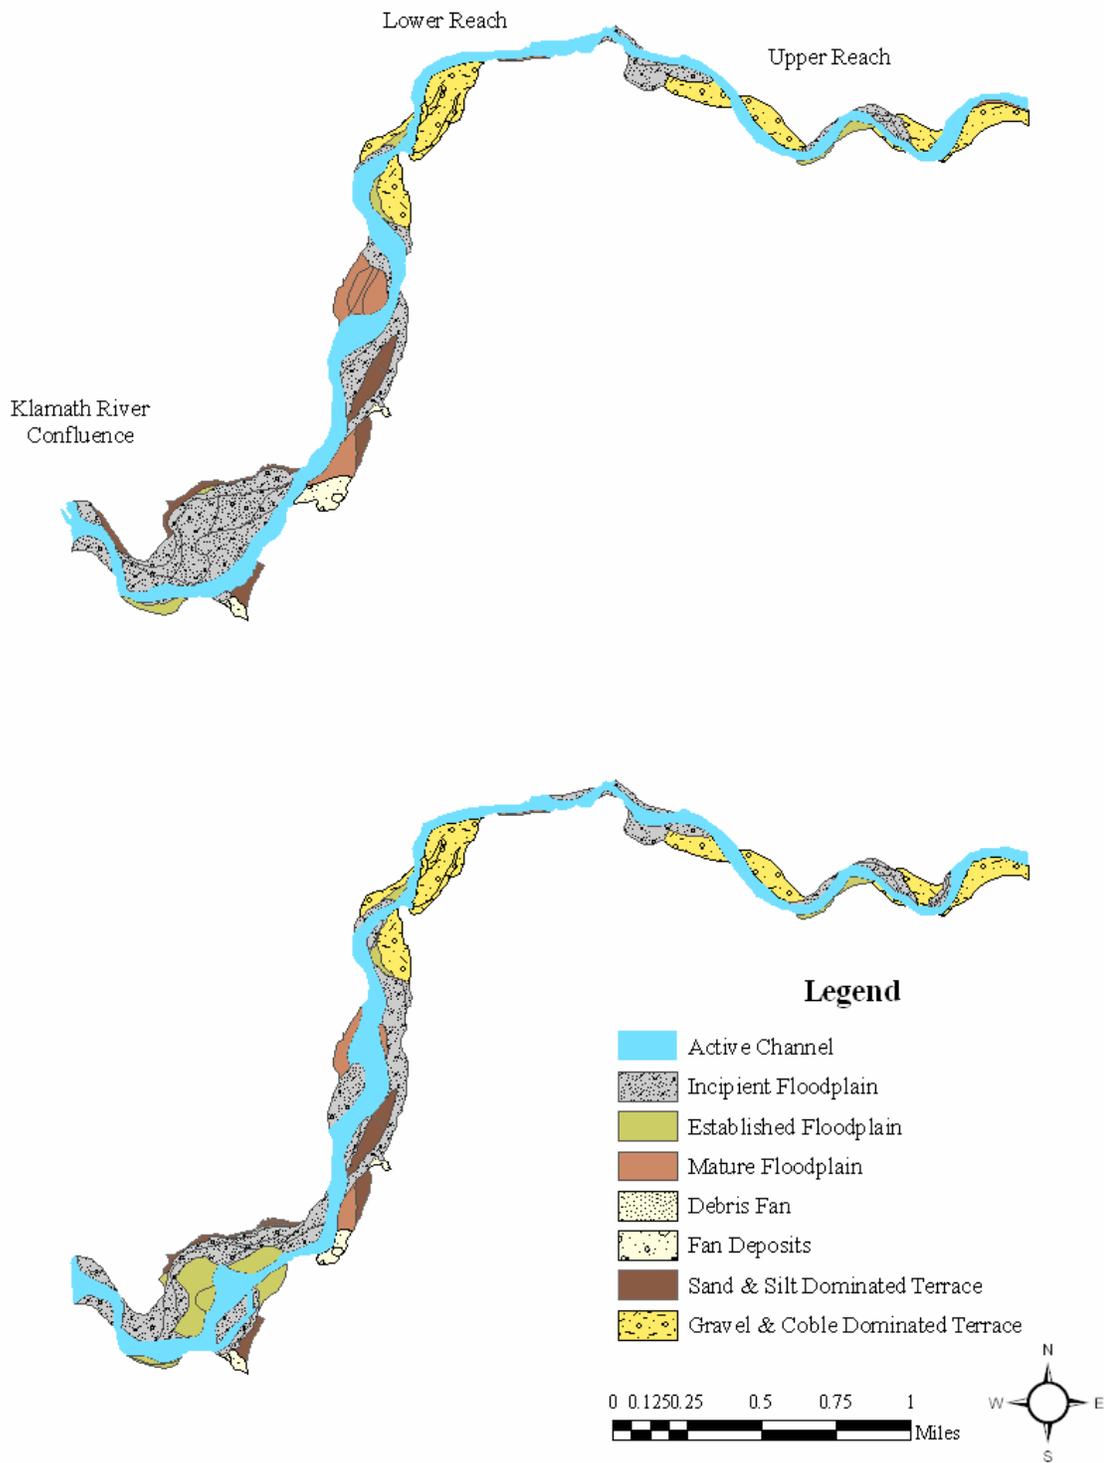
Figure 10. Geomorphic map of the Blue Creek valley floor for 1965 (top image) and 1970 (bottom image), Lower Klamath River Sub-basin, California.

Mapping and measurements from the 1965 images show significant changes in channel and valley landforms following the 1965 flood (Figure 10). In the lower reach, the area of active channel planform and incipient floodplain increased by 26 and 129 percent, respectively (Figure 9). These changes were exhibited by significant areas of vegetation loss, channel avulsion, aggradation and channel straightening in the reach below One Mile Creek. While major changes were recorded in the lower reach, the first appearance of channel instability also occurred in the upper reach just upstream of West Fork Blue Creek during this mapping period (Figure 10).

Analysis of the 1970 images shows the near complete degradation of key valley landforms in the lower reach (Figure 10). A large mature floodplain on the right bank was completely stripped and its area occupied by the straightening active channel. It could not be determined from the available images if the old growth stand visible on earlier images was harvested from this surface prior to the 1970 image date. Remnant sand and silt dominated terraces (type 5a), which supported old growth forest stands, were also reduced and the active channel planform area increased slightly. The 92 percent increase in established floodplain since the 1970 mapping period (Figure 9) was likely in association with rapid recovery of grasses and cottonwoods that re-sprouted on the undissected portions of Black Bear and Pularvasar Flats.

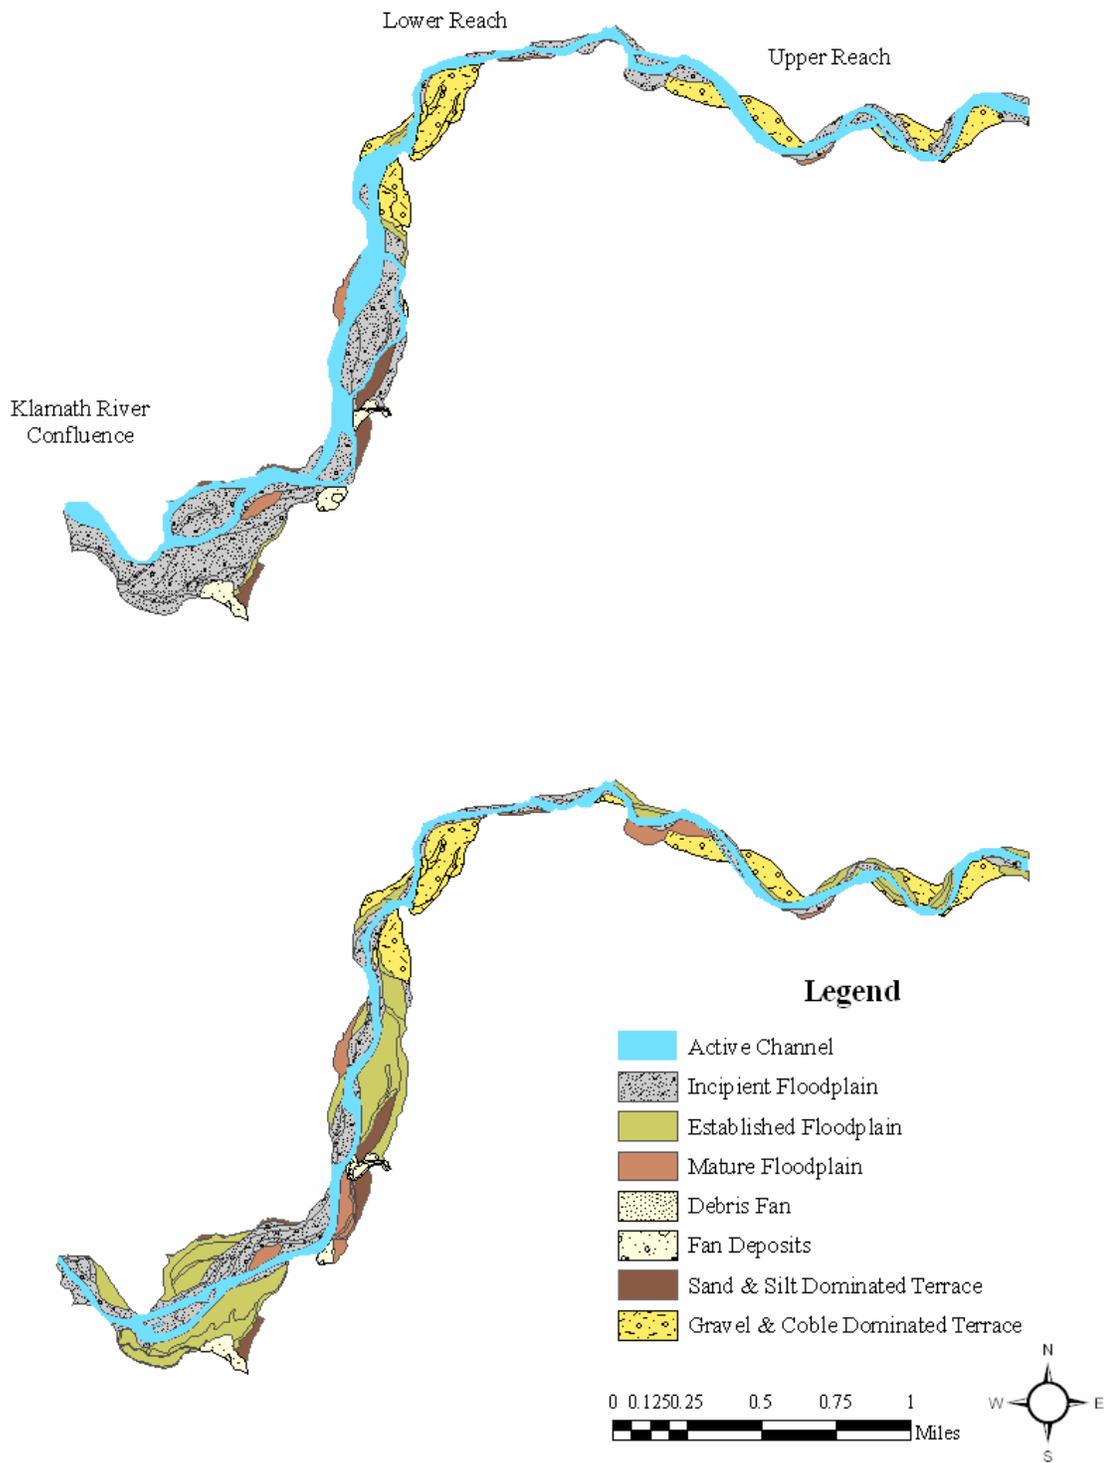
Figure 11. Geomorphic map of the Blue Creek valley floor for 1975 (top image) and 1988 (bottom image), Lower Klamath River Sub-basin, California.

Map analysis of the 1975 images show the flow path in the lower reach of Blue Creek had nearly straightened and shifted to the right side the valley since the 1970 images (Figure 11). The greatest decrease in the more stable landforms (types 3, 4 and 5a) accompanied by the greatest increase in incipient floodplain area occurred during this mapping period (Figure 9). The remnant type 5a terraces along western margin of Black Bear Flat were mapped in the field. Several of these features supported residual old growth redwood and second growth from redwood stump sprouts. The conditions observed at the type 5a terraces in the lower reach indicate there once was a period of long-term stability for these surfaces.

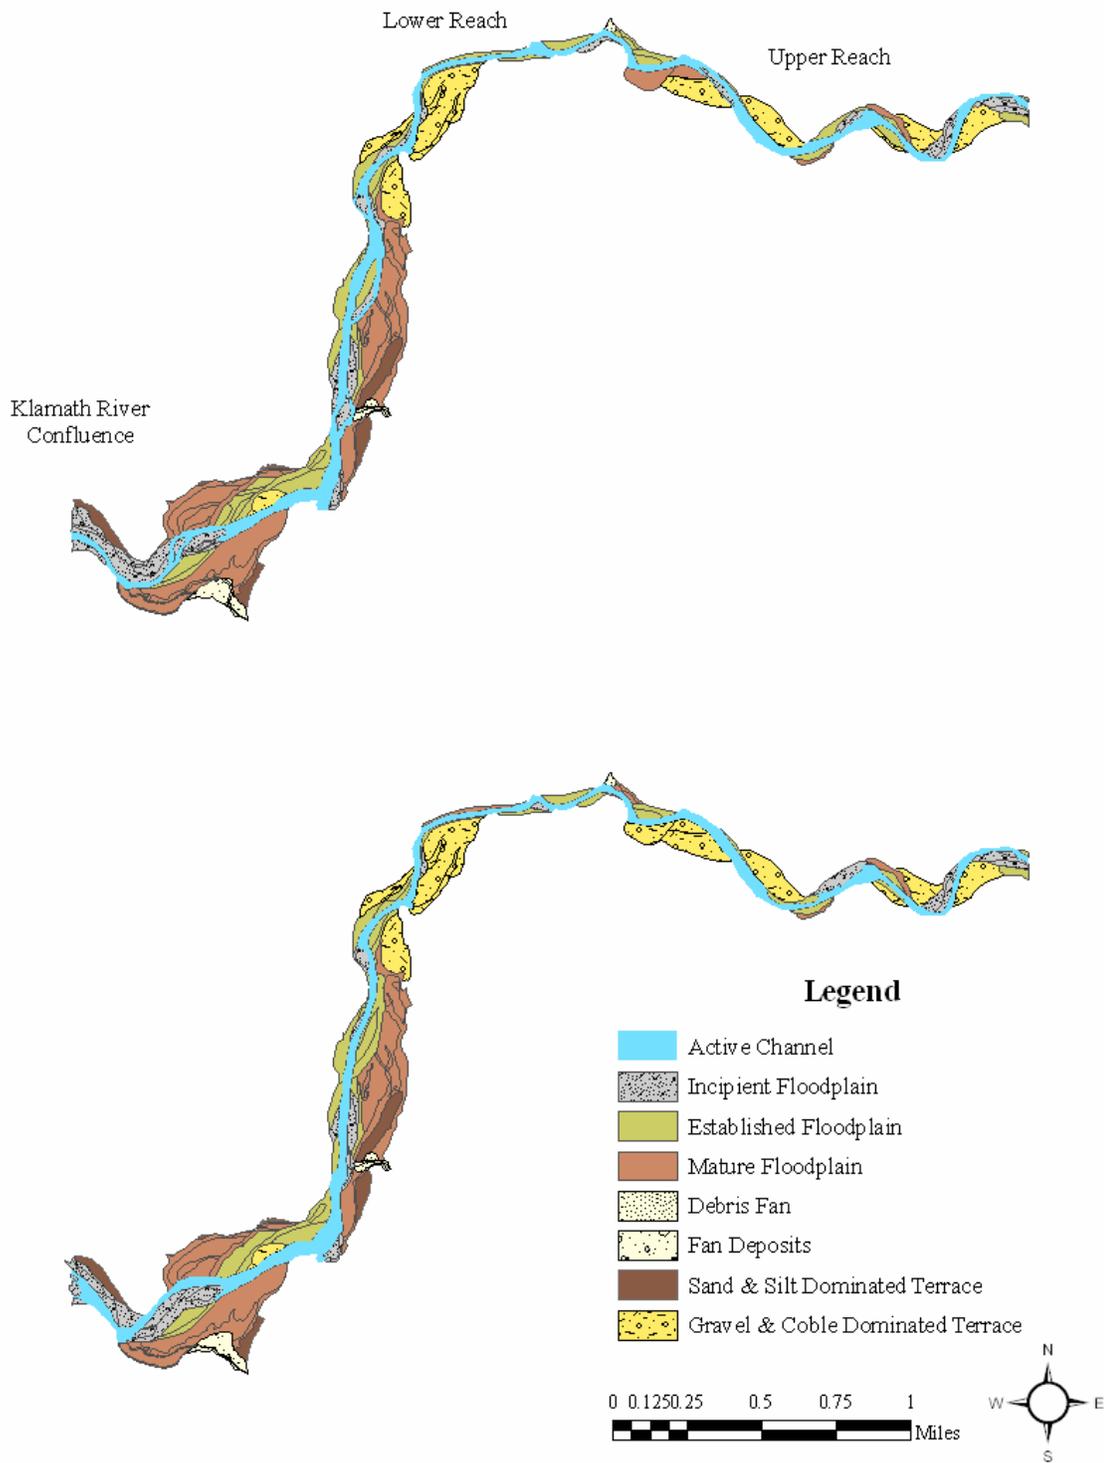
Figure 12. Geomorphic map of the Blue Creek valley floor for 1997 (top image) and 2005 (bottom image), Lower Klamath River Sub-basin, California.

Analysis of the maps from the 1997, and 2005 aerial images (Figure 12), combined with the 2007 geomorphic mapping and other recent evidence showed the active channel is degrading and becoming isolated from its floodplain. Although, analysis presented in the next section showed floodplain occupancy rates did increase following the 1988 map period, surveyed cross-sections and field observations of flood peaks in 2008, had limited capacity to deposit or erode floodplain surfaces. These data indicated flood peaks above 17,000 cfs, that were formerly capable of significant geomorphic work, appeared to be generally contained within a narrowing and deeper channel, with the stream power focused on the channel bed.

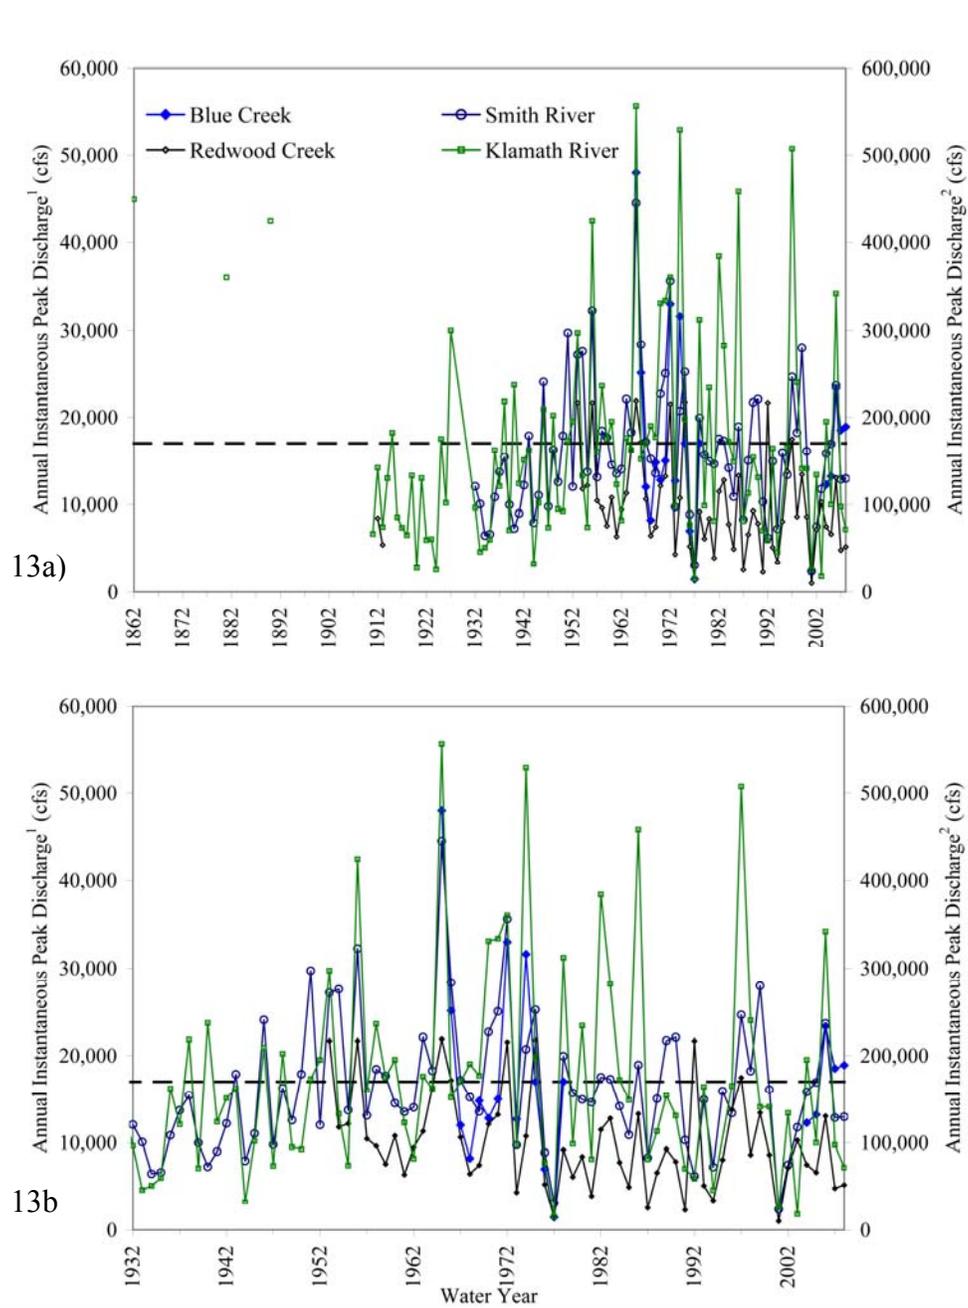
Figure 13. 13a) Annual instantaneous peak discharges for Blue Creek near Klamath (BCK), Smith River near Crescent City (JED), Redwood Creek at Orick (ORK), and Klamath River near Klamath (KNK), period of record. 13b) Annual instantaneous peak discharges for BCK, JED, ORK and KNK, for the period 1932 to 2008. All data is from USGS, except Blue Creek – 2004 to 2008, from Yurok Tribe Environmental Program. Notes: 1) Discharge for Smith River and Redwood Creek scaled by drainage area ratio with Blue Creek; 2) KNK discharge is not scaled and corresponds to the right axis. Dashed line at 17,000 cfs represents the apparent magnitude where discharge becomes geomorphically effective in Blue Creek.

Discharge information is often used to provide a measure of the geomorphic energy available to effect changes in valley landforms. Because a continuous record of discharge was not collected in Blue Creek during the years 1979 – 2003, the instantaneous annual flood peaks from gages on the Smith River and Redwood Creek were used as surrogates for the missing records in Blue Creek. The instantaneous annual flood peaks from these gages were scaled by their drainage area ratio with Blue Creek. This provided a reasonable estimate of the annual flood peaks for the missing records (Figure 13).

For the period 1975 to 1988, occupancy rates for the upper and lower reaches, decreased to 4.0 and 4.4 percent per year, coincident with a period of lower flood peaks (Figures 13 and 14). During this same period the valley floor continued to degrade, however, the rate decreased to -0.14 ft/yr, compared to the -0.34 ft/yr calculated for the previous period.

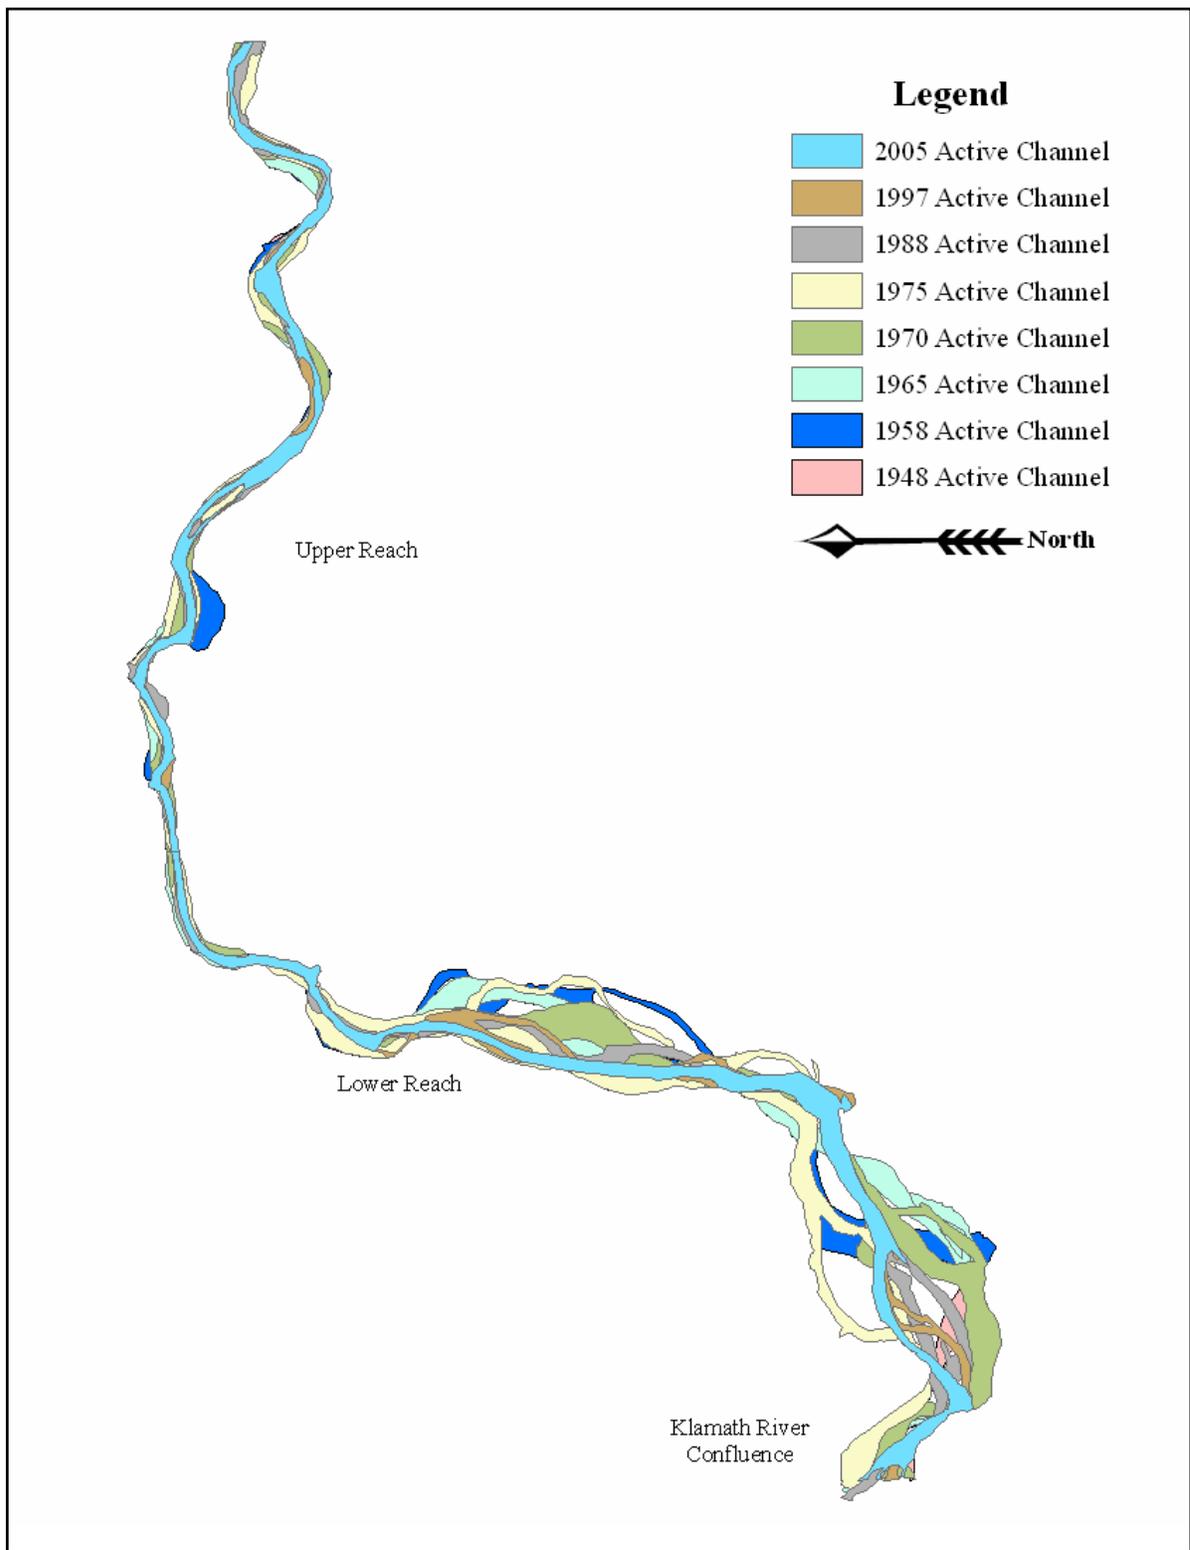
Figure 14. Geomorphologic map of the active channel of lower Blue Creek (1948 – 2005), Lower Klamath River Sub-basin, California.

Mapping and related measurements showed distinct changes over time (Figures 14 and 15). The occupancy rate increased from 1.9 and 1.6 percent per year prior to 1958 to a maximum of 10.4 and 10.5 percent per year by 1975, for the upper and lower reaches respectively (Figure 15a). For this same period the degradation rate was calculated as -0.13 to 0.49 and -0.34 ft/yr for the years 1948, 1965 and 1975, respectively (Figure 15b). Since positive values indicate aggradation, this analysis shows the period between 1948 and 1975 included phases of aggradation and degradation. The 1948 degradation rate is conservative because of the uncertainty in landform change between 1860 and 1942 (1942 was the earliest aerial images available). The period between 1958 and 1975 was associated with intensive timber harvest activities and several flood events that equaled or exceeded 17,000 cfs (Table 2).

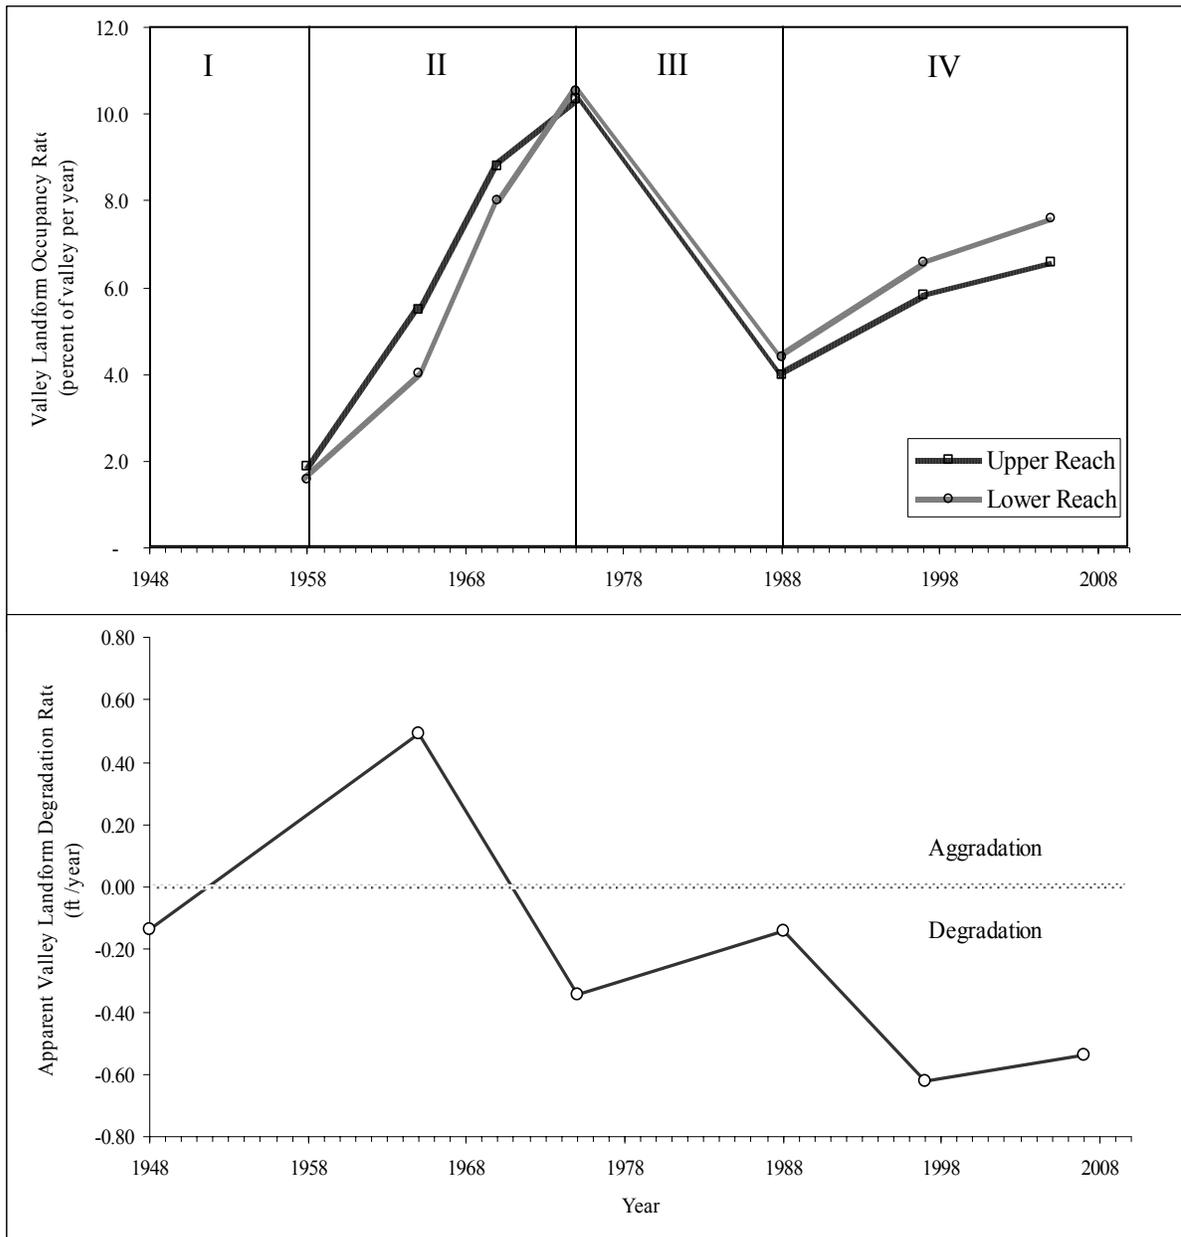
Figure 15. Temporal variation in mean annual erosion of valley landforms by the active channel (15a), and apparent valley landform degradation rate (15b). Occupancy rate is calculated on the basis of annual percent area of channel movement into formerly unoccupied areas of mapped valley landforms. Roman numerals indicate different phases of valley landform evolution. Degradation rate estimated at cross-section 19, where positive values show aggradation. See text for additional details.

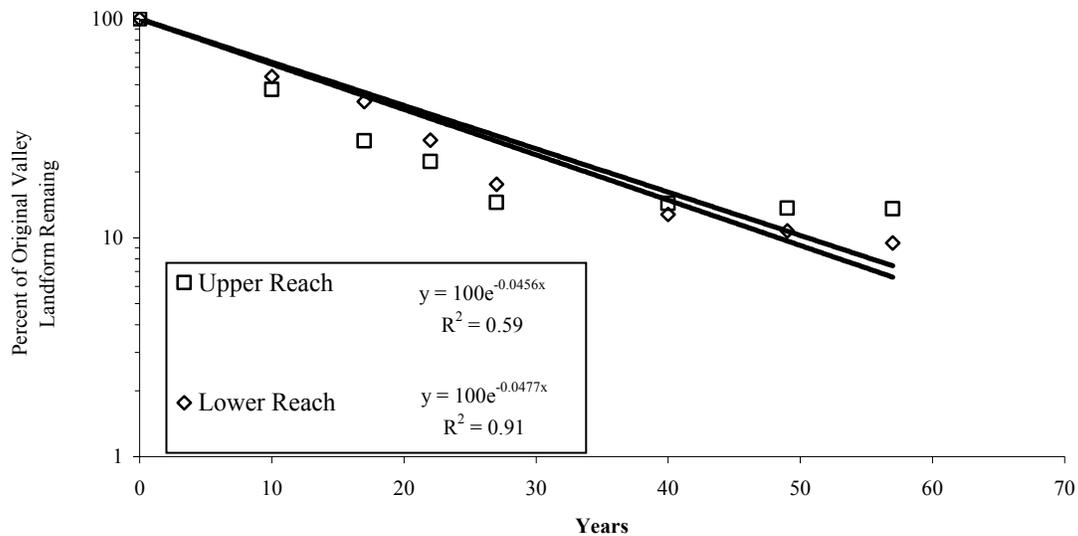
Figure 16. Long-term average (1948 to 2005) exponential decay curves fit to the cumulative erosion of the portion of formerly unoccupied areas of mapped valley landforms. Cumulative erosion analysis for mapping shown in Figure 26.

Valley landform half-life was calculated by fitting exponential decay curves to the cumulative erosion of the mapped 1948 valley landforms (the area outside the 1948 mapped active channel) over the three time periods: i) 1948 to 1975 ( 27 years); ii) 1975 to 2005 ( 30 years); and iii) 1948 to 2005 (57 years) (Figure 16). The method used here follows the approach of O’Conner et. al (2003).

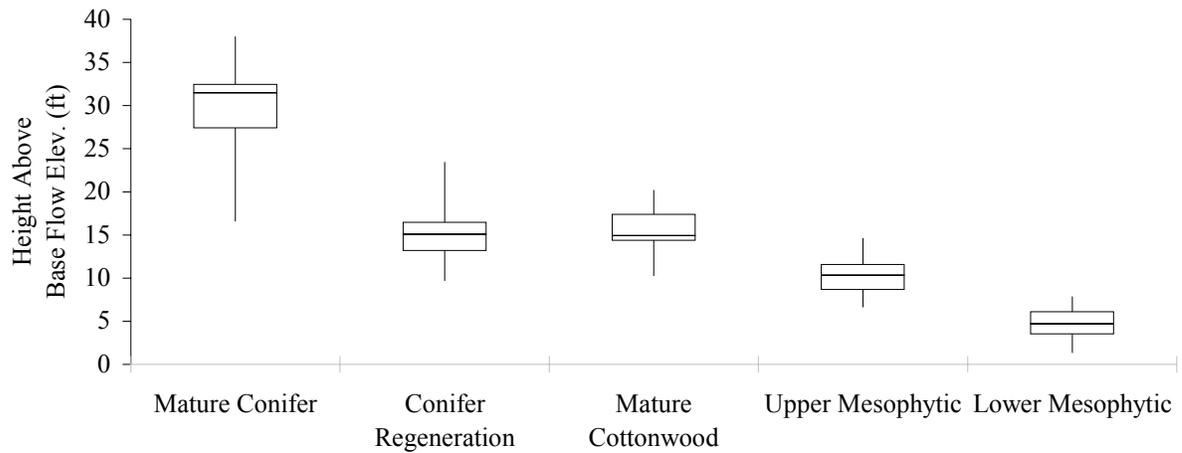
Figure 17. Box plots depicting summary statistics for vegetation information collected in lower Blue Creek, Lower Klamath River Sub-basin, California (2007 – 2008). The horizontal lines in the box denote the 25th, 50th, and 75th quartile values, vertical lines denote the 5th and 95th percentile values and the outline of the box shows the innerquartile range.

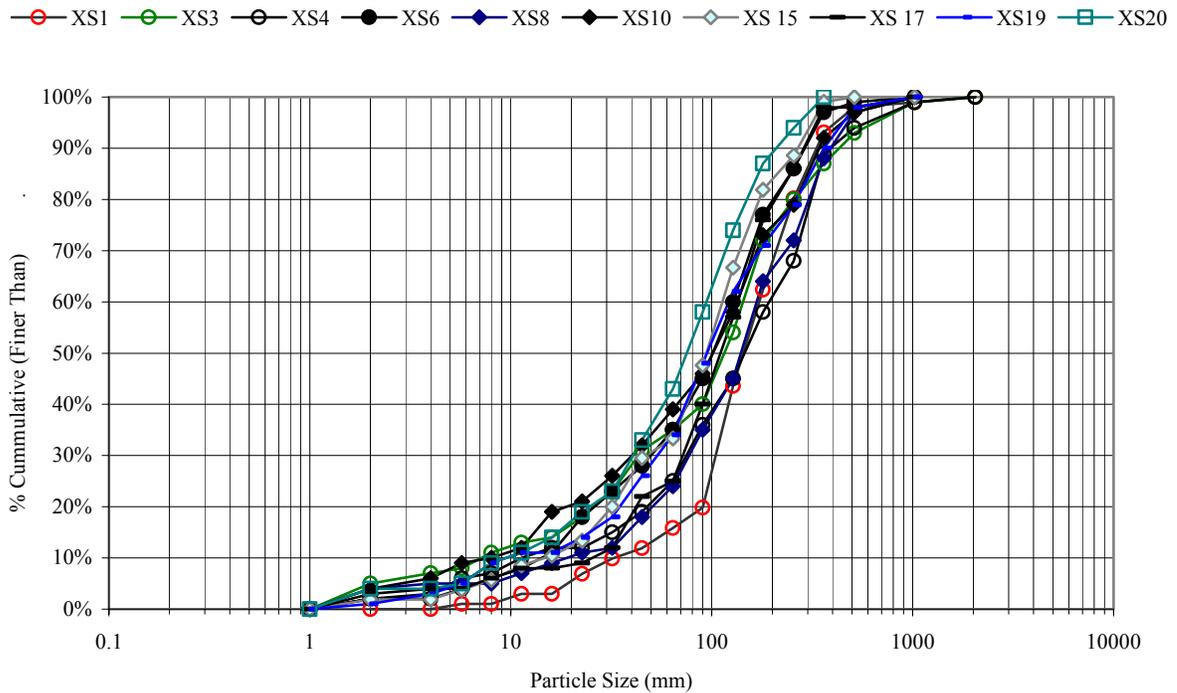
Figure 18. Surface particle size distribution for samples collected in lower Blue Creek, Lower Klamath River Sub-basin, California (2007 – 2008).

Long-term channel incision has resulted in coarsening of bed materials and likely reduced the amount of suitable salmonid spawning gravels in this reach. This was evident from the surface particle size analysis (Table 4; Figure 18). Results of the particle size analysis suggested that spawning gravels may also be limited in upstream reaches. Channel degradation and subsequent reductions in floodplain connectivity concentrates surface and subsurface flow paths, results in increased stream velocities, stream power, and sediment transport capacity and has several significant implications for salmonid and riparian productivity. Concentrated flows and high water velocities require adult and juvenile fish to expend more energy to sustain their position in the water column or to migrate upstream. During high flow events adult and juvenile salmonids migrate to areas protected from high velocity currents (i.e. backwaters, alcoves, or inundated floodplains) to conserve energy. These types of habitats become increasingly limited and hydrologically disconnected during periods of long-term channel incision.
