## Restoration Planning in Lower Blue Creek, Lower Klamath River: Phase I

Final Technical Report - 2008

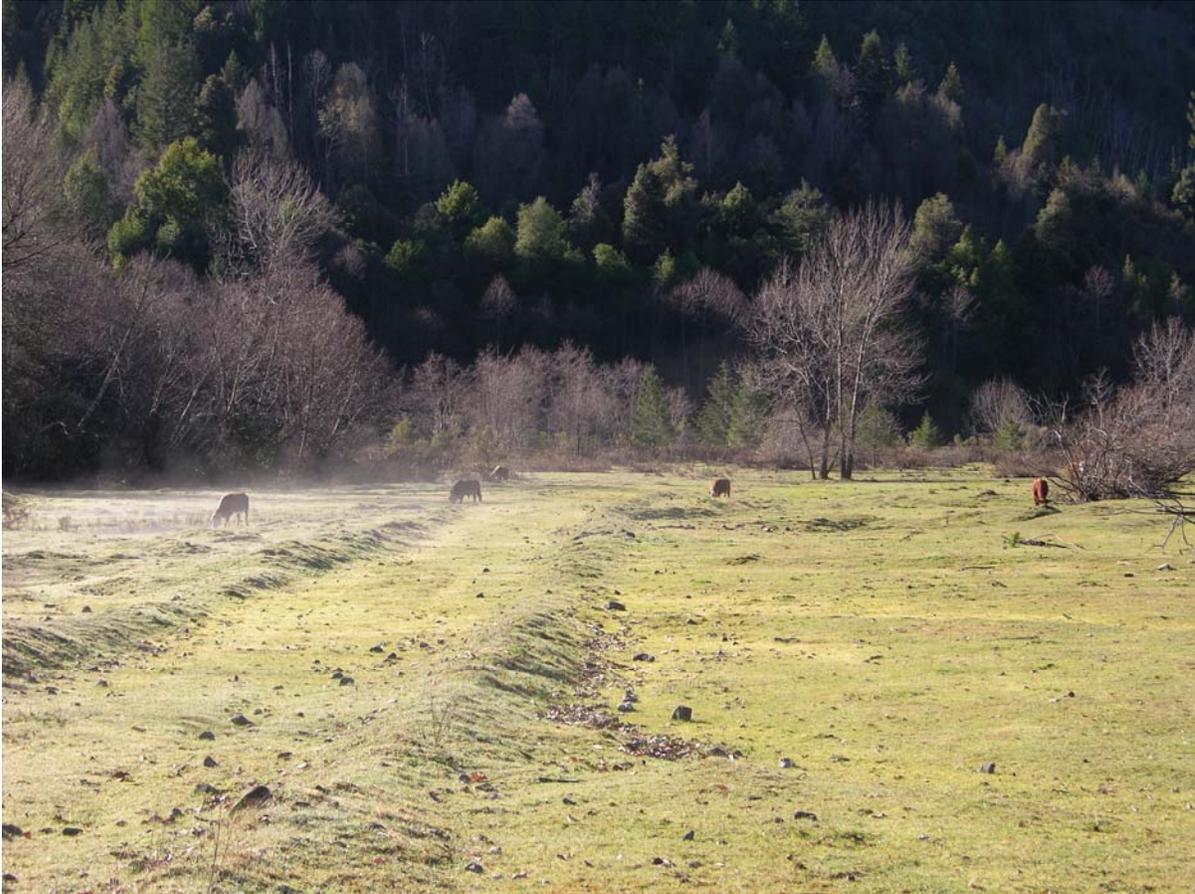
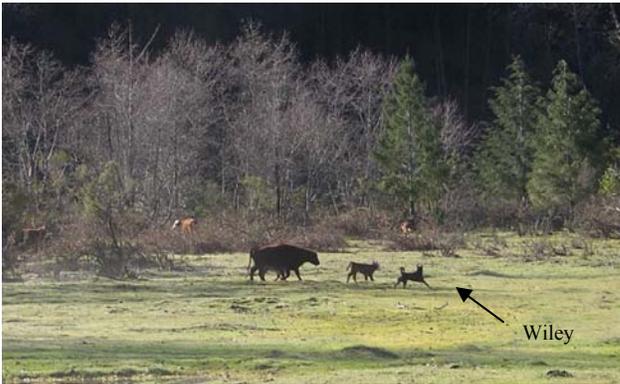
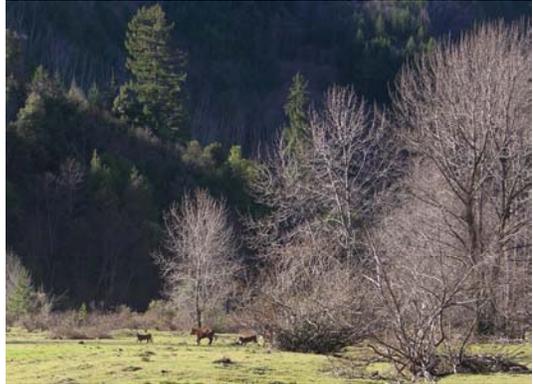
Figure 19. Photographs of feral cattle on floodplains of lower Blue Creek, Lower Klamath River Sub-basin, California (2008).

Based on the research conducted during this study, cattle were likely brought into the Blue Creek watershed during the mid-1800s to support the gold rush and homesteaders. Currently, several feral populations inhabit Blue Creek and many other Lower Klamath River watersheds (Figure 19) (Gale and Randolph 2000). Feral herds inhabiting lower Blue Creek have caused severe riparian degradation over the past several decades. Cows inhibit riparian plant survival and recruitment by browsing or trampling young trees and shrubs (i.e. 1 – 15 years) (Figure 20). A majority of young trees in the valley had evidence of cattle browse or trampling and were stunted in their development (Figure 21).

The Pularvasar Flat has sustained considerable damage from natural and anthropogenic disturbances and long-term unmanaged grazing by feral cattle. Young trees in the area are severely stunted or damaged and recruitment of new trees is minimal, especially in the open grasslands (Figure 19). Cattle tend to occupy this surface in greater numbers relative to the other areas due to the increased seclusion and protection (i.e. forested escape routes) offered at this site. This is a high priority area for employing cattle eradication methods given the relatively high density of cows present in this area. Once the populations are greatly reduced, riparian enhancement measures should be employed in select areas on this flat. An effective strategy for reestablishing riparian forests in systems degraded by multiple valley floor mobilization events is to work from the valley side wall towards the more active surfaces. This would likely be a successful strategy to employ on the Pularvasar Flat given that the best growing conditions (i.e. fine grained, organic rich soils and established vegetation to provide shade and moisture) existed along the base of the valley side wall.

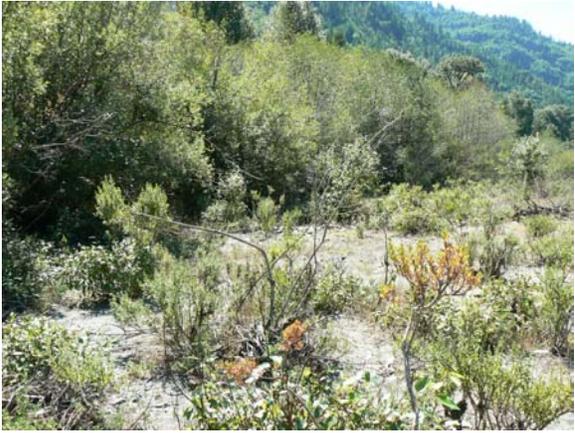
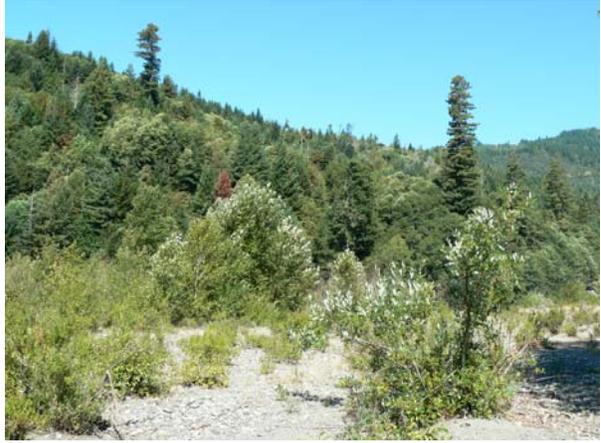
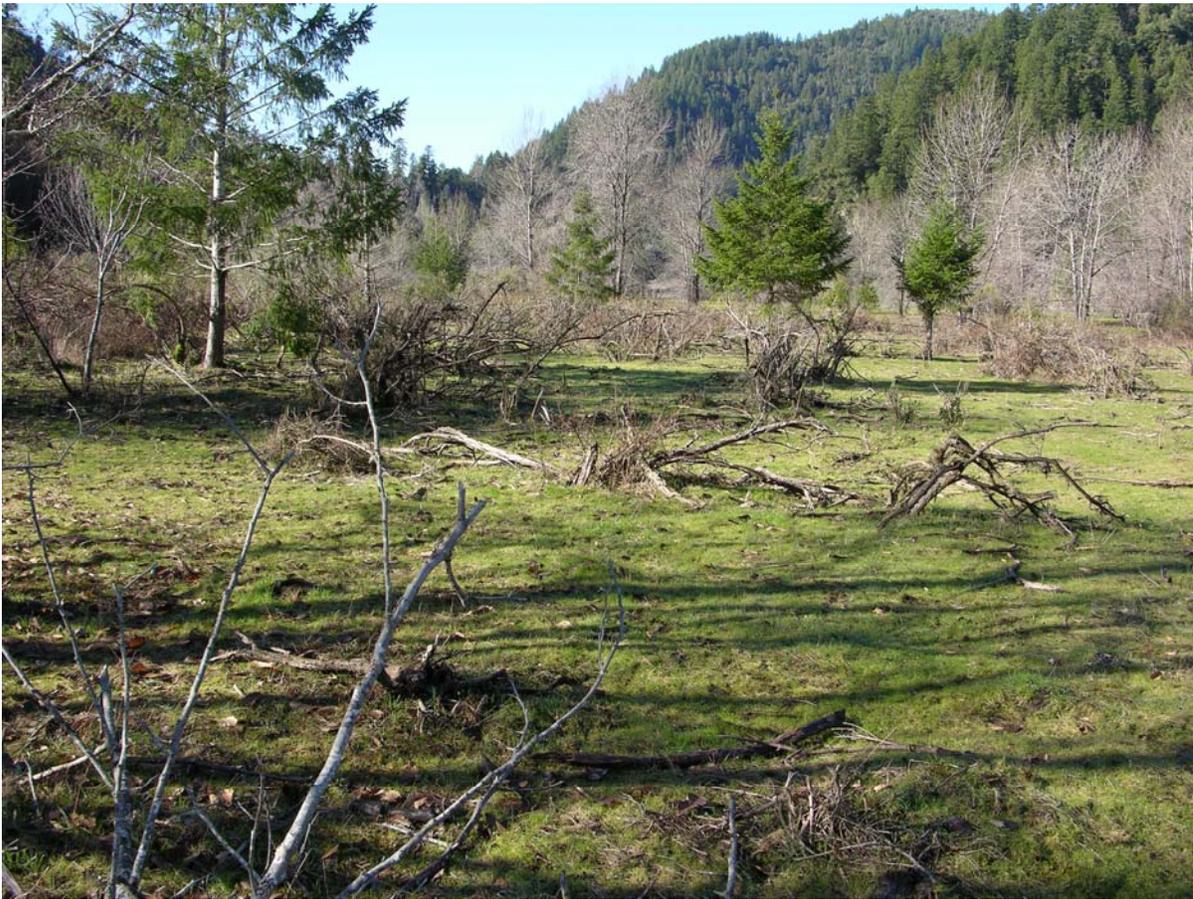
Figure 20. Photographs of riparian vegetation trampled and damaged by feral cattle, Blue Creek, Lower Klamath River Sub-basin, California (2008).

The lower Blue Creek herds have also caused substantial impacts to floodplain and terrace soils. The herds have developed extensive trail networks and compacted large areas of the valley floor through long-term, unmanaged grazing activities. The cows have also disturbed riparian soils by digging depressions for sleeping or to search for mineral deposits. These actions, carried out over several decades, have resulted in fairly degraded conditions for native riparian trees and shrubs and inhibited critical soil forming processes. Other long-term consequences of these unmanaged herds include degraded water quality at springs and ephemeral wetlands, reduced recruitment of wood and other organic materials to stream and floodplain habitats, diminished riparian canopy coverage and shade relief for stream habitats.

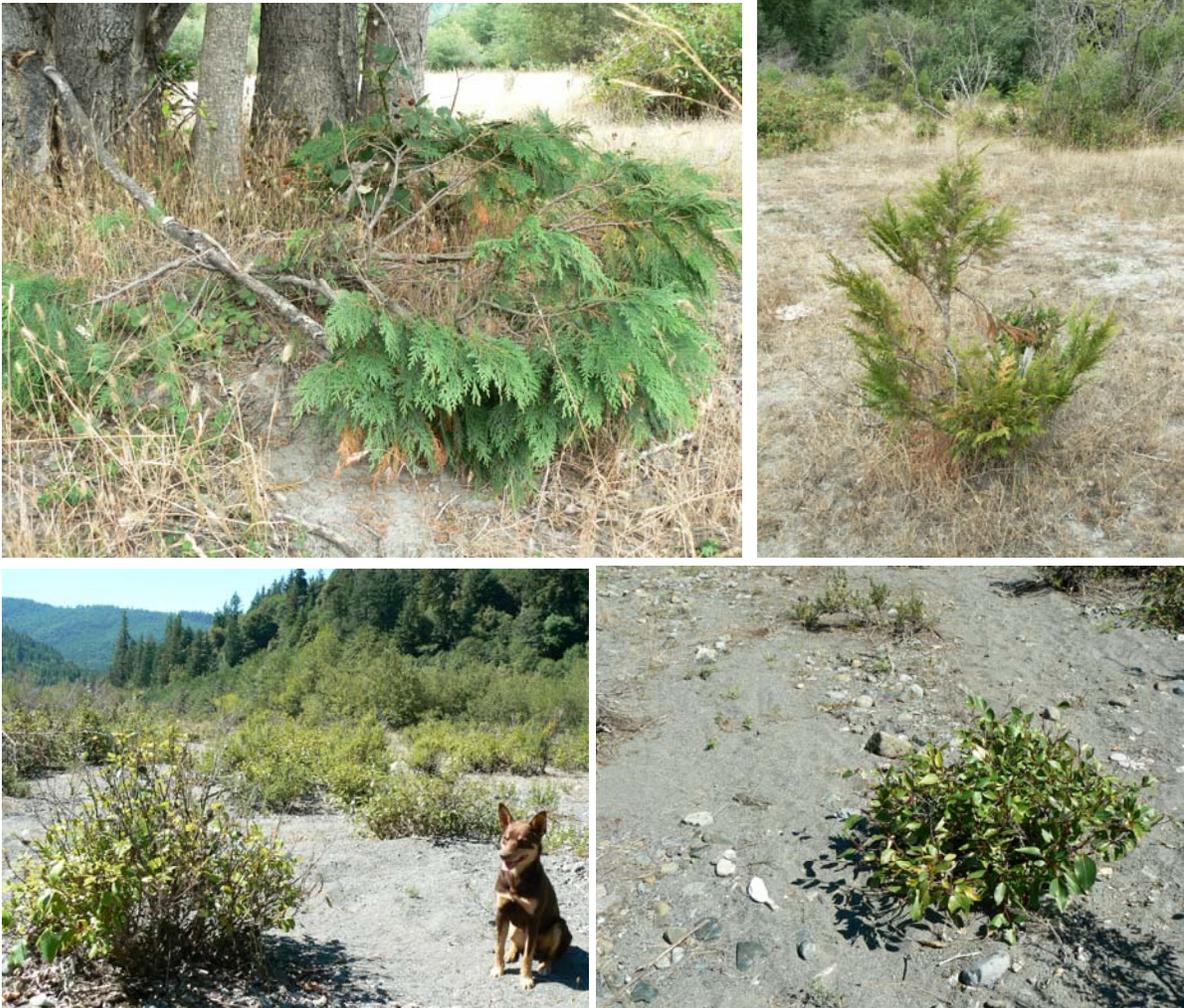
Figure 21. Photographs of young cedar (top photographs) and cottonwood (bottom photographs) that have been damaged and stunted by feral cattle, Blue Creek, Lower Klamath River Sub-basin, California (2007).

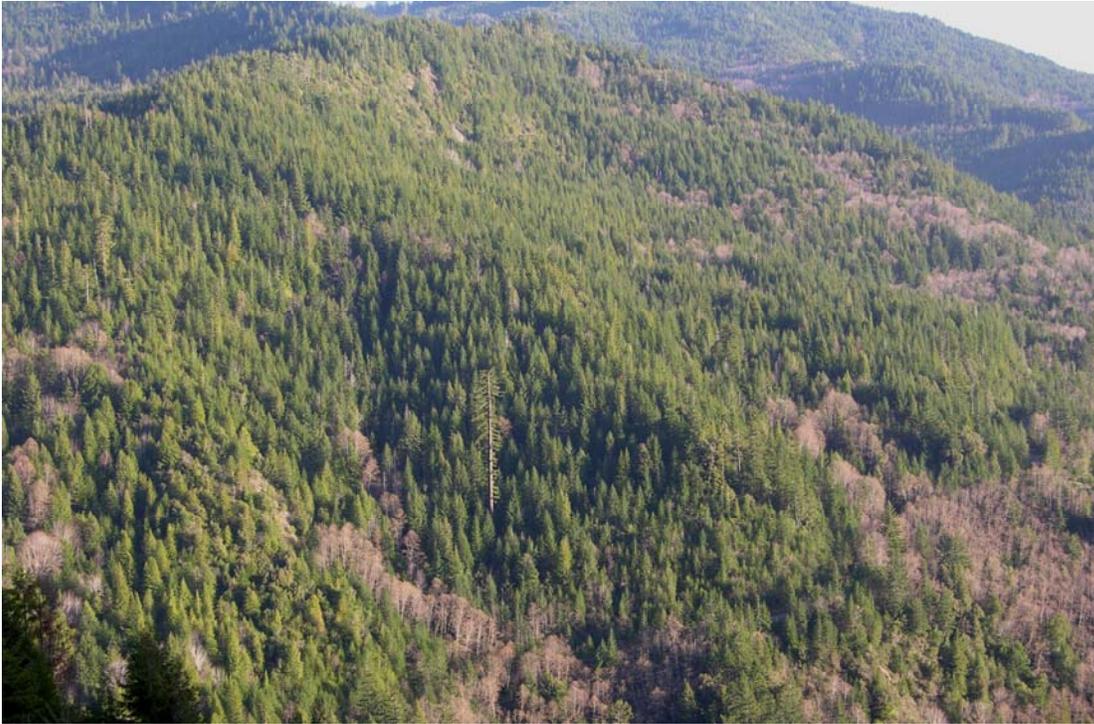
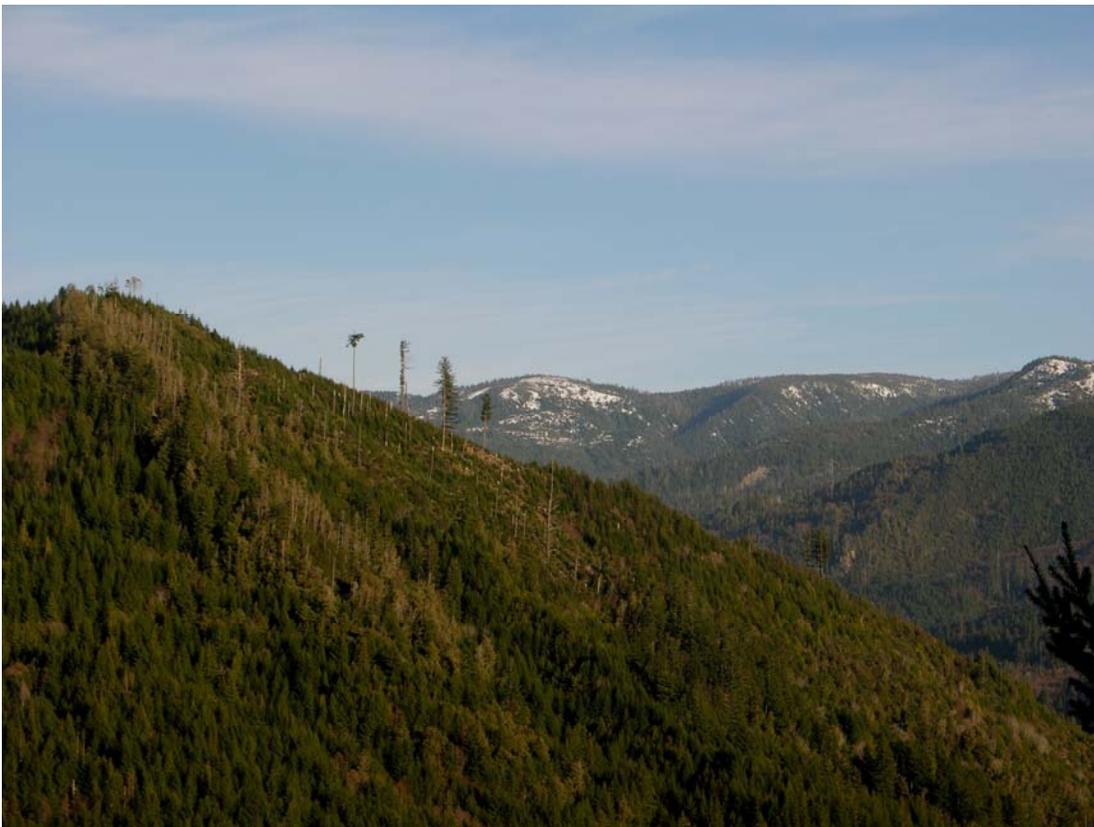
Figure 22. Photographs of past harvest units in Blue Creek, Lower Klamath River Sub-basin, California (2008). Note the old growth redwood located in the middle of the top photograph.

Industrial timber harvest has been occurring in the Blue Creek watershed since the mid-1950s. A majority of old growth conifers have been removed from lower Blue Creek and the area continues to be managed for industrial timber harvest (Figures 1 and 22). Although most of the upper watershed has various levels of protective status, timber harvest has occurred on the SRNF property. Harvested units remain in various states of recovery and would benefit from management activities such as thinning overcrowded stands, reducing brush and fuel loads to decrease fire hazards, and upgrading and decommissioning roads.

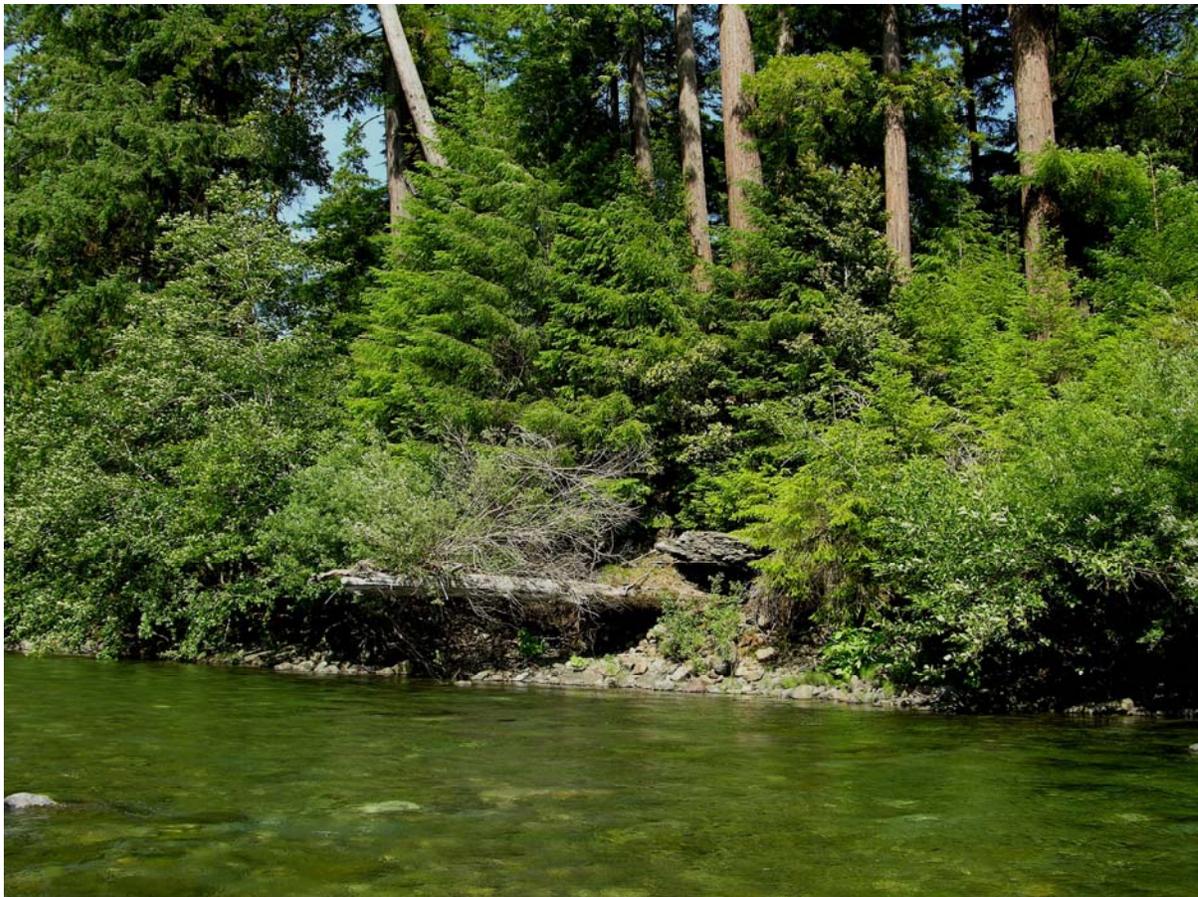
Figure 23. Photograph of buried wood and regenerated redwoods and associated conifers located in lower blue Creek, Lower Klamath River Sub-basin, California (2008).

Field surveys conducted in the Blue Creek valley revealed a significant absence of small and large wood in the stream and on floodplain surfaces. This is likely a result of limited recruitment rates following large-scale timber harvest; and impacts associated with long-term, unmanaged grazing by feral cattle and firewood collection activities. Downed wood serves many different and critically important functions in a watershed. Channel stored wood can dramatically alter sediment storage and delivery dynamics, facilitate the formation and maintenance of critical salmonid habitats (i.e. spawning beds and pools), and provide cover for fish and other aquatic dependent species. Hillslope derived and channel stored wood plays a crucial role in floodplain forming processes. Accumulations of large wood were observed as a significant component in floodplain and terrace deposits at several locations. In many cases the trees growing at the surface had regenerated from the buried wood (Figure 23).

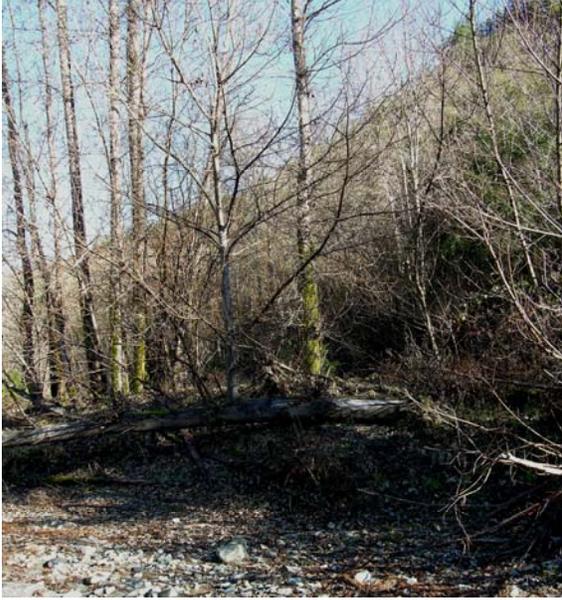
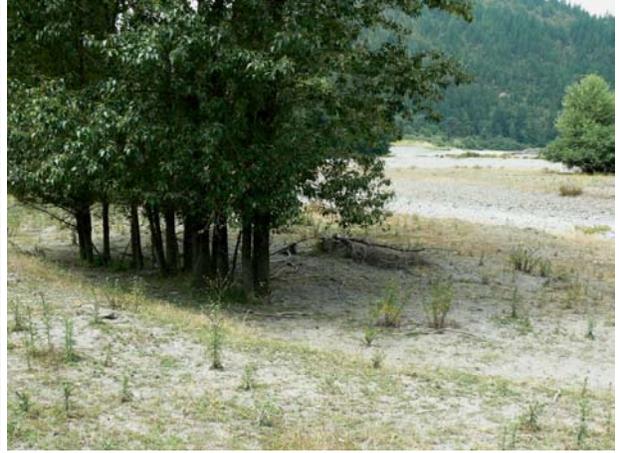
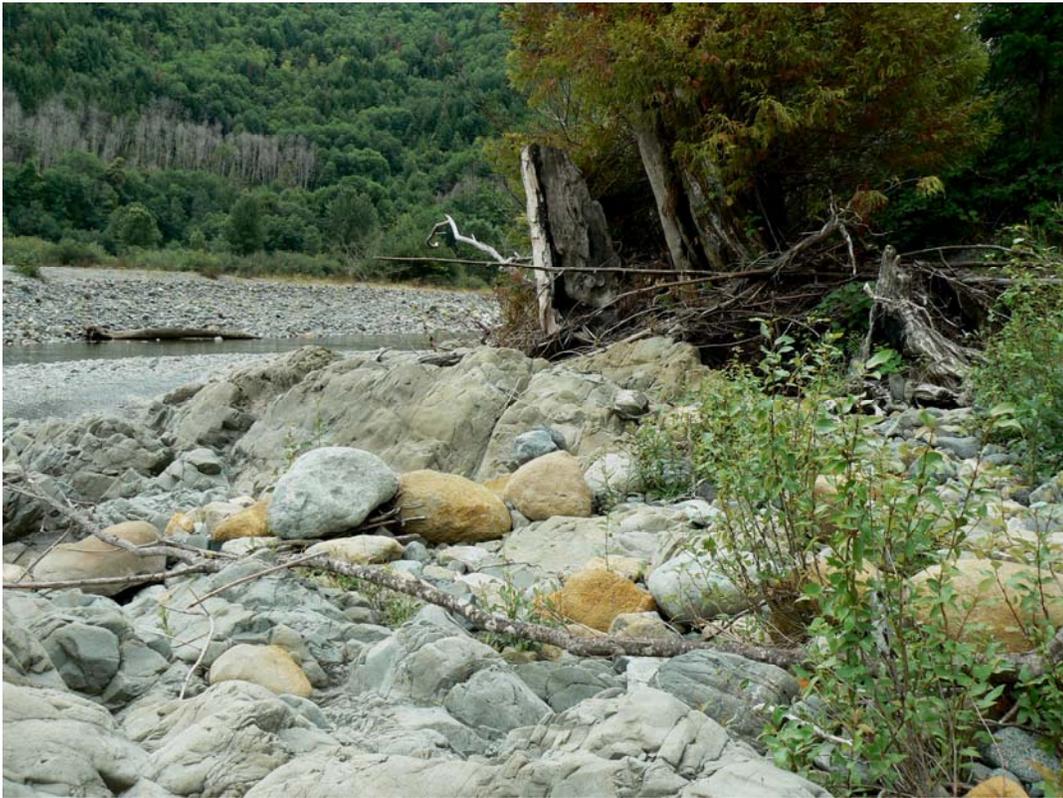
Figure 24. Photographs of young trees sprouting from downed cottonwood nurse logs (top photographs) and a redwood sprout growing from an old growth stump (bottom photograph), lower Blue Creek, Lower Klamath River Sub-basin, California (2007 – 2008).

wood when linked together by a network of live roots may be a key stabilizing element adding to the resiliency of valley landforms during and after flood events. Floodplain stored wood will also absorb moisture during the wet season, release it to the soil and nearby plants in the dry season, and thereby improve growing conditions during the development of seedlings and young trees. Floodplain stored wood eventually breaks down to form productive riparian soils. Field observations in lower Blue Creek revealed that many of the native riparian trees were capable of regenerating from downed segments or from stumps (i.e. coastal redwood, big leaf maple, California bay, cottonwood, and willow) (Figure 24).

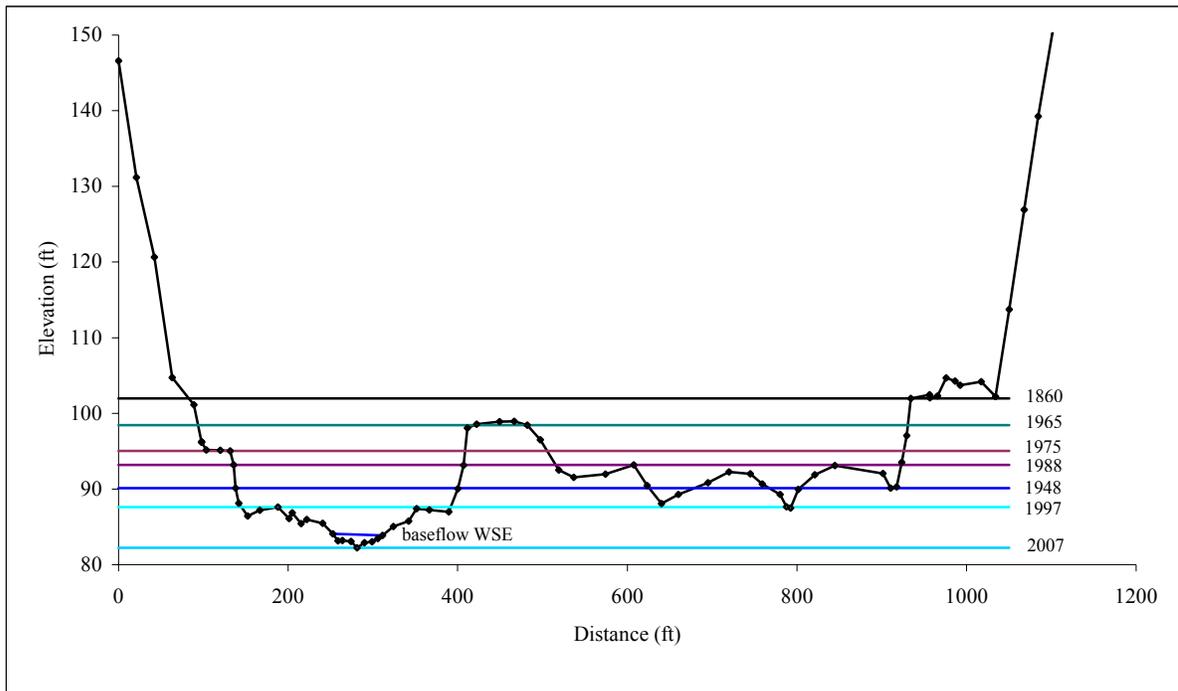
Figure 25. Sequential valley landform surface elevations at cross section 19 in lower Blue Creek, Lower Klamath River Sub-basin, California (2007 – 2008).

Channel migration for the upper and lower reaches, and the apparent degradation rate of valley landforms at cross-section 19 (Figure 6), were measured to characterize the temporal pattern and rates associated with these processes. Channel migration rates were calculated as the percent valley landforms were occupied by the active channel per year (O’Conner 2003) (Figure 15a). Apparent valley landform degradation rates were calculated as the difference between successive landform surface elevations divided by the surface age estimated at cross-section 19 (Figure 15b). The 1860 date for the highest alluvial surface at cross-section 19 was estimated based on a radiocarbon dated peat sample for a concordant surface located at cross-section 13. The 1860 date for this surface was also supported by the size range of redwood stumps occupying both sites and radiocarbon dates for the flood deposits studied by Helley and LaMarche (1973). The remaining surface ages were estimated from aerial images that show when a surface at the cross-section was last occupied by the stream channel or flood deposit and supported by geomorphic mapping.

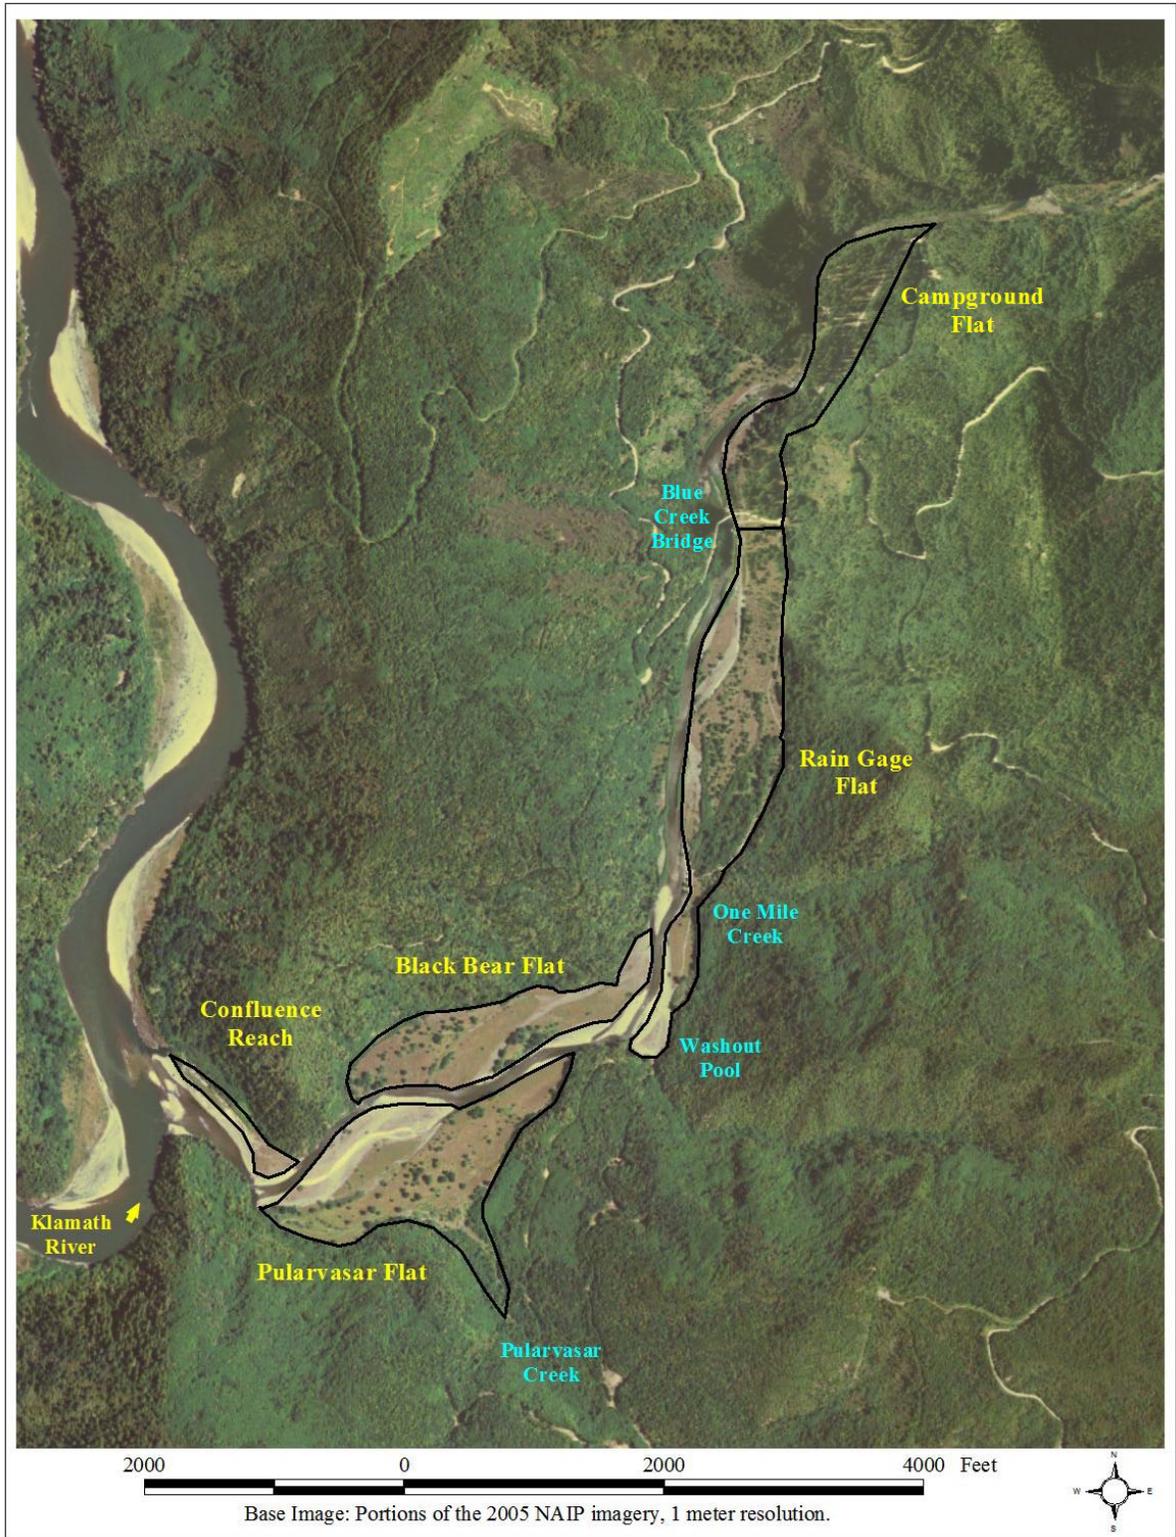
Figure 26. Map depicting designated restoration areas in Blue Creek, Lower Klamath River Sub-basin, California.

For this study, we defined five potential treatment areas in lower Blue Creek: 1) the Campground Flat, 2) the Rain Gage Flat, 3) Black Bear Flat, 4) Pularvasar Flat, and 5) the Confluence Reach (Figure 26). These designations were based on existing geomorphic and hydrologic conditions, topography, and riparian vegetation. We also developed various restoration related recommendations to address watershed-level concerns.

The confluence of Blue Creek and the Klamath River is an extremely dynamic area and the channel occupying this reach is prone to high rates of lateral migration and braiding (Figures 13 and 26). The Confluence Reach has been actively eroding and a substantial amount of fine grained materials have been mobilized over the last few years (Figures 32 and 33). This area was designated as the lowest priority treatment area given the dynamic hydrologic processes and high rates of channel instability occurring in this reach. YTFP is hopeful that large-scale restorative actions implemented upstream of the Confluence Reach will result in improved hydrologic and geomorphic conditions at the mouth of Blue Creek. Blue Creek

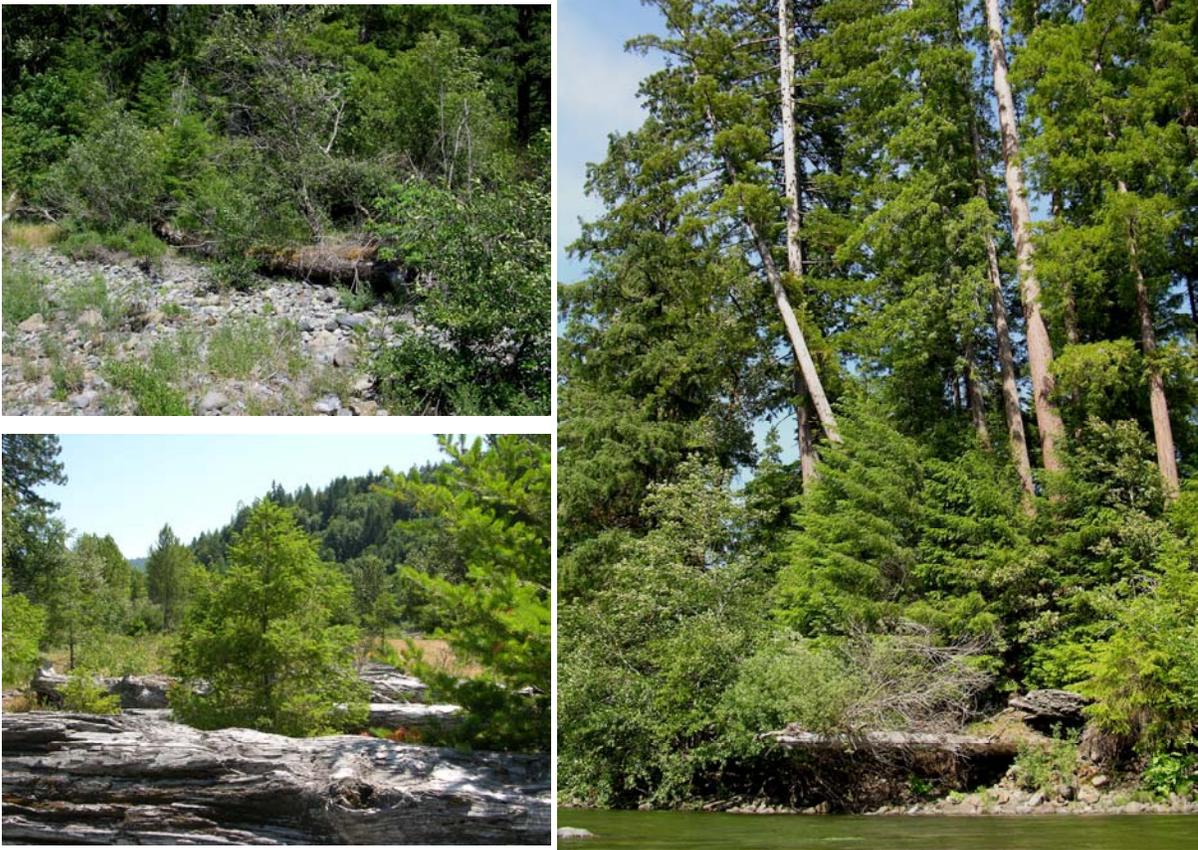
Figure 27. Photograph of a terrace surface in lower Blue Creek, Lower Klamath River Sub-basin, California (2008).

In general, the Campground Flat is comprised of relatively high elevation surfaces that are not typically inundated during high flow events. The dominant vegetation classes of this area include Mature Conifer, Conifer Regeneration, and Mature Cottonwood (Figure 27). The primary restoration recommendations for this area include 1) protecting standing trees and downed wood sources; and 2) planting native conifers and cottonwoods to promote future wood recruitment and improved riparian forest conditions. The Campground Flat is used every summer by timber industry staff that work in the Blue Creek watershed. This land use activity results in a significant loss of downed wood sources to fuel campfires (Figure 28) and the accumulation of a substantial amount of trash each year. This activity should be more closely managed and campers should bring in firewood from approved sources to protect wood sources located in lower Blue Creek.

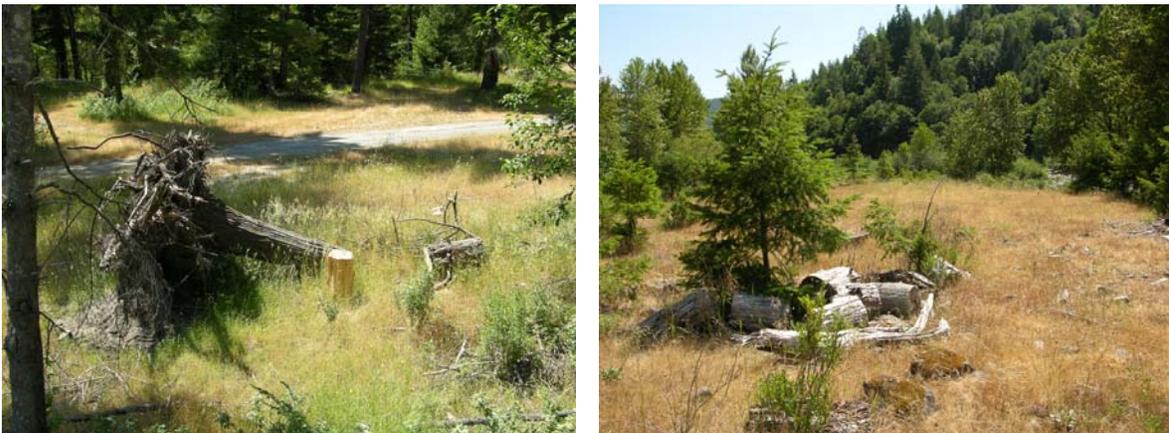
Figure 28. Photographs of downed wood cut for firewood, lower Blue Creek, Lower Klamath River Sub-basin, California (2008).

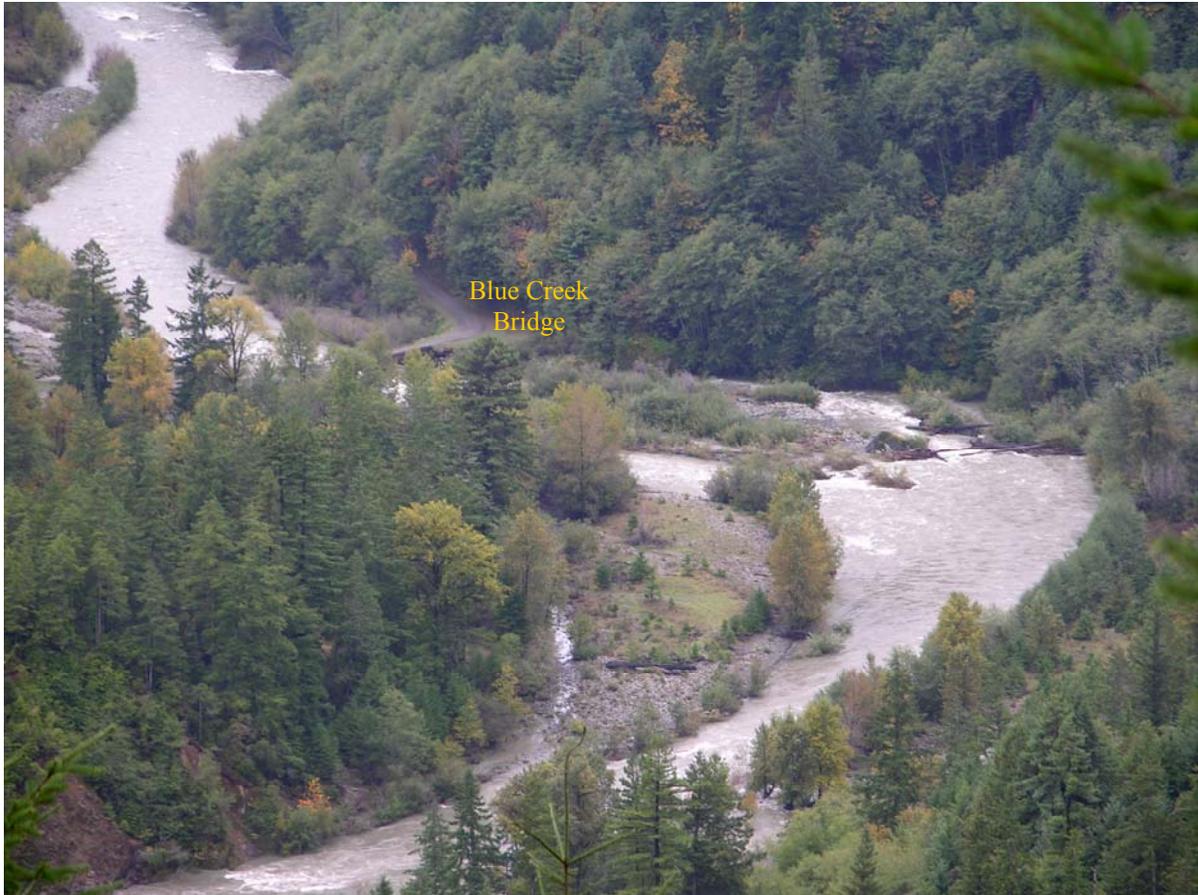
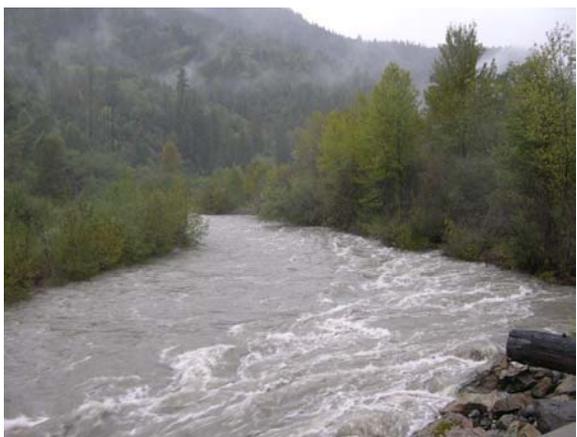
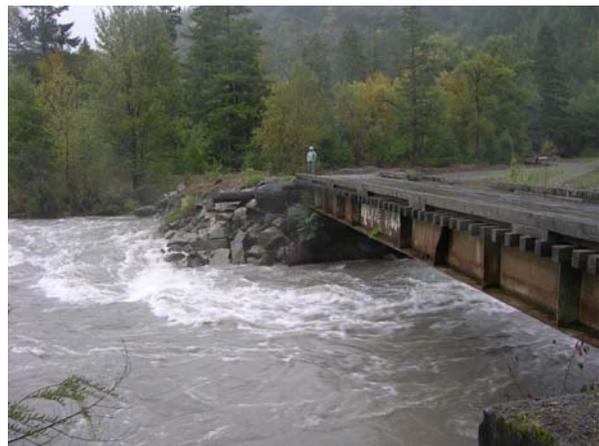
Figure 29. Photographs of the habitats located adjacent to the Blue Creek bridge, Lower Klamath River Sub-basin, California (October 2007). Flood flow at time of photographs approximately 10,000 cfs, following the 2008 water year peak flow of 18,908 cfs.

design improvements. The current configuration results in substantial channel and flow path constriction, thereby causing a significant loss in floodplain connectivity (Figures 29 and 31).

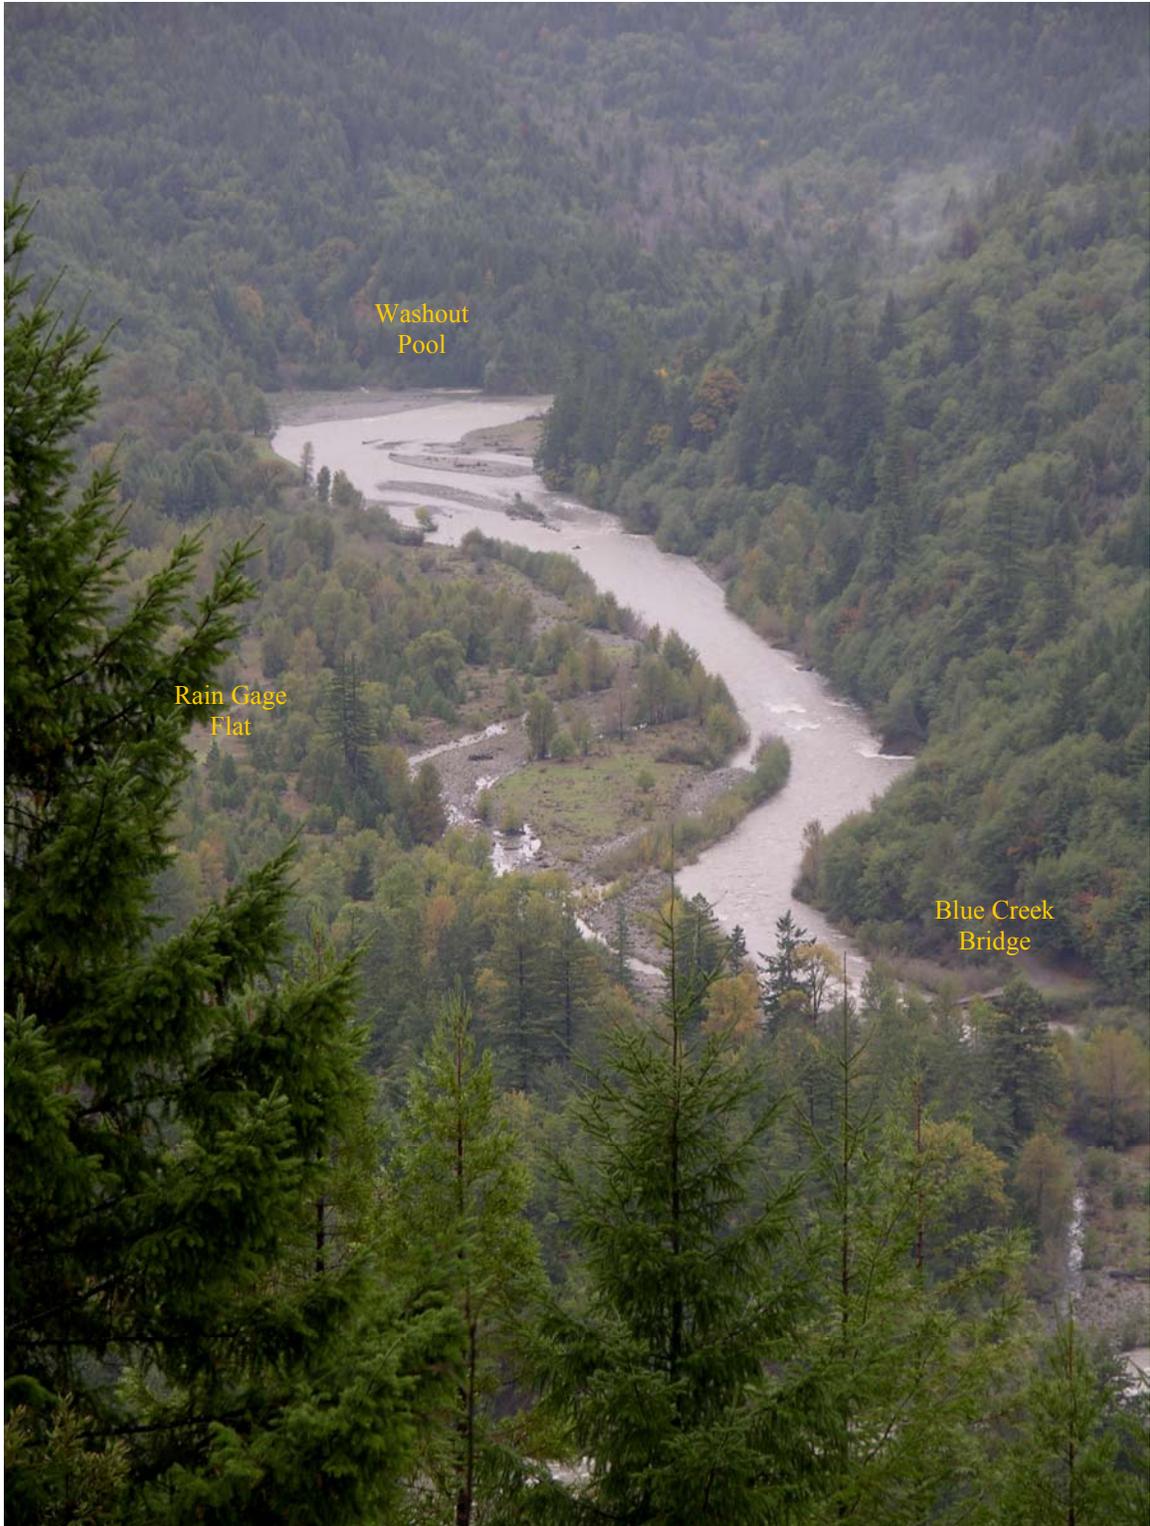
Figure 31. Photograph of lower Blue Creek, Lower Klamath River Sub-basin, California (October 2007). Flood flow at time of photograph approximately 6,000 cfs, following the 2008 water year peak flow of 18, 908 cfs.

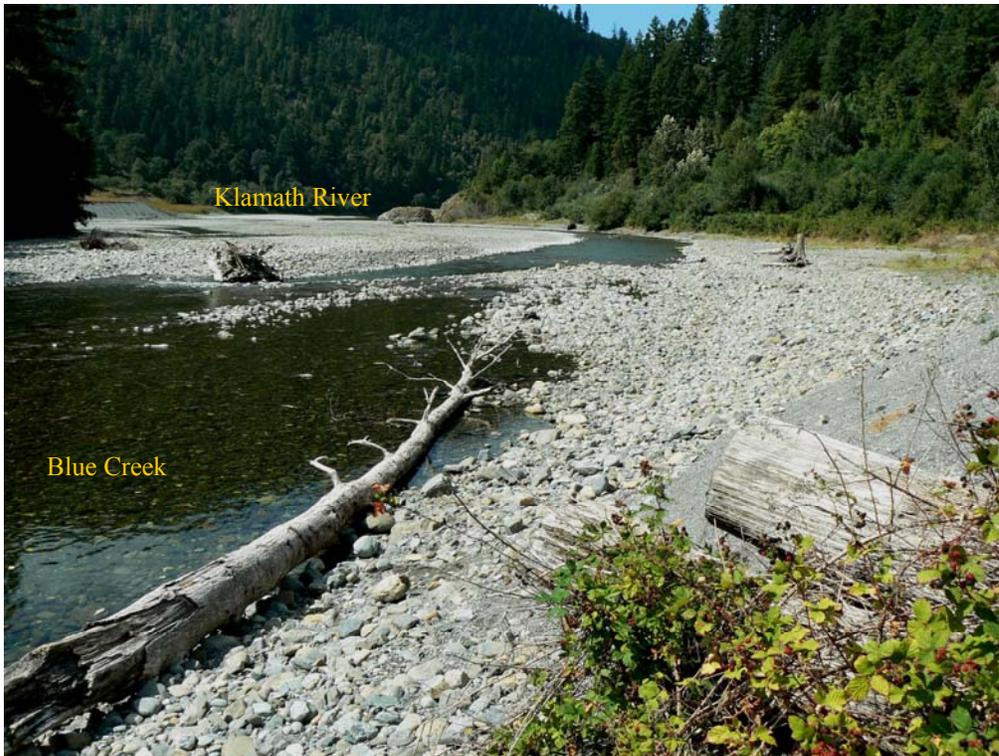
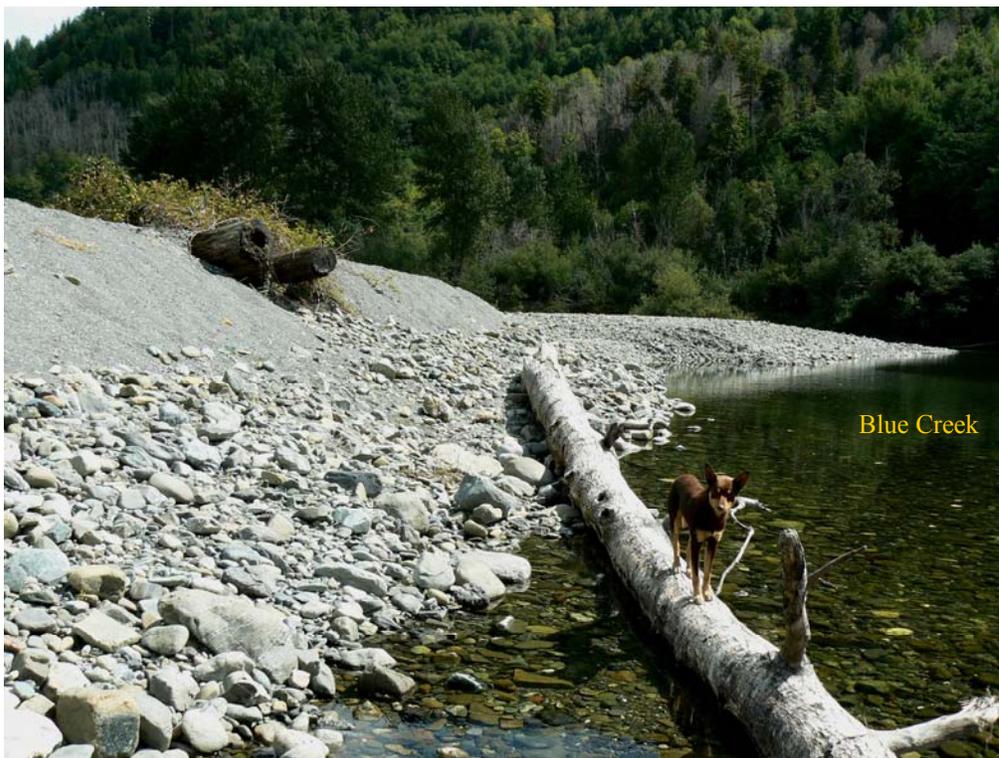
Figure 32. Photographs looking downstream towards the Klamath River (top photograph) and looking upstream at actively eroding banks (bottom photograph), lower Blue Creek, Lower Klamath River Sub-basin, California (2007).

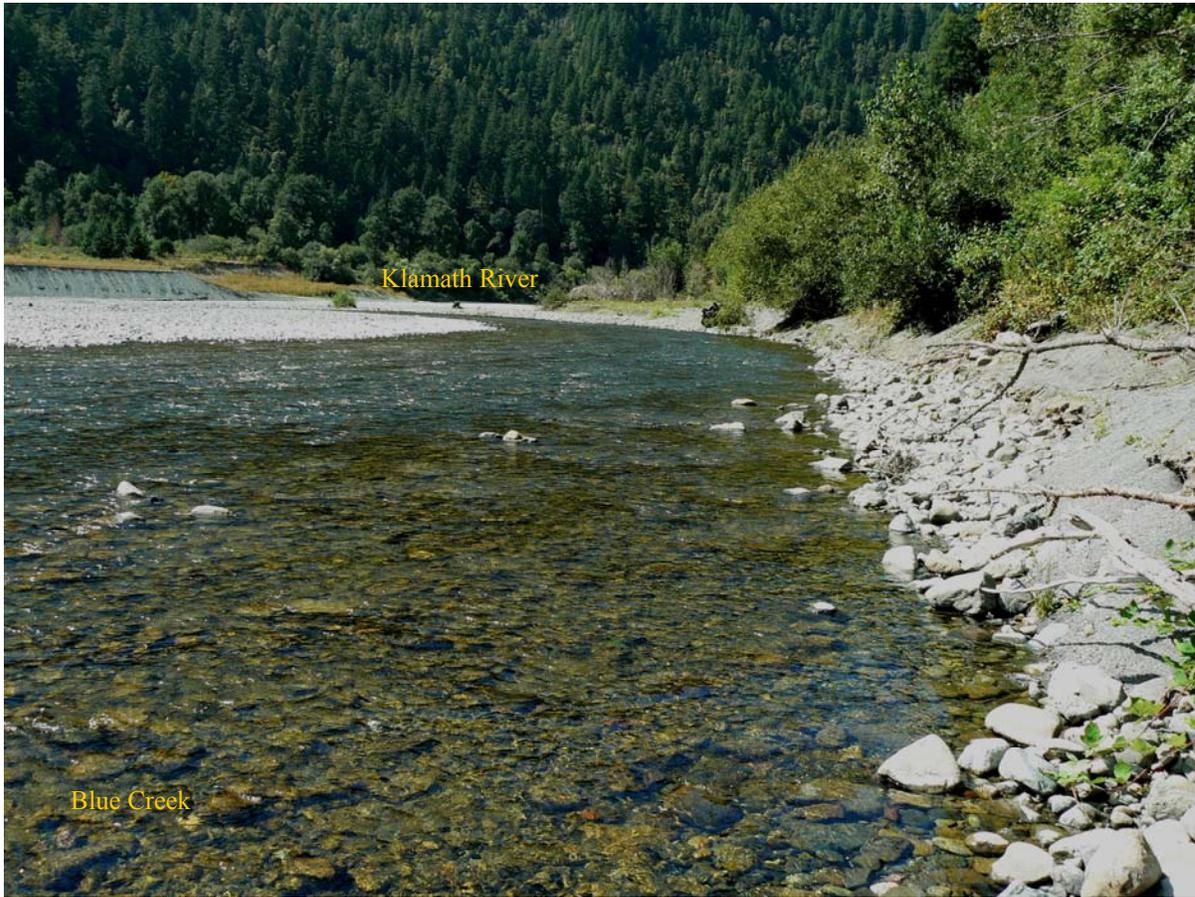
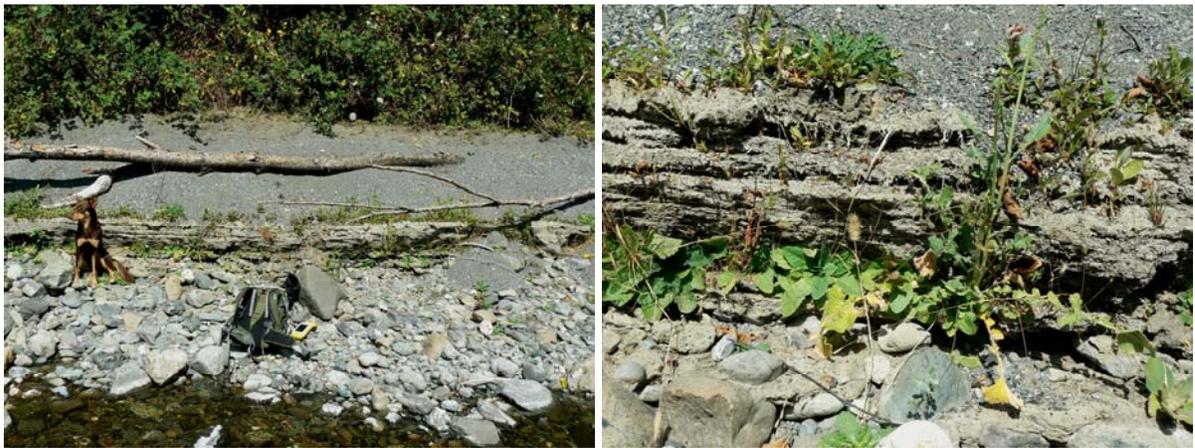
Figure 33. Photographs looking downstream towards the Klamath River (top photograph) and looking at the actively eroding banks (bottom photograph), lower Blue Creek, Lower Klamath River Sub-basin, California (2007).
