# YUOK TRIBE ENVIRONMENTAL PROGRAM

Source Water Assessment and Protection Program  
FISCAL YEAR 2013

Susceptibility Analysis  
October 1, 2013 through December 31, 2014

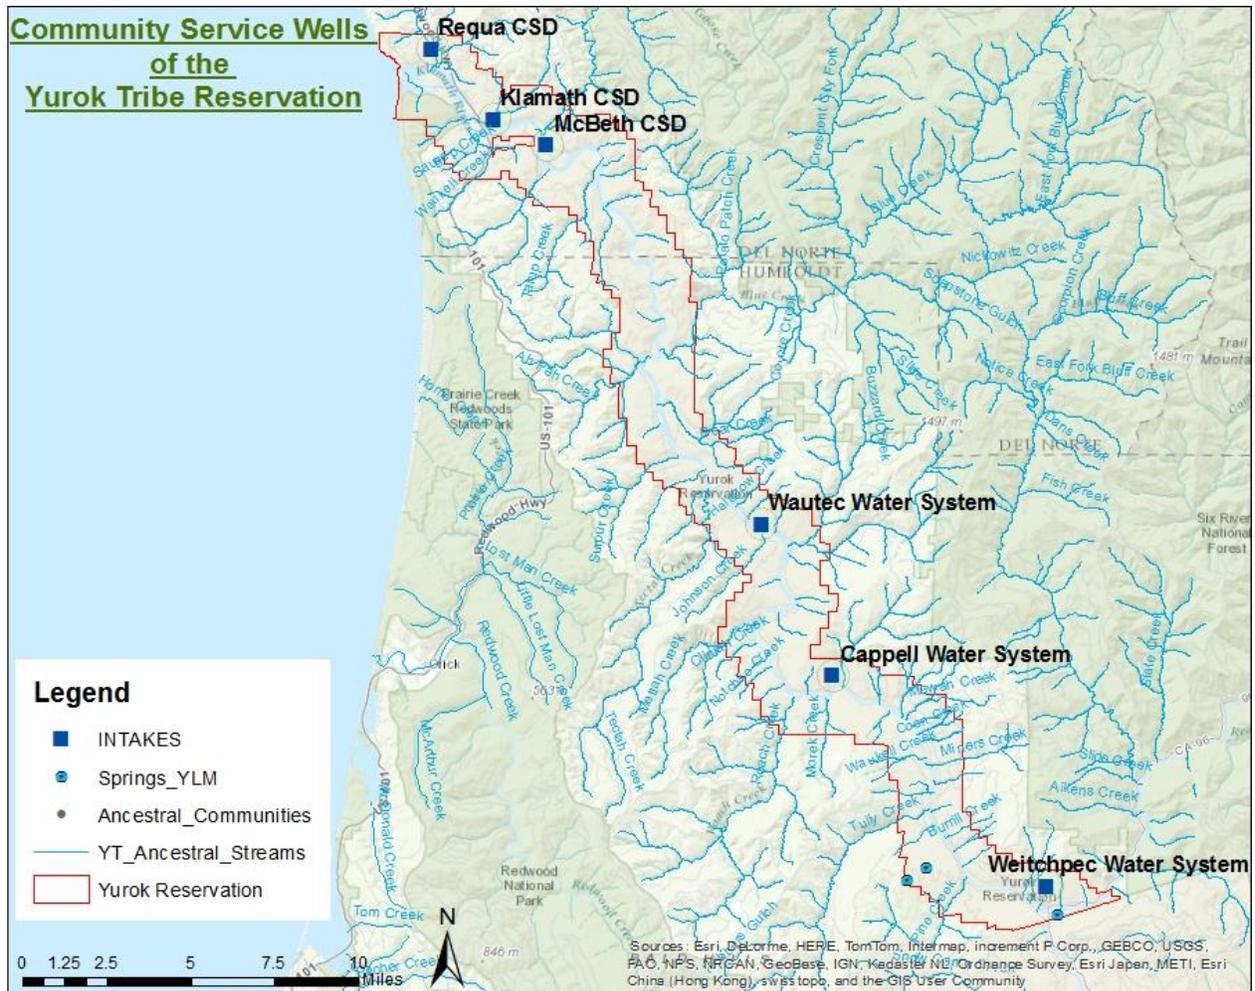
**Figure 2: Locations of the ‘in use’ intakes for the YIR CSD wells**

On the YIR there are a total of six 'in use' Community Service District (CSD) wells. These include the 'down river systems': Klamath CSD, McBeth Acres CSD, Requa CSD, and the 'up-river systems': Cappell CSD, Weitchpec CSD, and Wautec CSD (Table 1 and Fig 2). In the reporting year FY12 the Klamath and Requa CSDs were inventoried and assessed. For FY13, the Yurok Tribe has completed the inventory and assessment for the remaining 'down-river' system McBeth Acres CSD. 'Up-river' systems will be inventoried and assessed in the reporting year FY14.

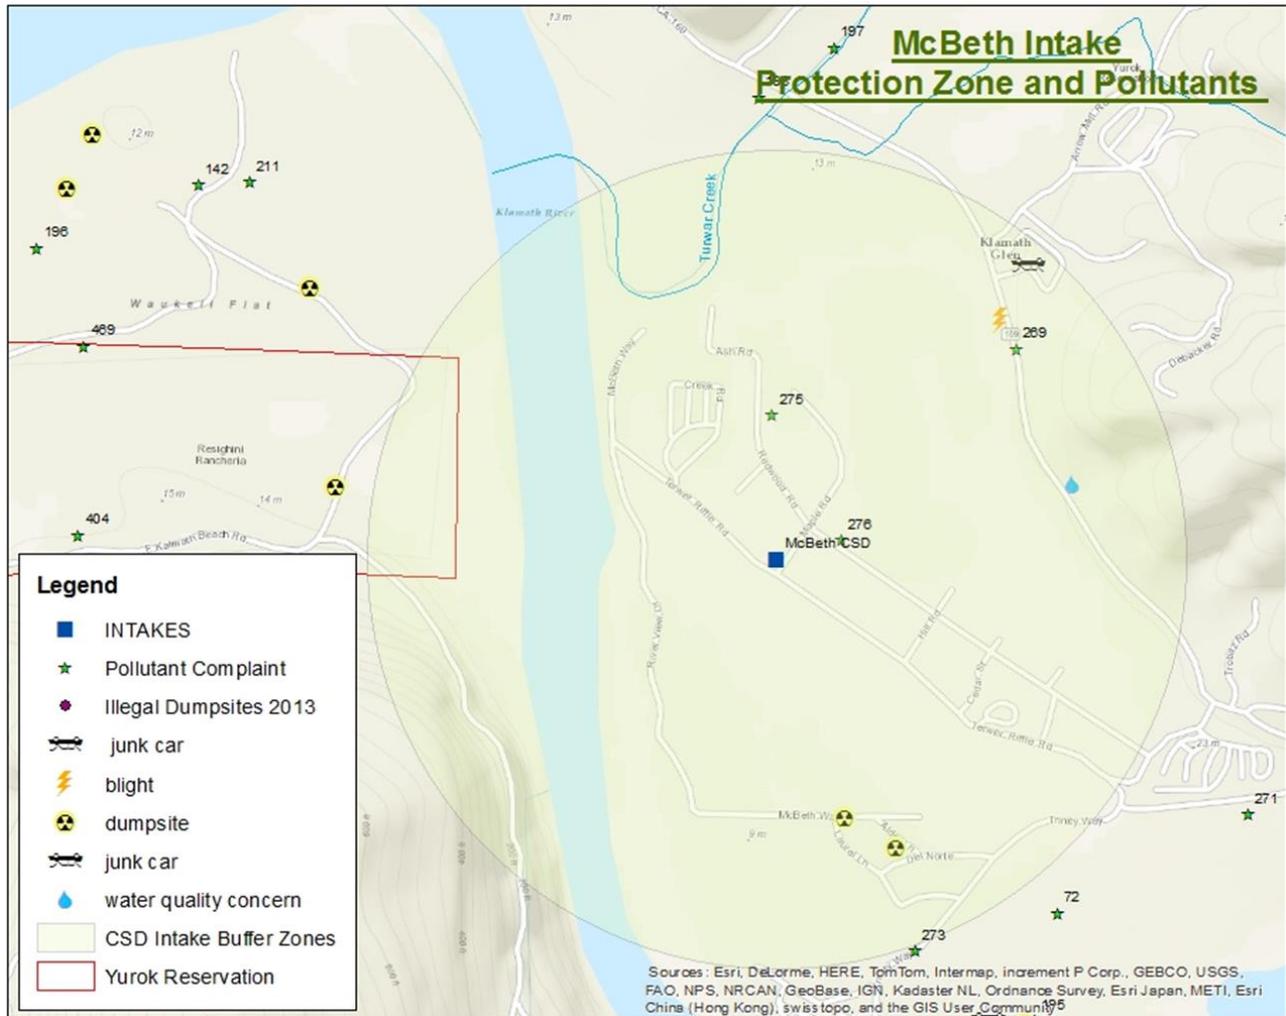
**Figure 3: Known Pollutants in McBeth Acres CSD**

In FY 2013, GIS was utilized to spatially analyze potential sources of contamination on the YIR and their proximity to drinking water systems. An arbitrary circular protection zone extending approximately 2500 feet in radius from the well head was established based on source water assessment guidelines for groundwater systems. This protection zone serves as the basis for inventory and assessment data collected in this project. Also, maps with the watershed, streams, topography and the protection zone were created. These maps allowed us to identify the residences,

businesses, commercial areas, agricultural practices, potential Brownfield sites, hazardous waste and dumps that were located within the protection zone (Fig.3).

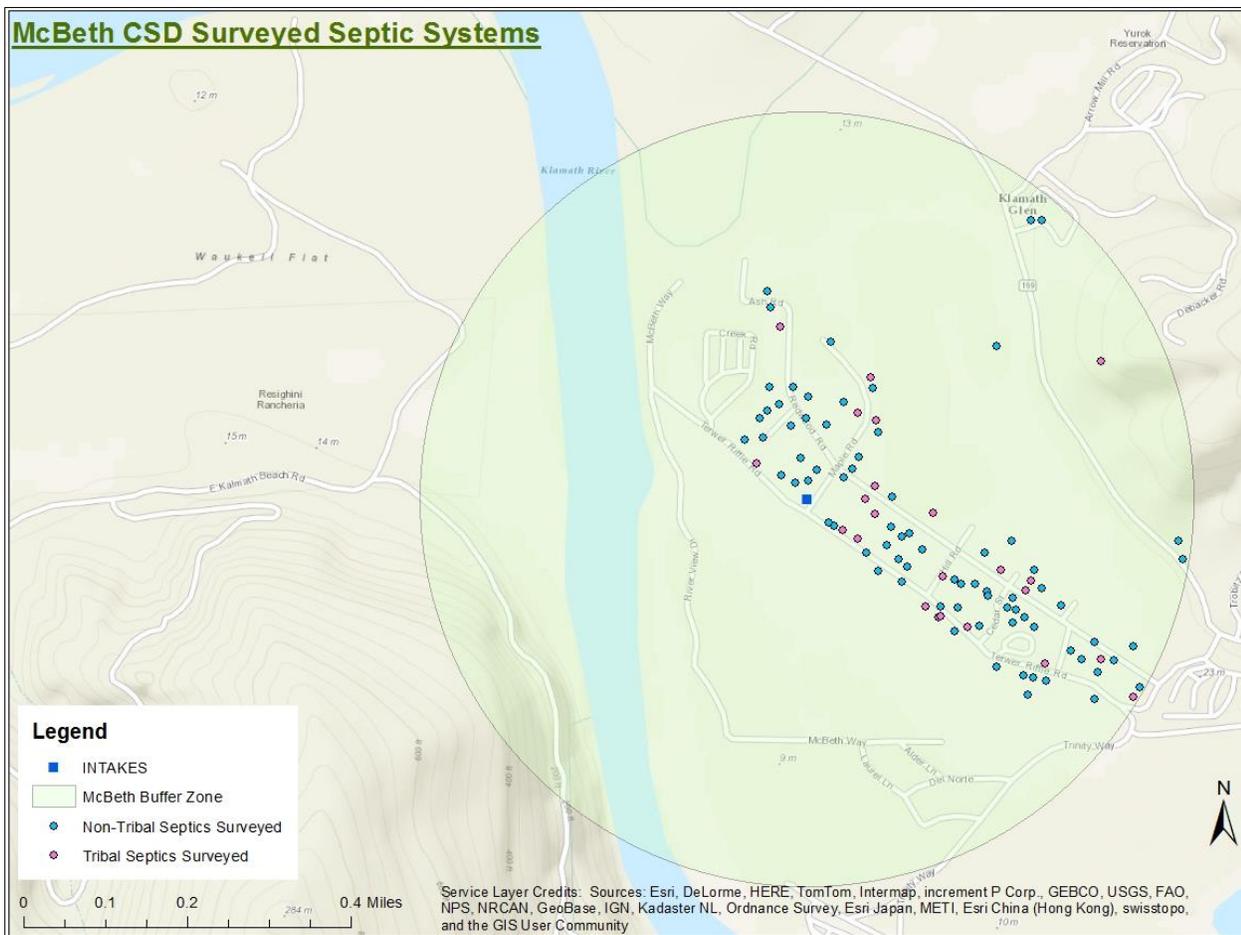
**Figure 4: Septic Systems that were assessed and inventoried**

In FY13 McBeth Acers CSD, located in the downriver community of Klamath Glen, was completed. The Mcbeth Acres CSD is by far the largest populated CSD with 160 connections. This is well over twice the amount of connections than all other CSD's on the YIR. Because of the high number of connections, out of the 160 septics a goal of 75 was set to be inventoried. The Yurok Land Management (YLM) assessed 23 Yurok Tribal septic systems in 2012, these septics were included in the analysis. Building off YLM's inventory, YTEP was able to assess a total of 76 septic systems in FY13. In total 99 septic systems were assessed and are included in this susceptibility analysis. These septic systems include both tribal and non-tribal residences (Figure 4).

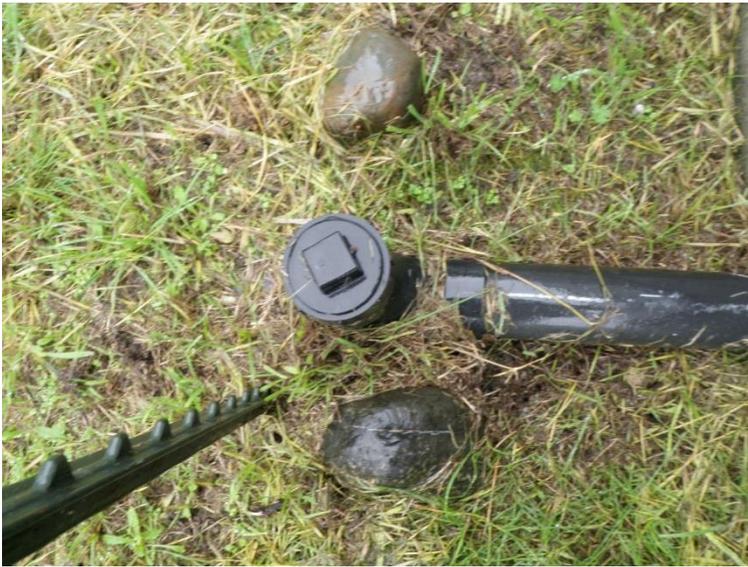
**Image 1: Example of a clean out cap for an assessed septic system designated ‘in place’**

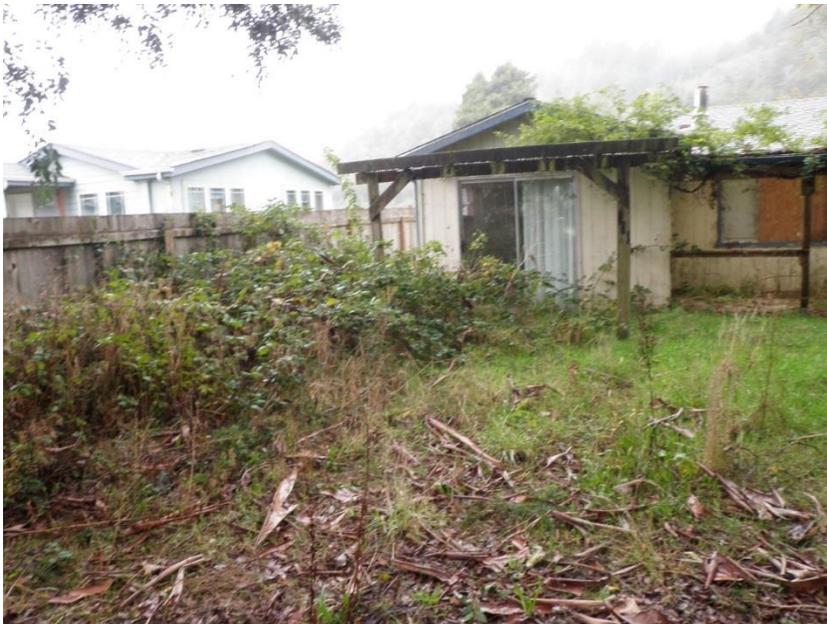
**Image 2: Example of a septic system that was too overgrown to assess.**

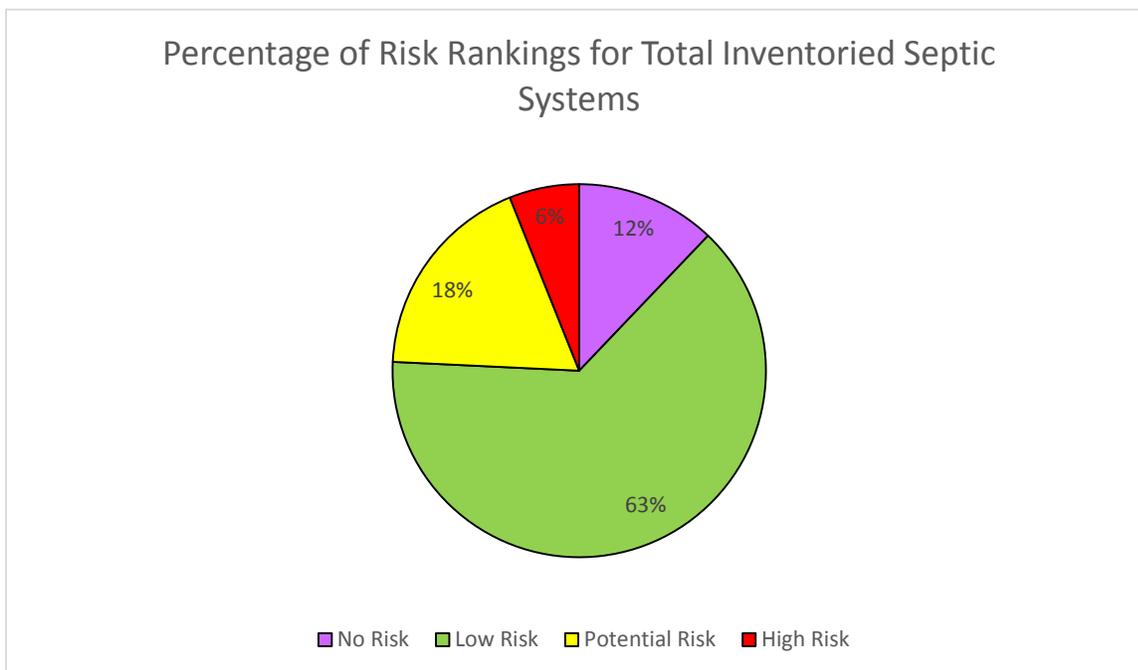
To improve visualization, the rankings for each septic system were uploaded into ArcGIS and assigned a color category based on risk levels. Risk categories included no risk (purple), low risk (green), potential risk (yellow), and high risk (red). 12 out of 99 residences (12%) scored zero, posing no risk of contamination to the CSD well. 63 out of 99 residences (63%) scored between 1 and 6, posing little to no risk of contamination. 18 out of 99 residences (18%) scored between 7 and 12, posing a potential risk of contamination. Six out of 99 residences (6%) scored between 13 and 18, posing a high risk of contamination (Graph 1, Figure 5).

**Graph 1: Percentage of ranking scores based on septic systems assessed.**

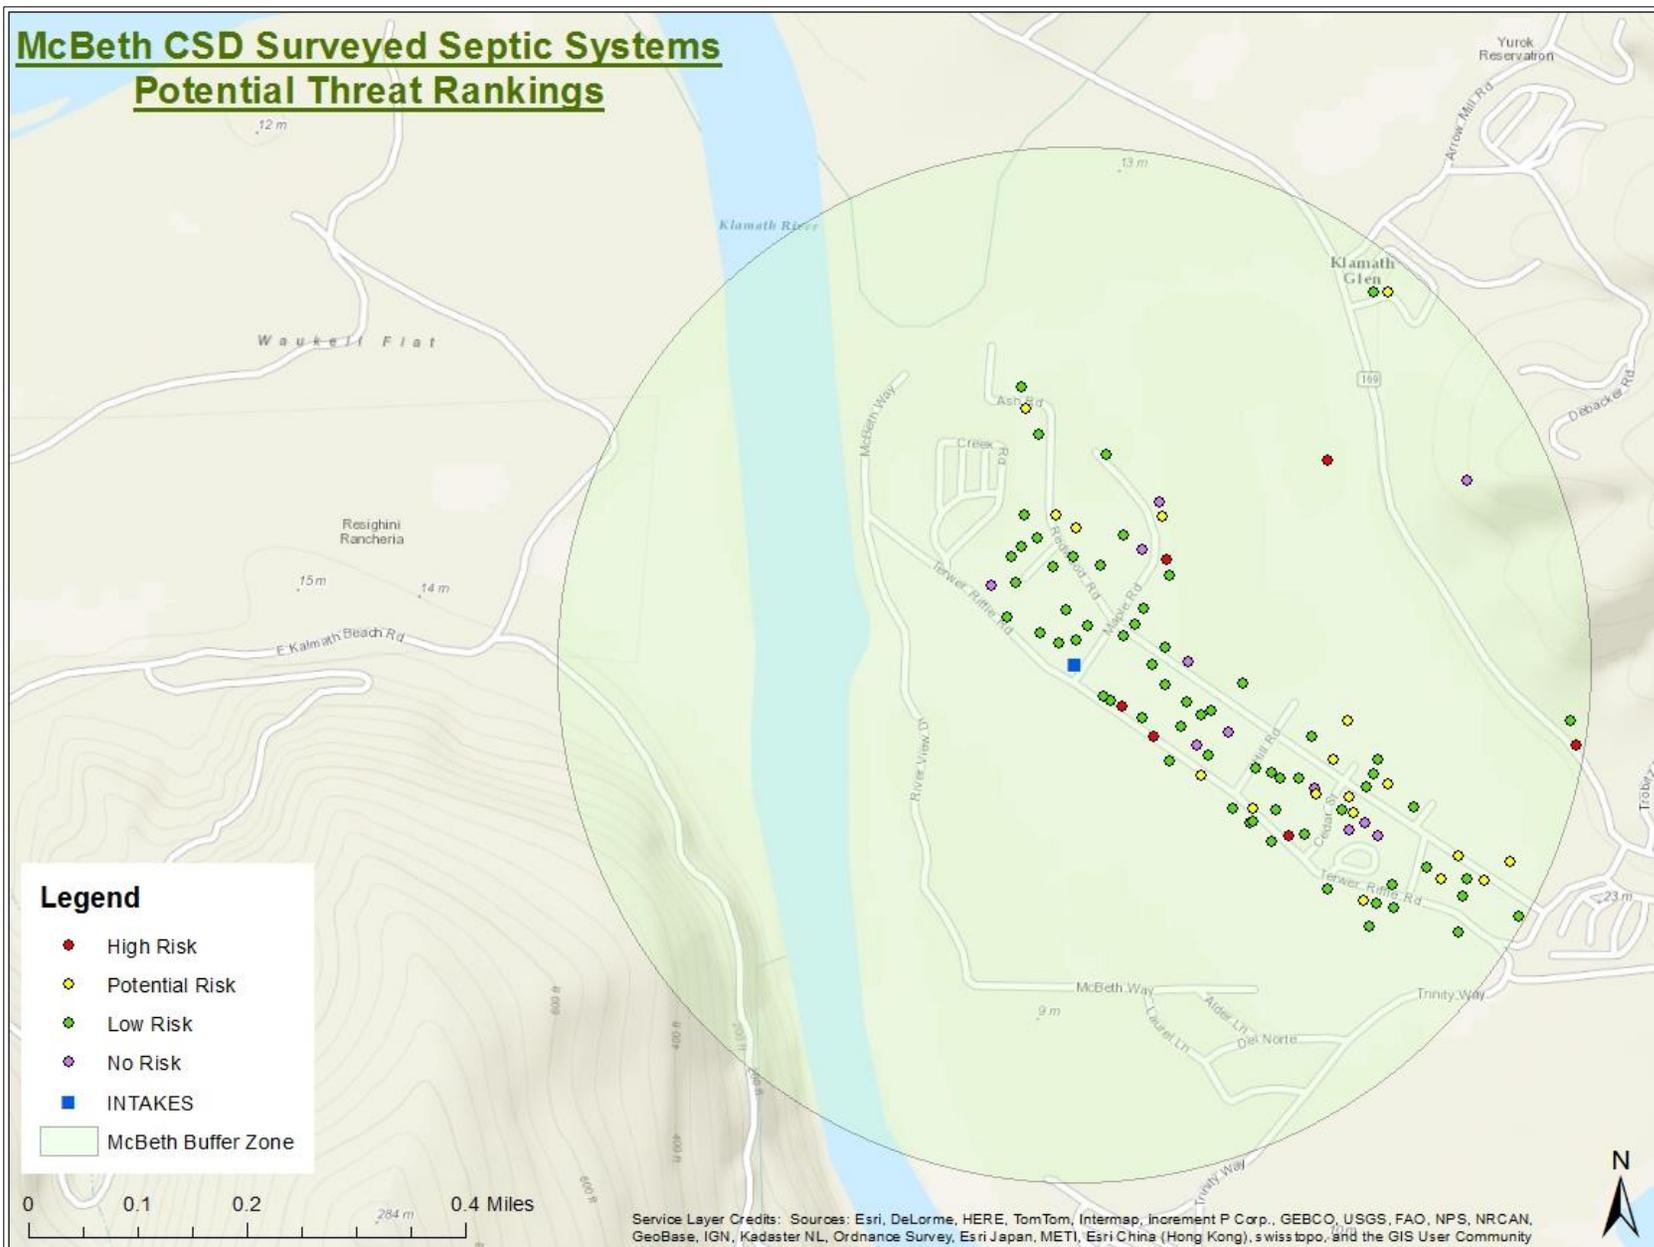
Based off the assessment rankings, only 6% of septic systems assessed are considered 'high risk'; the farthest high risk septic systems are more than 1500 feet from the well and the closest being just over 300 feet from the well (Figure 5). The two high risk septic systems that are the closest to the well likely pose a much higher threat than the other four, considering their close proximity (Figure 5). It is recommended that the 18 residences that pose a potential threat be monitored until appropriate mitigation can be achieved. The majority of the residences surveyed, pose little to no risk of contamination, and therefore are not seen as a threat to the CSD well.

**Figure 5. Rankings given to septic systems based on their assessment score and potential risk of contamination**
