## Stream and Riparian Habitat Enhancement of Waukell Creek: Phase I

September 2010

## **Appendix A. Waukell Creek 2009 Wood Loading Project Photo-Monitoring**

## Appendix B. Topographic data collected in Waukell Creek 2008 – 2010.

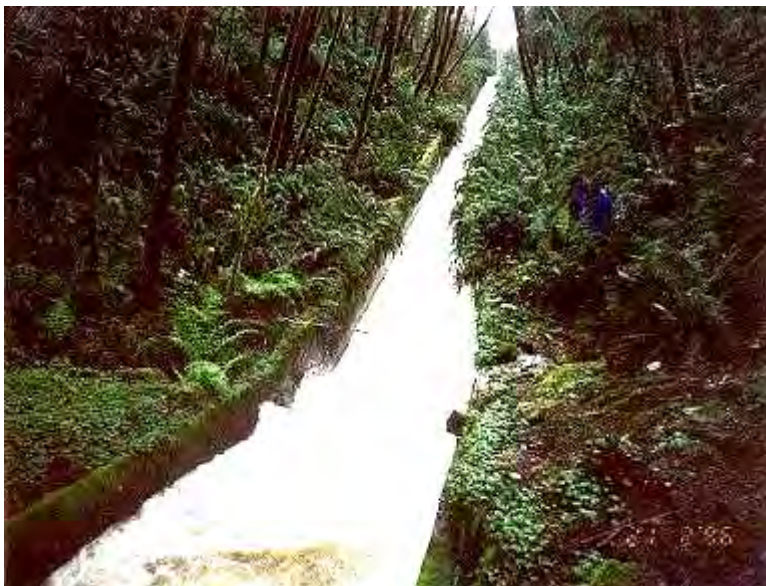
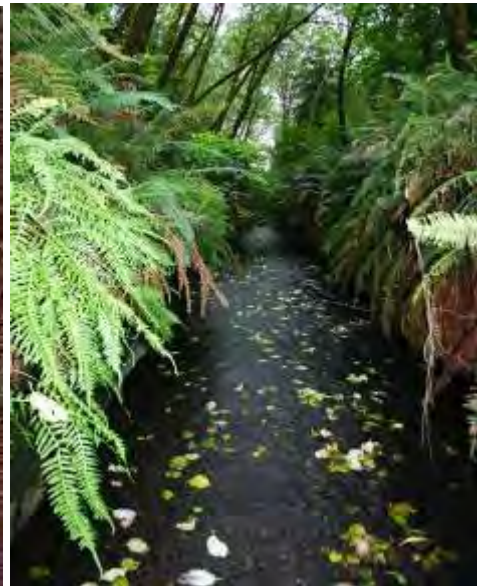
Figure 5. Highway grade control ramp in Waukell Creek (Left-Winter 1996 and Right-2007).

geomorphic conditions in this system. The highway was built on ~1.6 miles of lower Waukell (Figures 2-4). The stream was routed to the east side of the valley and a steep concrete grade control ramp was installed to accommodate the significant increase in gradient resulting from channel realignment and loss of floodplain (Figures 2, 4-5). The highway grade control structure and culvert located upstream have prohibited fish access to the upper watershed since the 1960s.

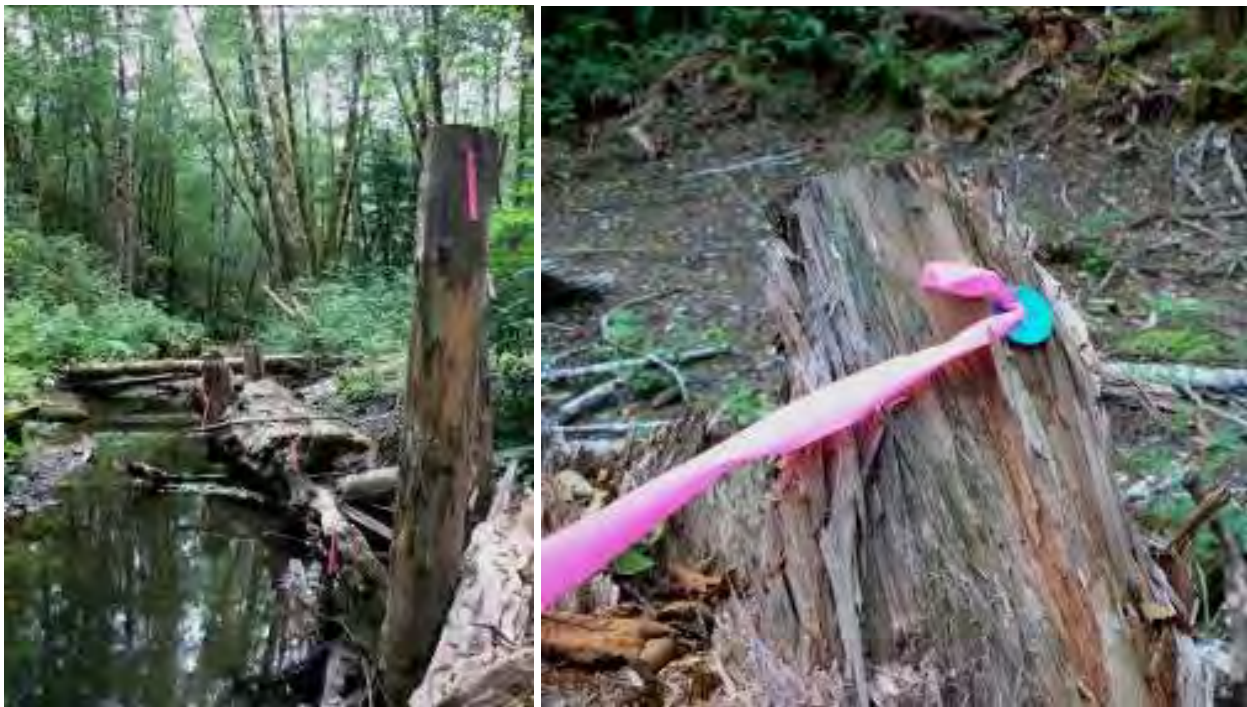
Figure 12. Photographs of complex wood jams constructed in Waukell Creek in summer 2009 and the numbered ID tags applied to the placed wood for monitoring purposes.

Topographic data collected since 2008 revealed slight changes in channel profile and geometry following CWJ construction and winter 2009-2010 flows (Appendix B). CWJ construction appeared to influence pool scour at sites 5-9 (Appendix B – Thalweg Profile). Cross section data collected in 2010 revealed minimal improvements in channel geometry at a few of the monitored sites (i.e. development of a low flow channel and flood benches) following winter 2009-2010 (Appendix B). Data collected downstream of the CWJs revealed some deposition occurring in the channel following winter 2009-2010 (Appendix B). Wood surveys conducted in 2010 indicated negligible movement of placed wood during winter 2009-2010.

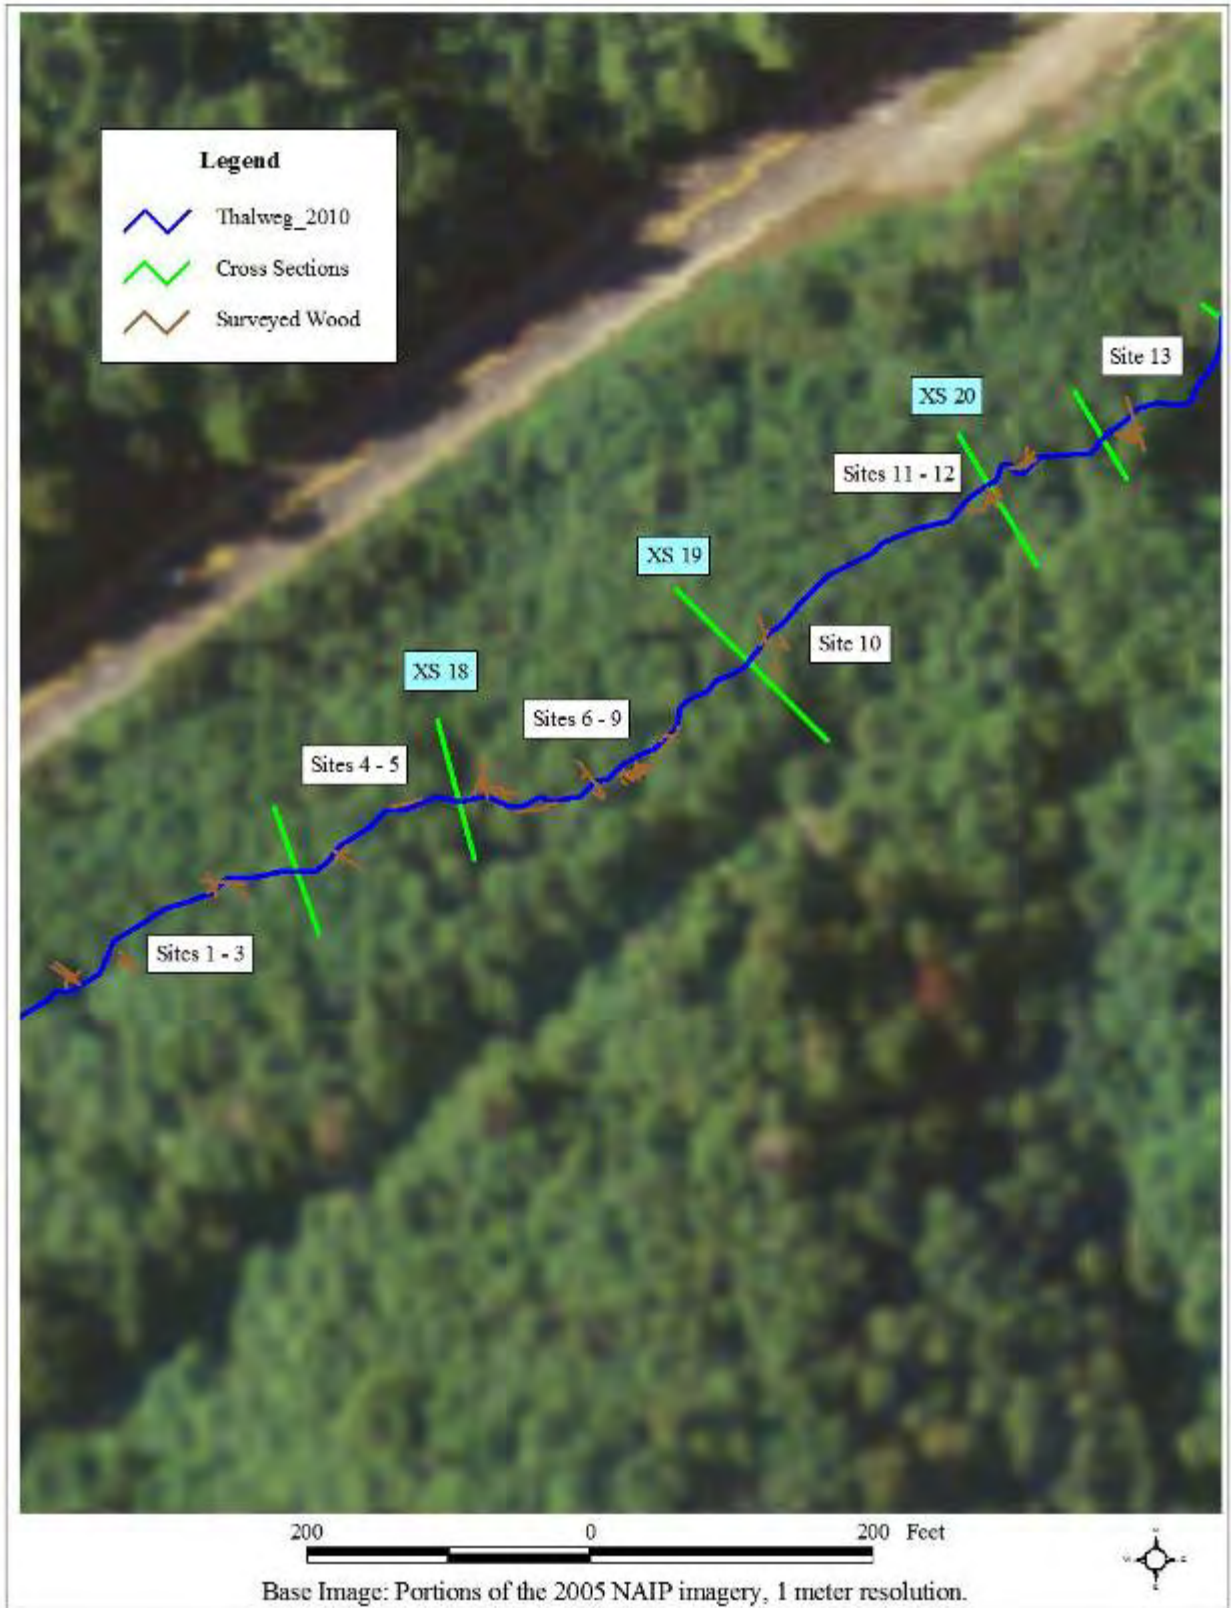
Figure 14. Map depicting 2009 wood placement sites and surveyed logs in Waukell Creek.

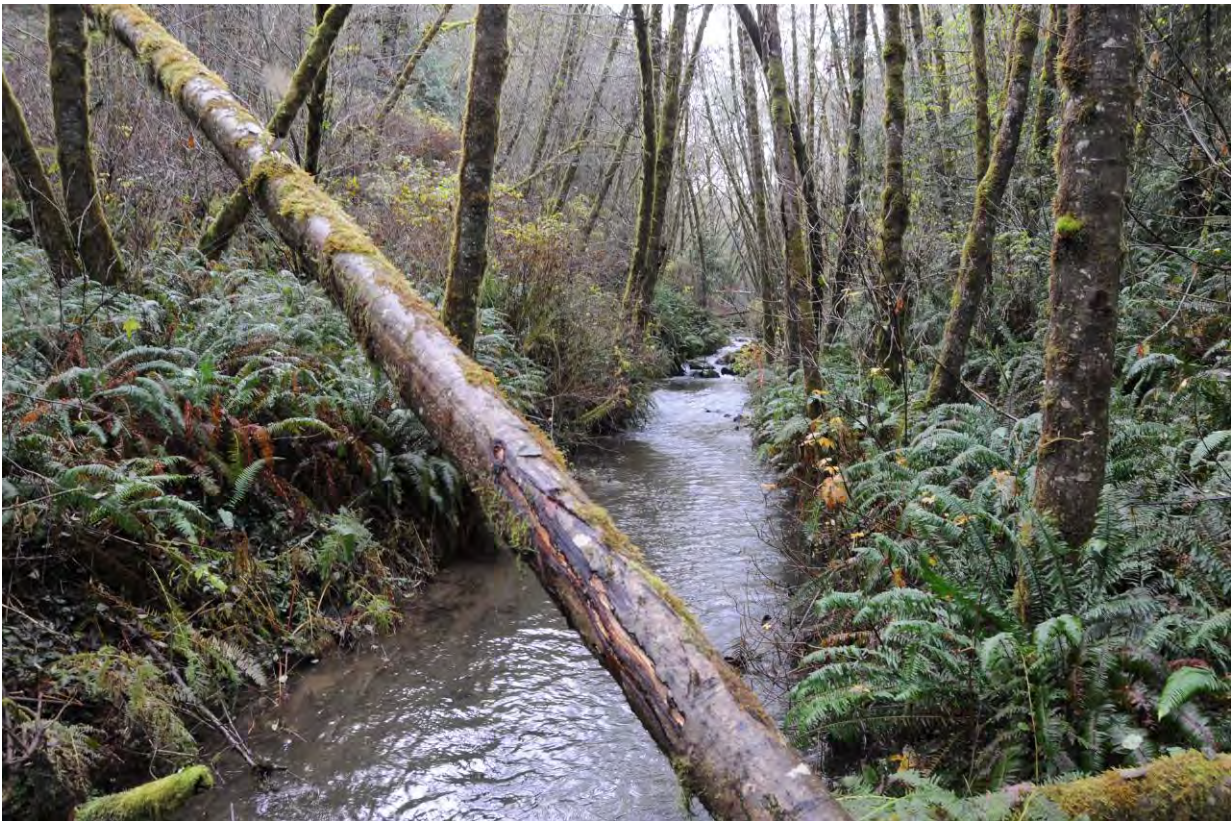
Figure 1. Typical view representative of depleted wood and channelized conditions within the project reach. Upstream view from Site 1. Image dates: top 9-24-2009, bottom 12-05-2010.

Photo-monitoring of wood loading sites constructed in 2009 occurred immediately before construction in September 2009, and post-construction in December 2010. Additional photographs of these sites were taken during reconnaissance field evaluations during the year since construction. The photographs included herein were selected to provide the best before and after views of the 13 sites and show site conditions with moderate winter flows. The 2010 water year tested these sites with two peak flow events that had a 4.2 year and a 1.1 year recurrence interval ratings according to record analysis for the nearby USGS Smith River gage at Jed Smith. Waukell Creek was flowing at approximately 15 cfs at the time of the December, 2010 photographs. The 12/10/13 photographs indicate the constructed wood jams (CWJs) performed well in terms of stability and habitat formation.

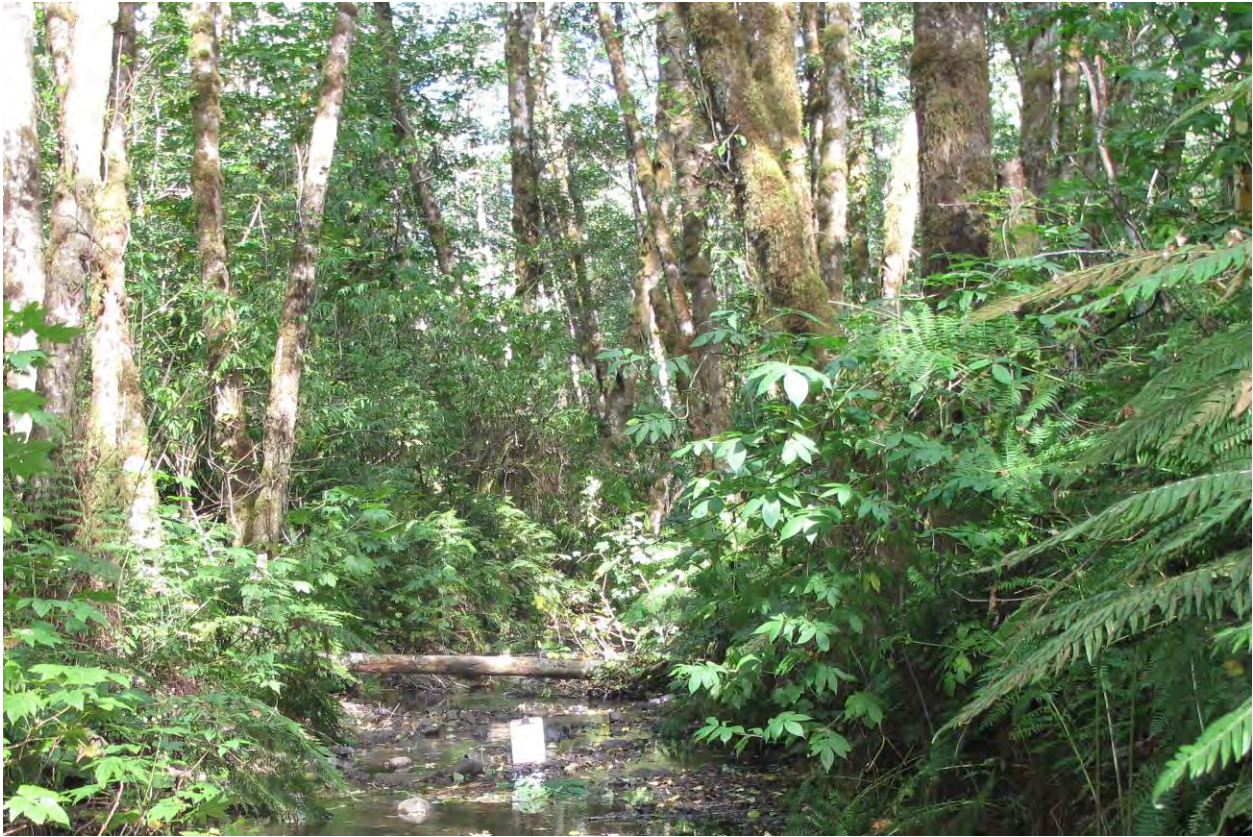
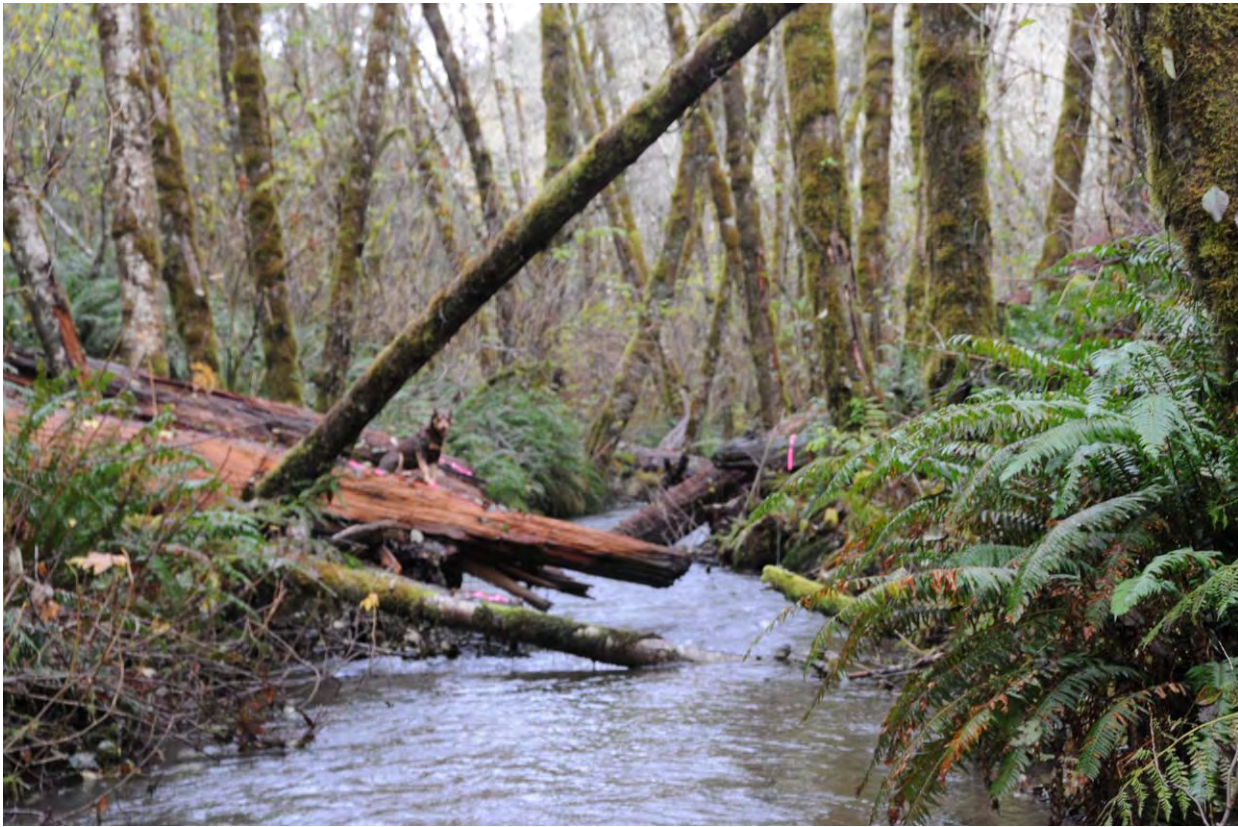
Figure 2. Paired before and after downstream view of Sites 1 and 2. Image dates: top 9-24-2009, bottom 12-05-2010.

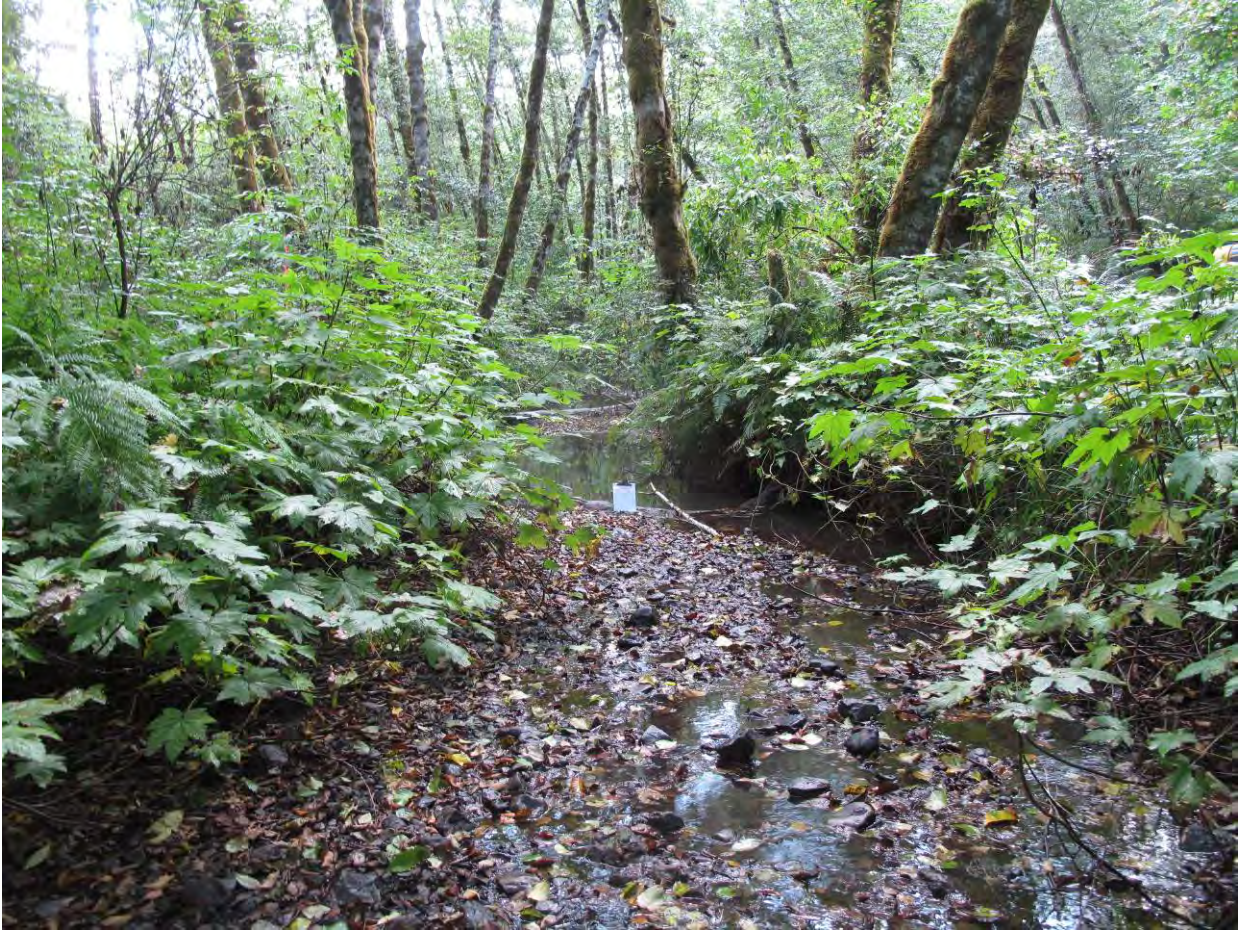
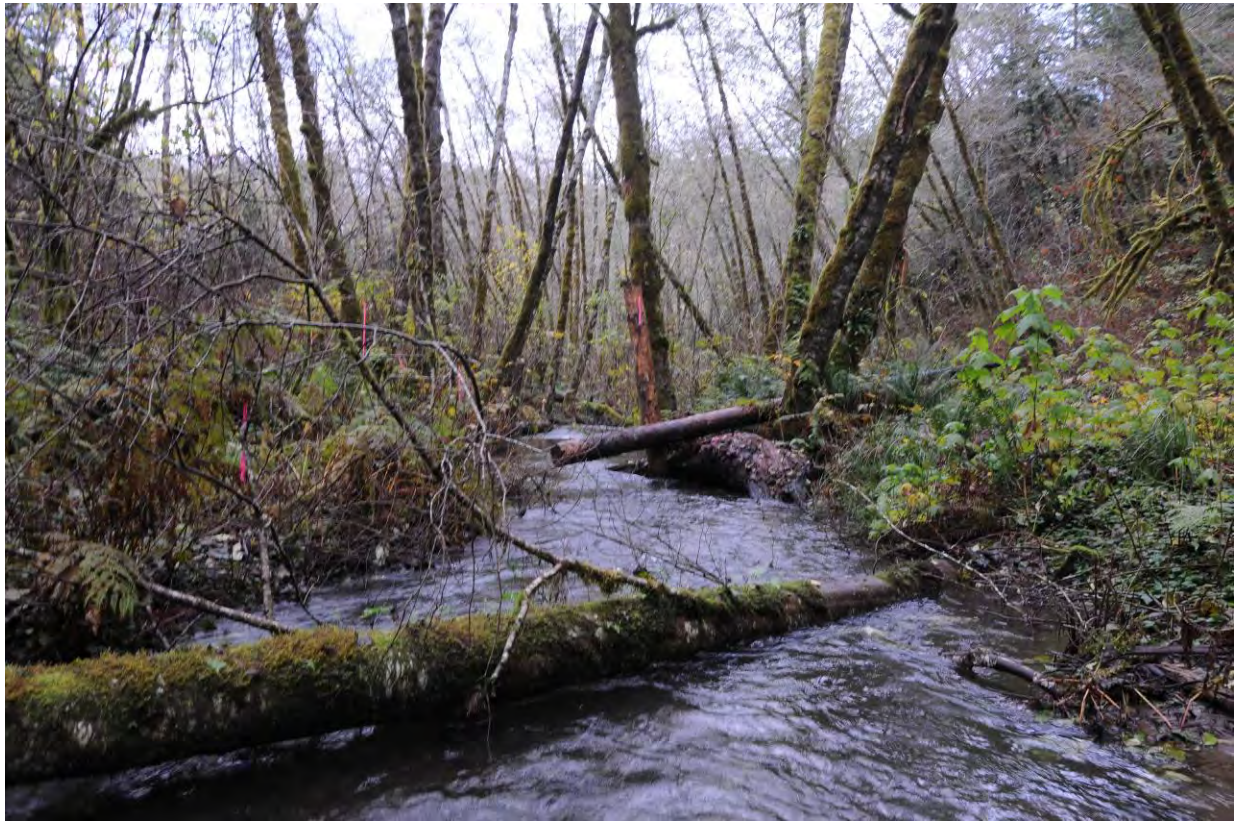
Figure 8. Paired before and after downstream views of Site 4. Image dates: top 9-29-2009, bottom 12-05-2010.

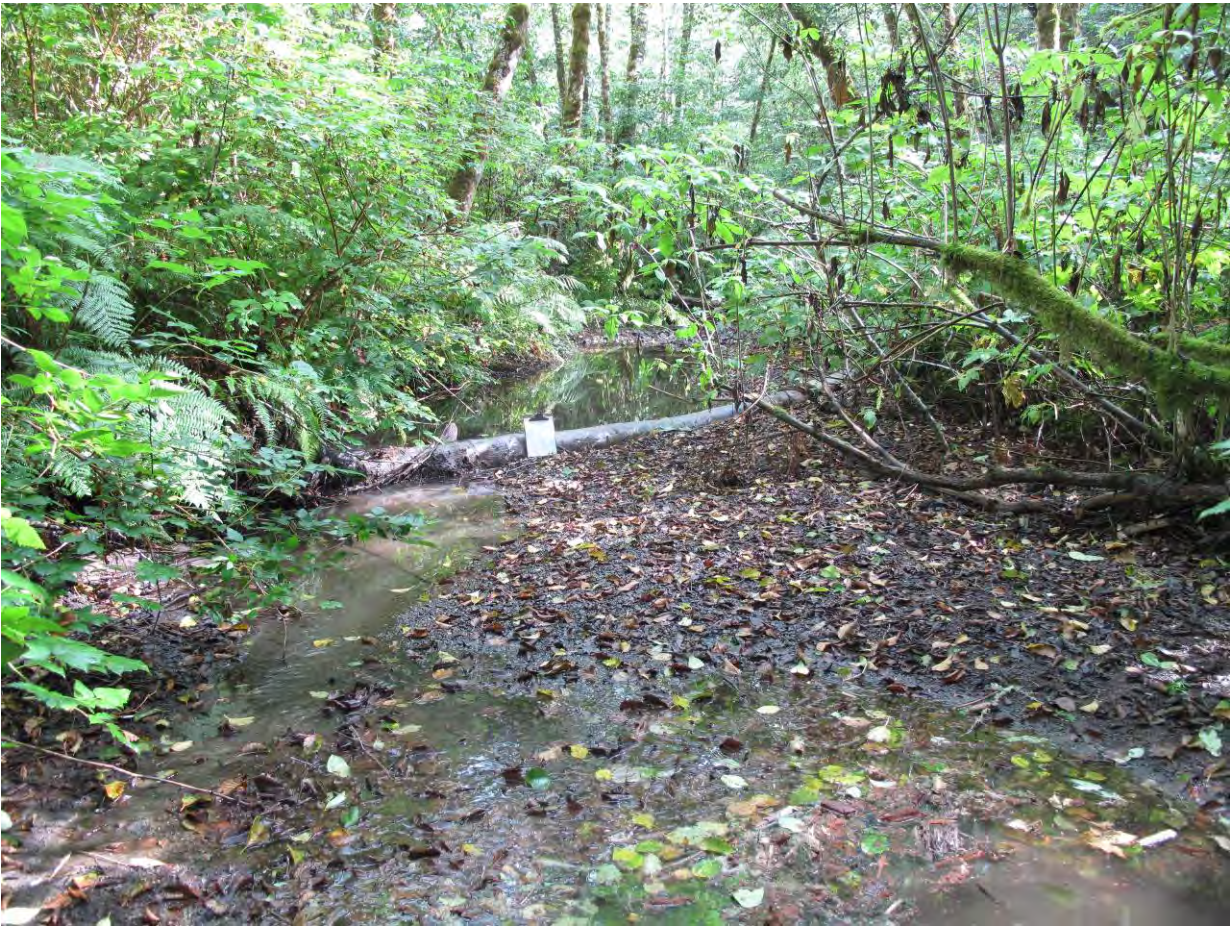
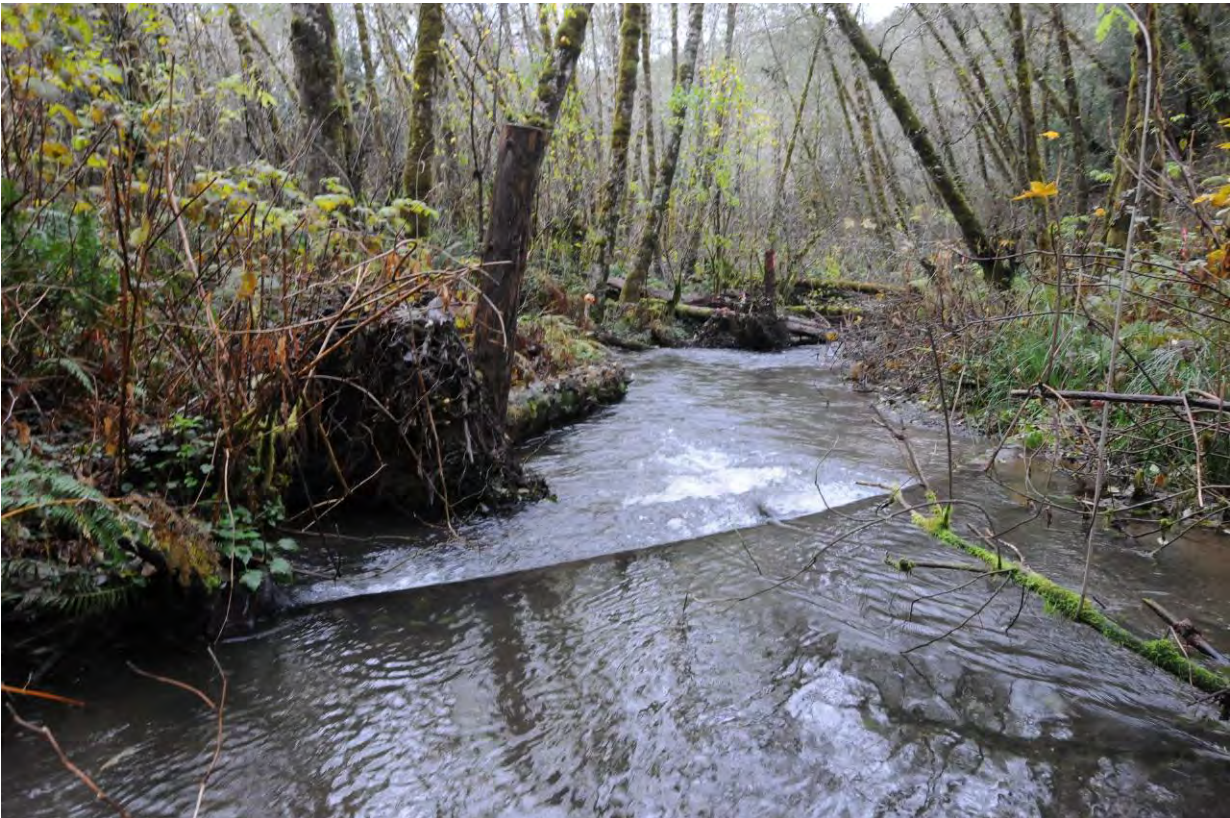
Figure 10. Paired before and after downstream views of Site 5. Image dates: top 9-29-2009, bottom 12-05-2010.

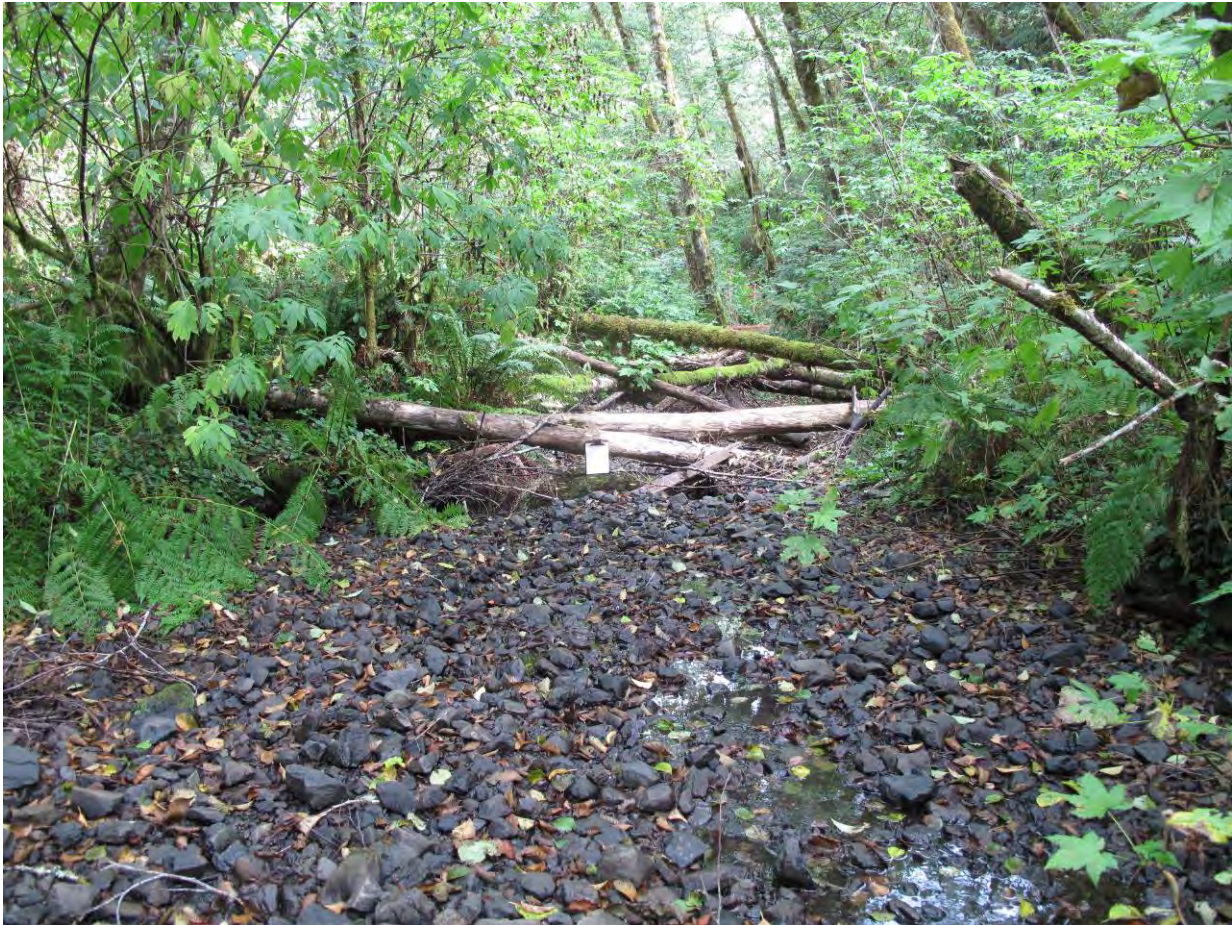
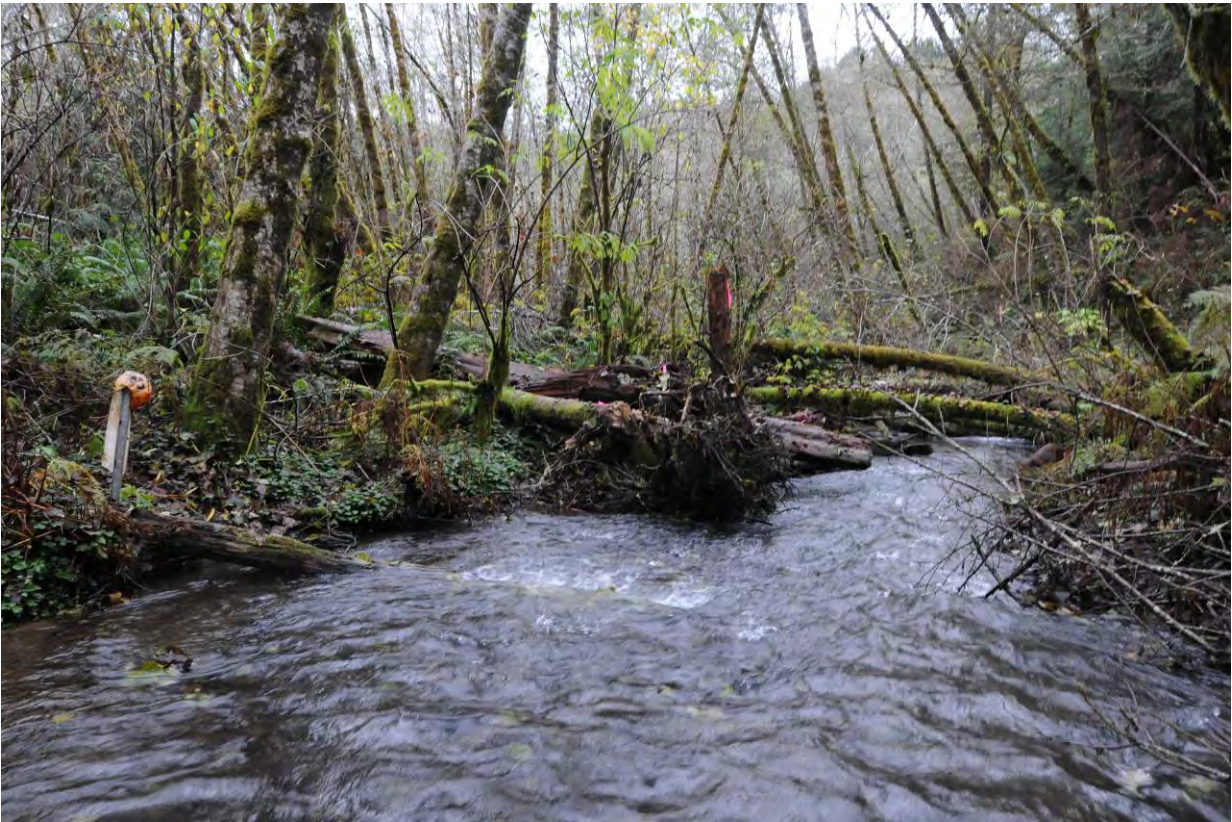
Figure 12. Paired before and after downstream views of Site 6. Image dates: top 9-29-2009, bottom 12-05-2010.

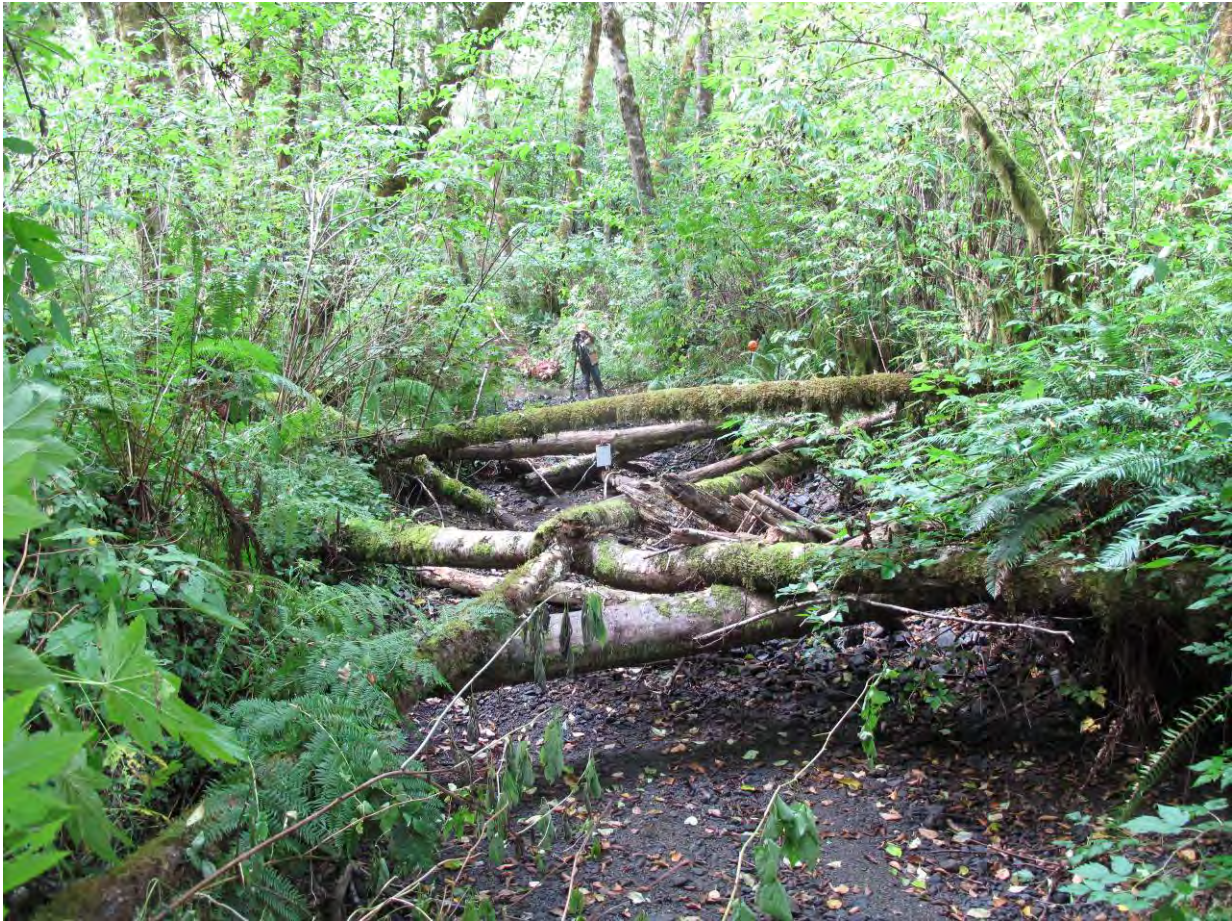
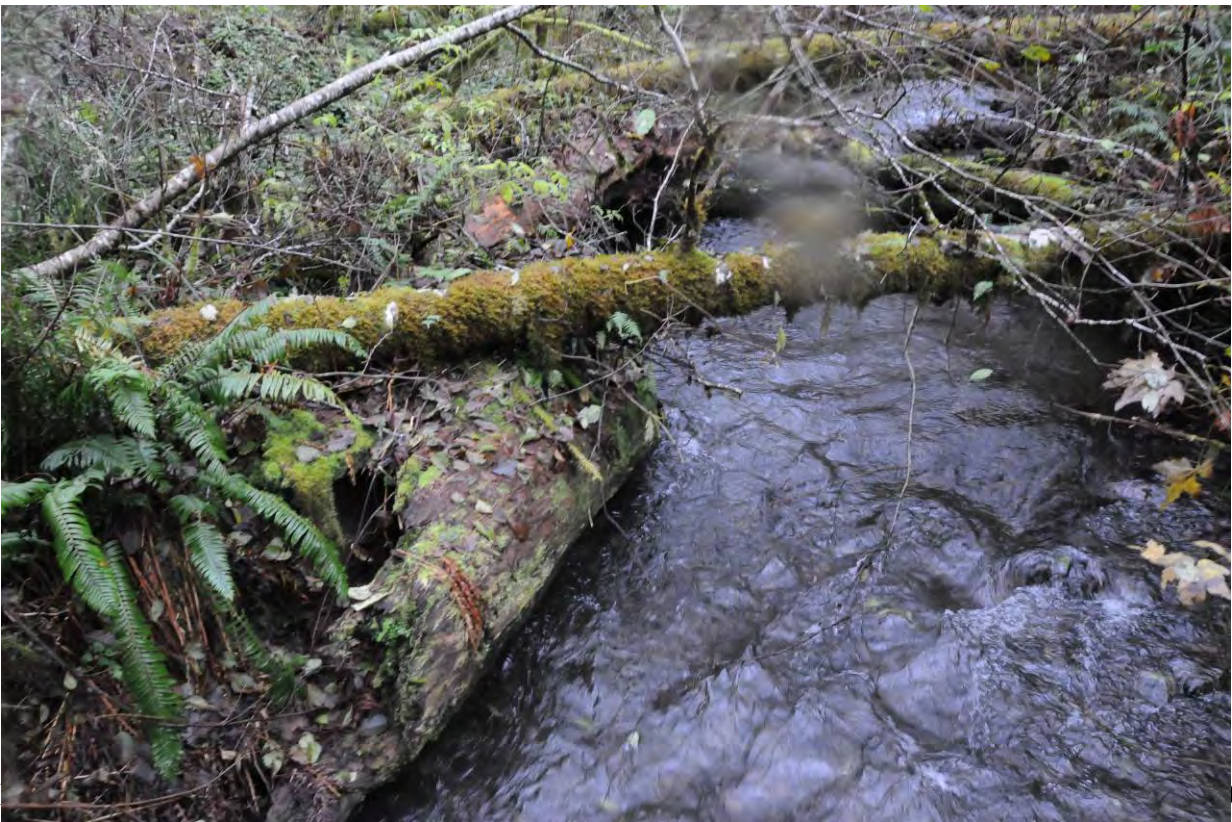
Figure 14. Paired before and after upstream views of Site 7. Image dates: top 9-29-2009, bottom 12-05-2010.

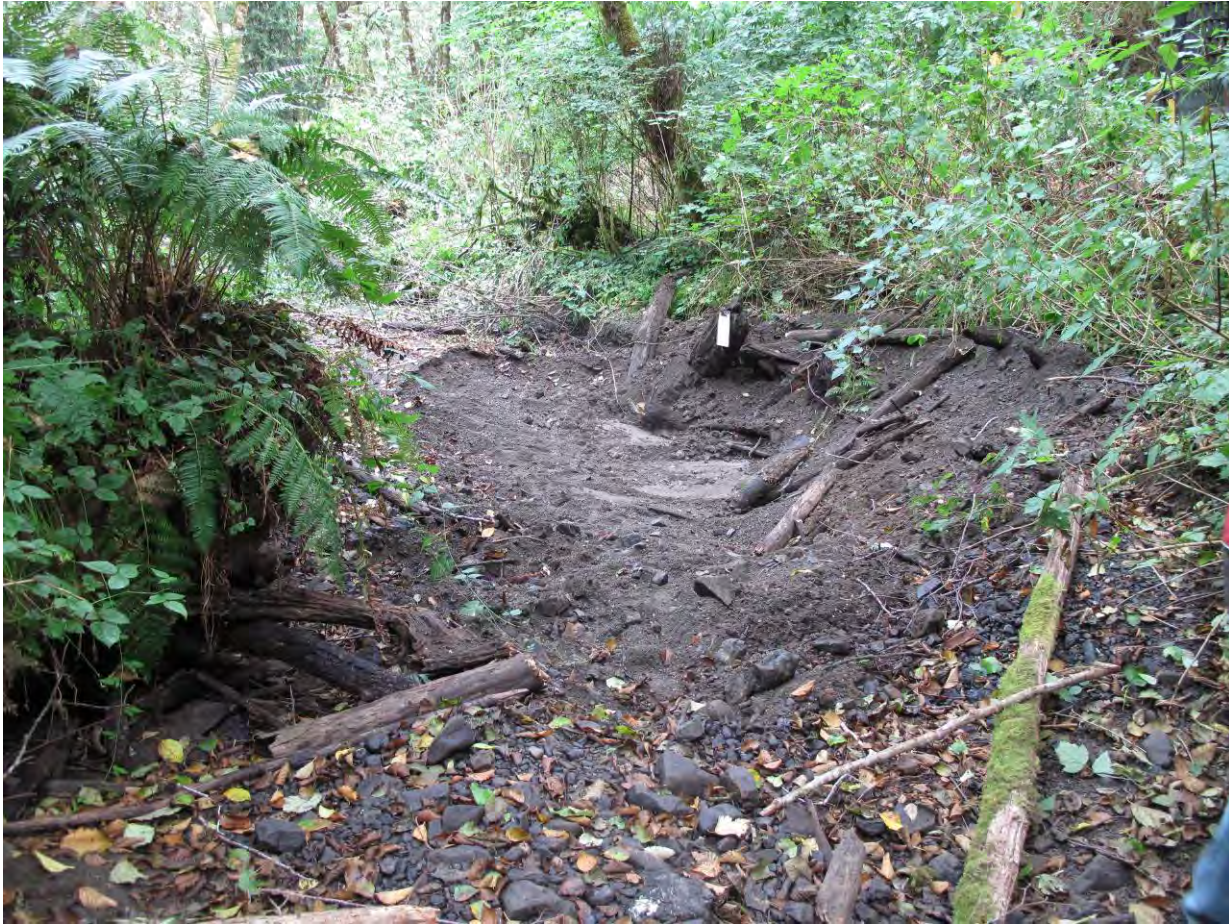
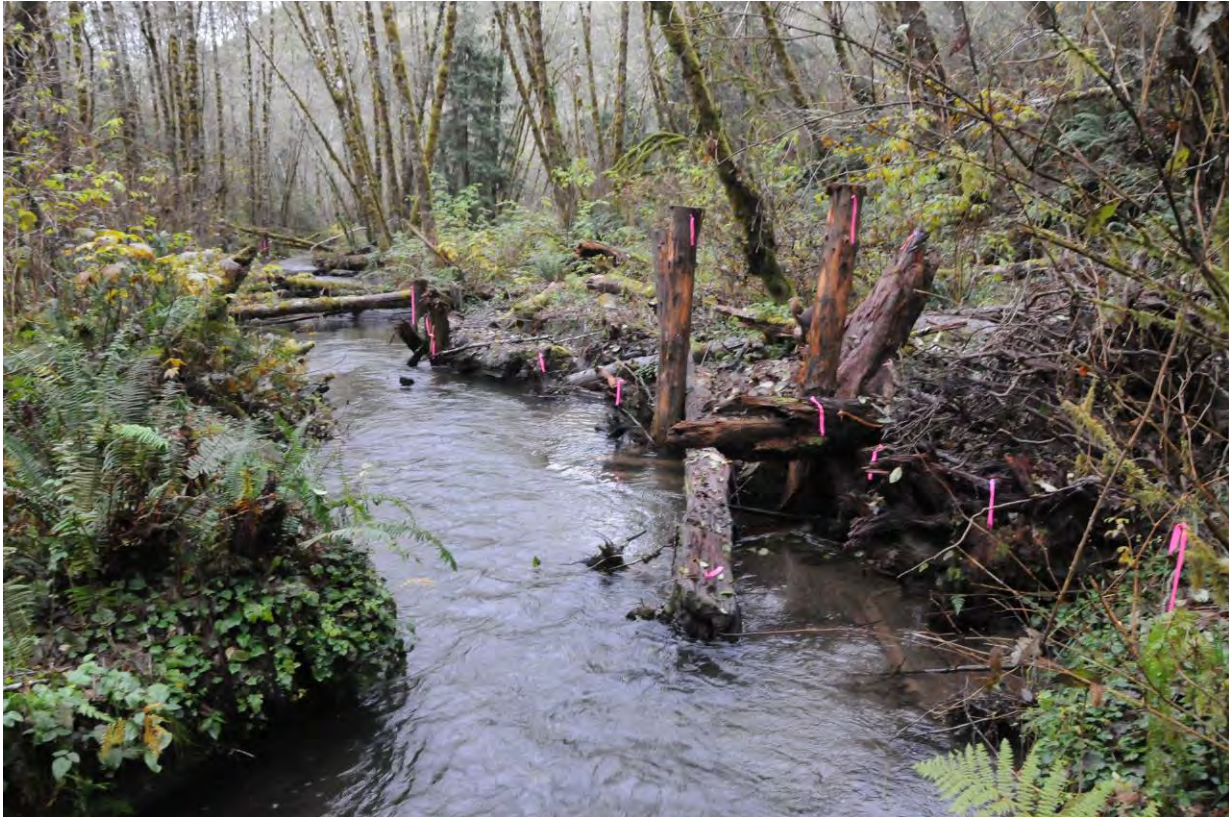
Figure 16. Paired before and after downstream views of Site 9 from Site 8. Image dates: top 9-29-2009, bottom 12-05-2010. Top image shows site prep of stream bed needed to fit multiple pieces of large wood.

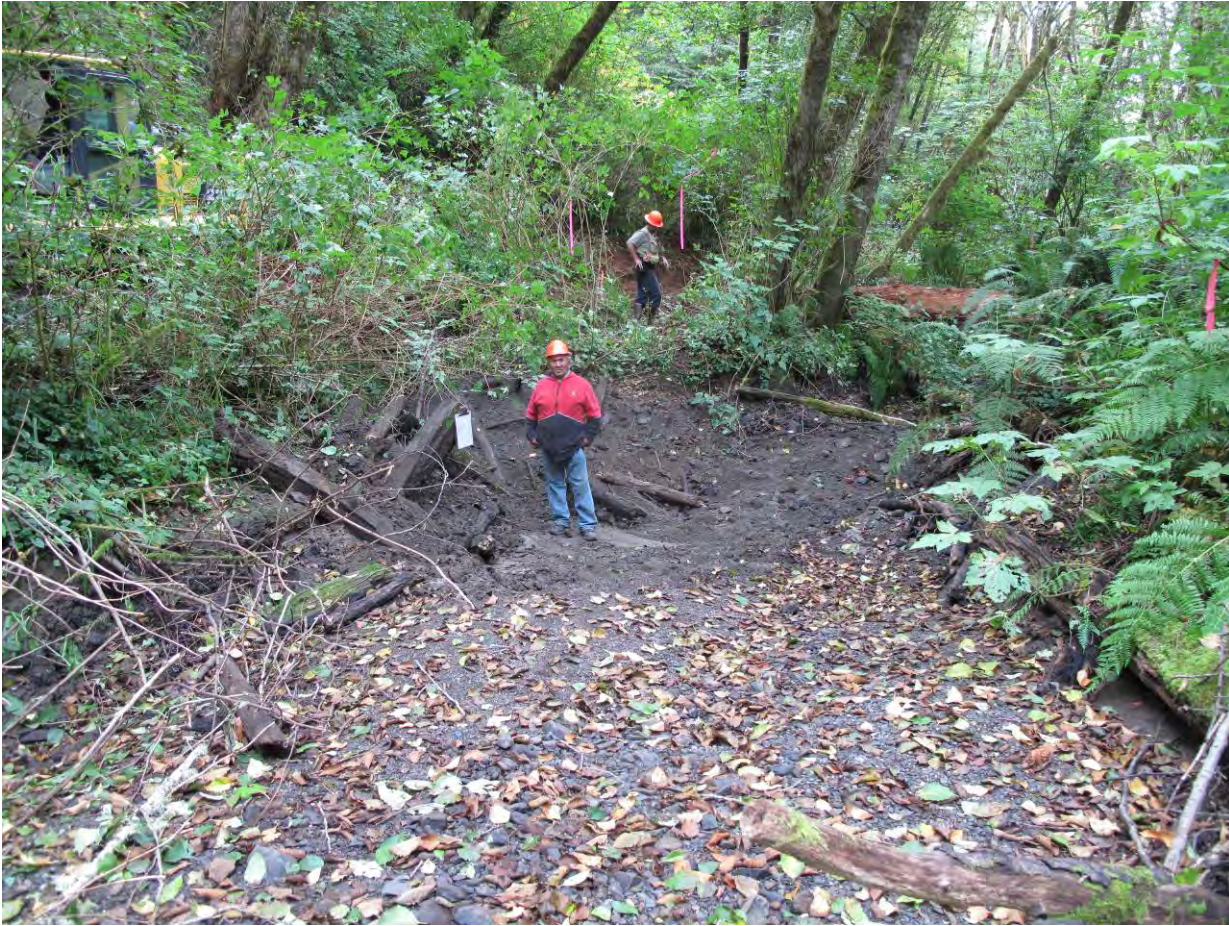
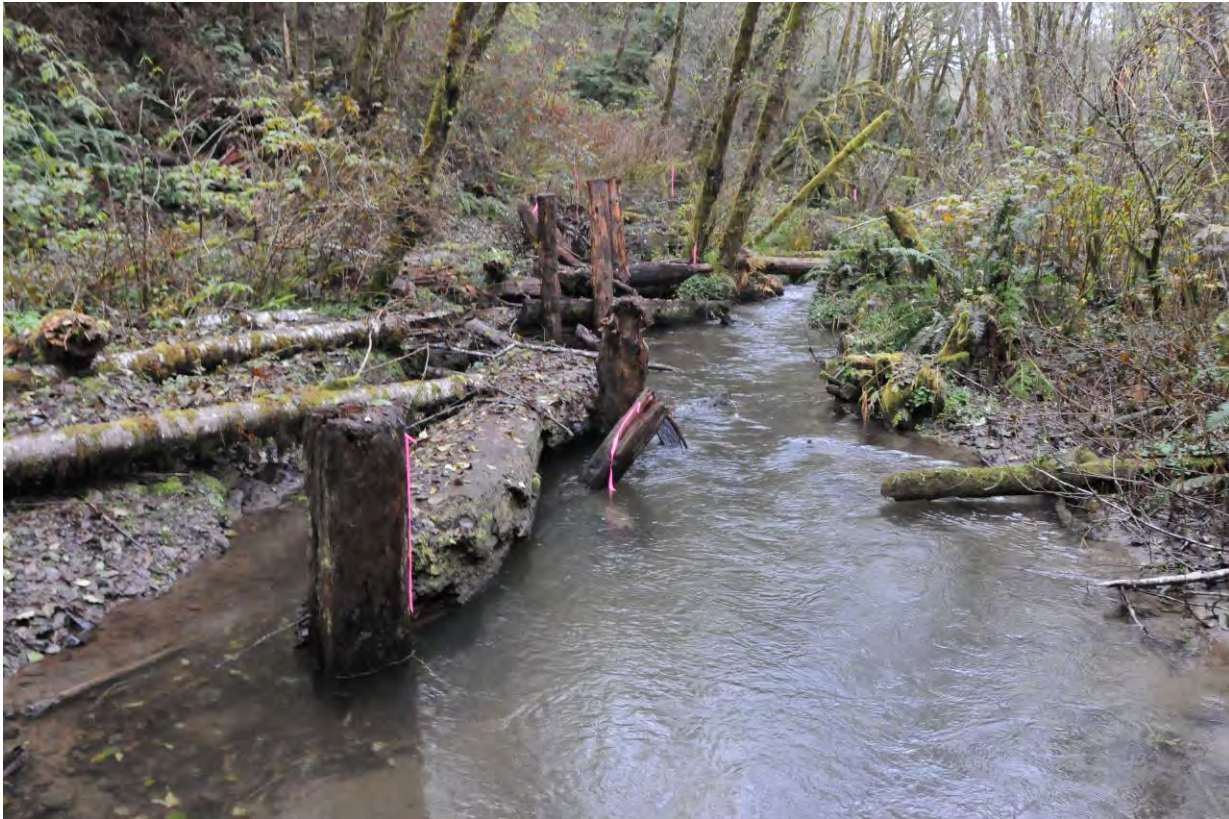
Figure 17. Paired before and after upstream views of Site 9. Image dates: top 9-29-2009, bottom 12-05-2010. Top image shows site prep of stream bed to fit multiple pieces of large wood. Man in red jacket is standing on buried wood exposed during construction.

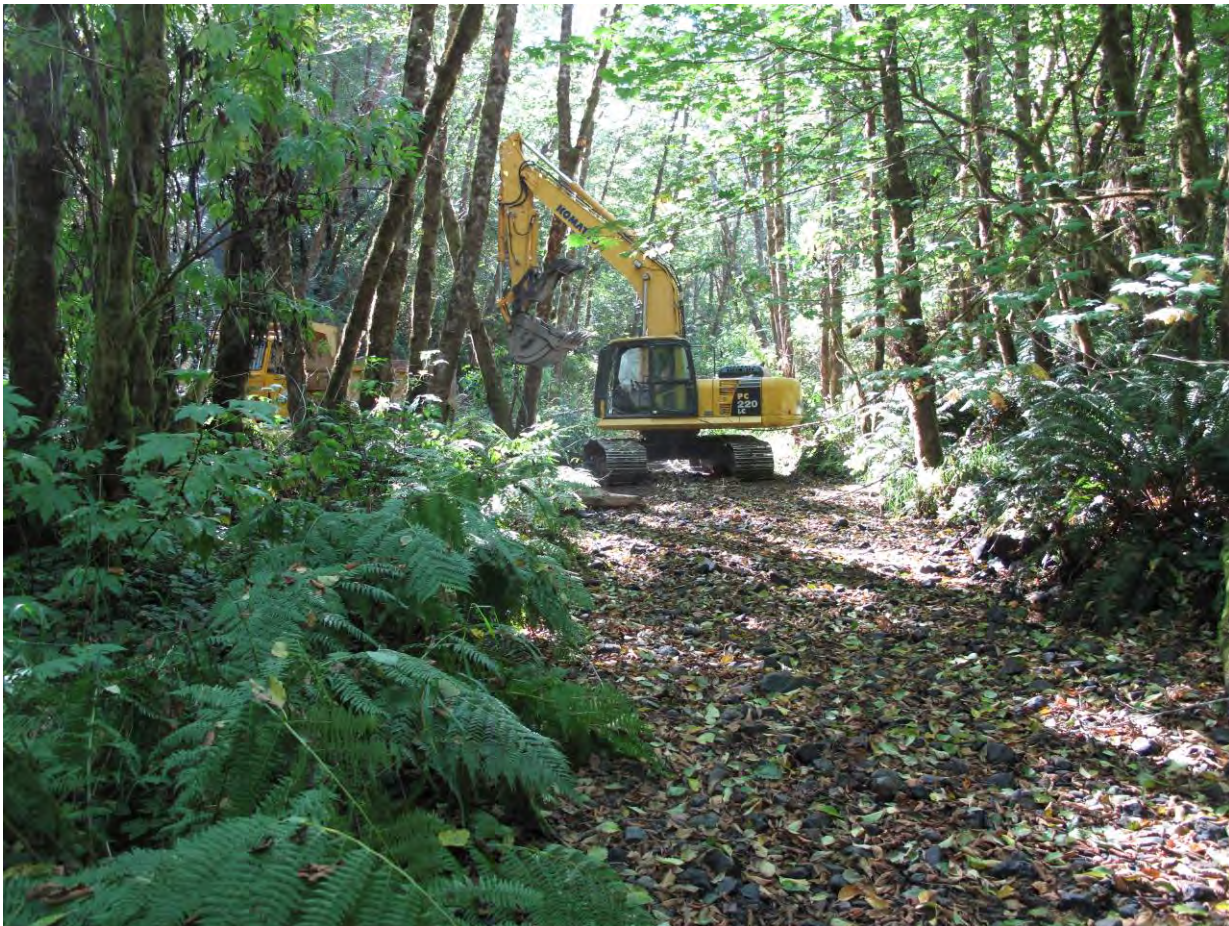
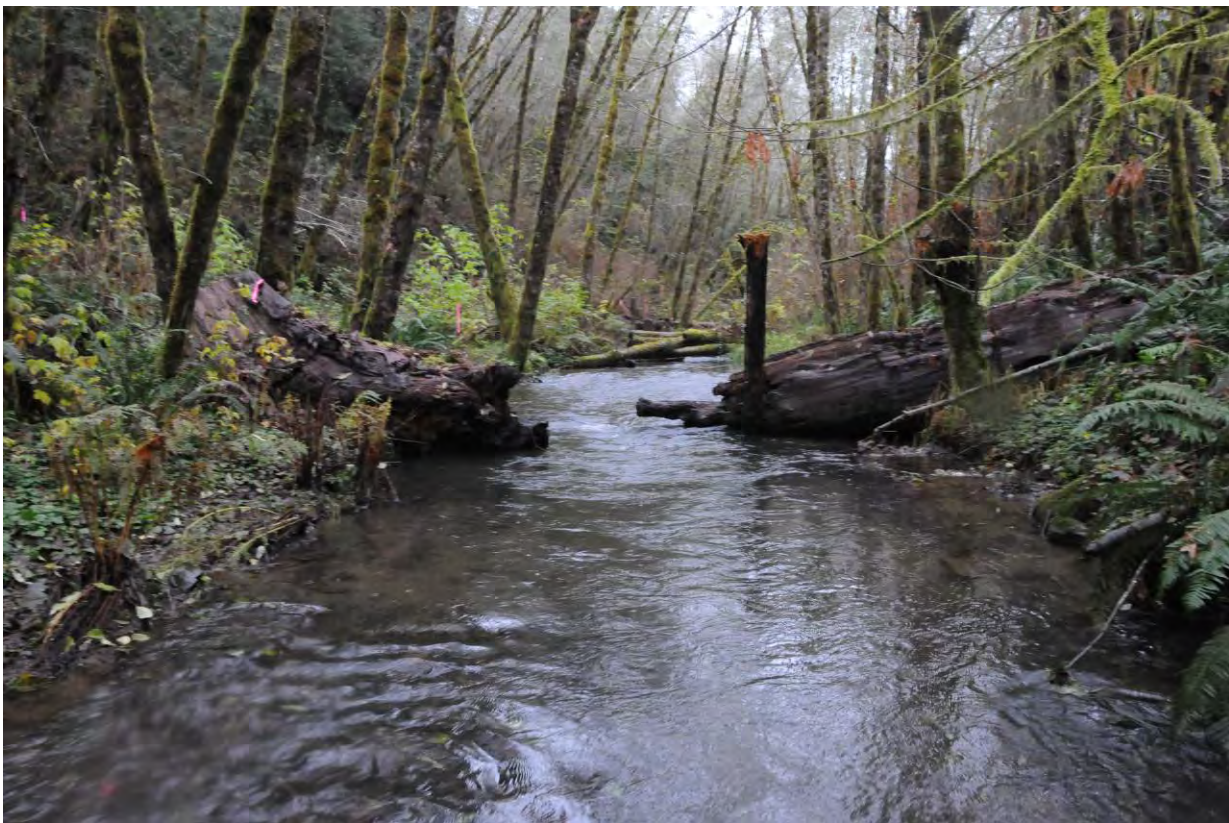
Figure 18. Paired before and after upstream views of Site 10. Image dates: top 9-29-2009, bottom 12-05-2010.
