## Stream and Riparian Habitat Enhancement of Waukell Creek: Phase I

September 2010

## **Appendix A. Waukell Creek 2009 Wood Loading Project Photo-Monitoring**

## Appendix B. Topographic data collected in Waukell Creek 2008 – 2010.

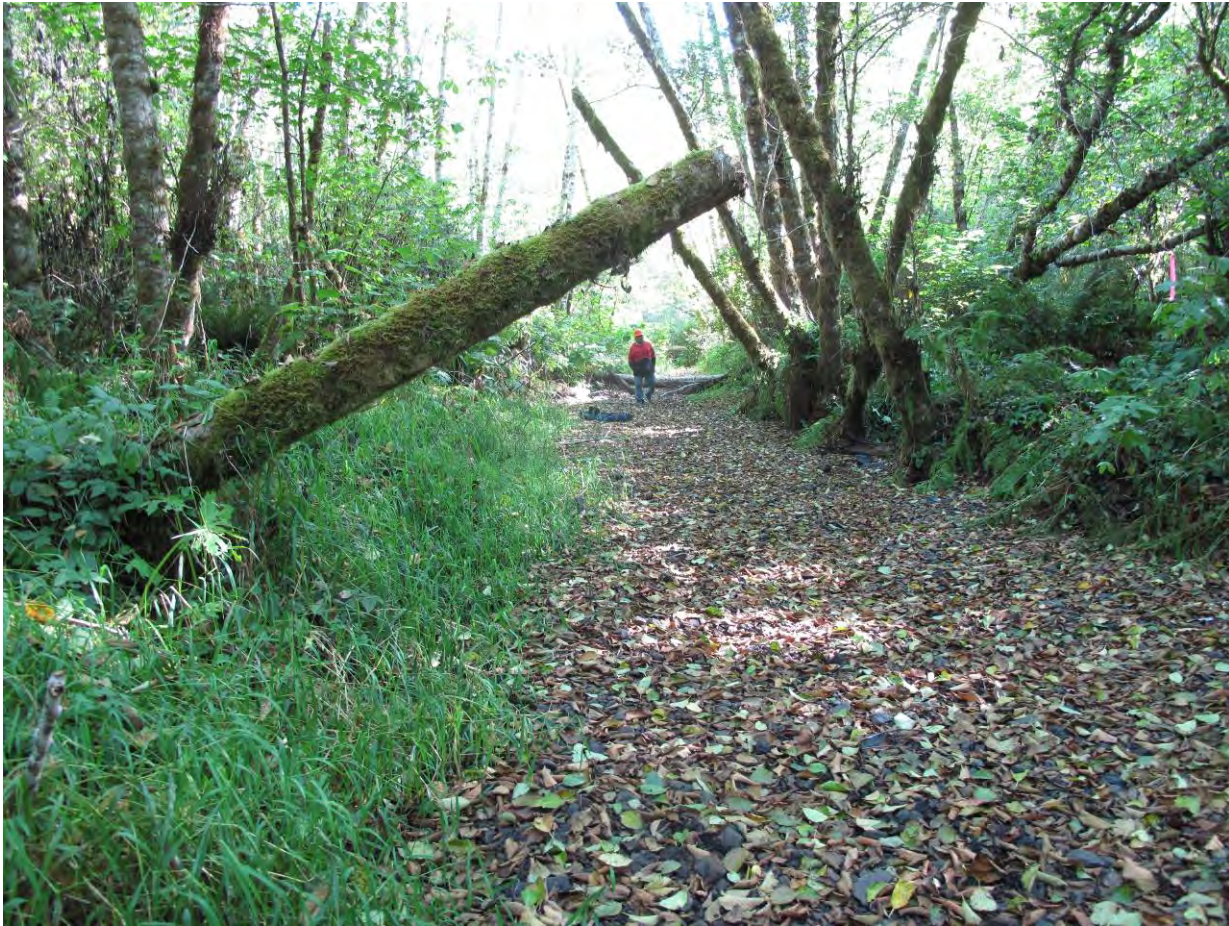
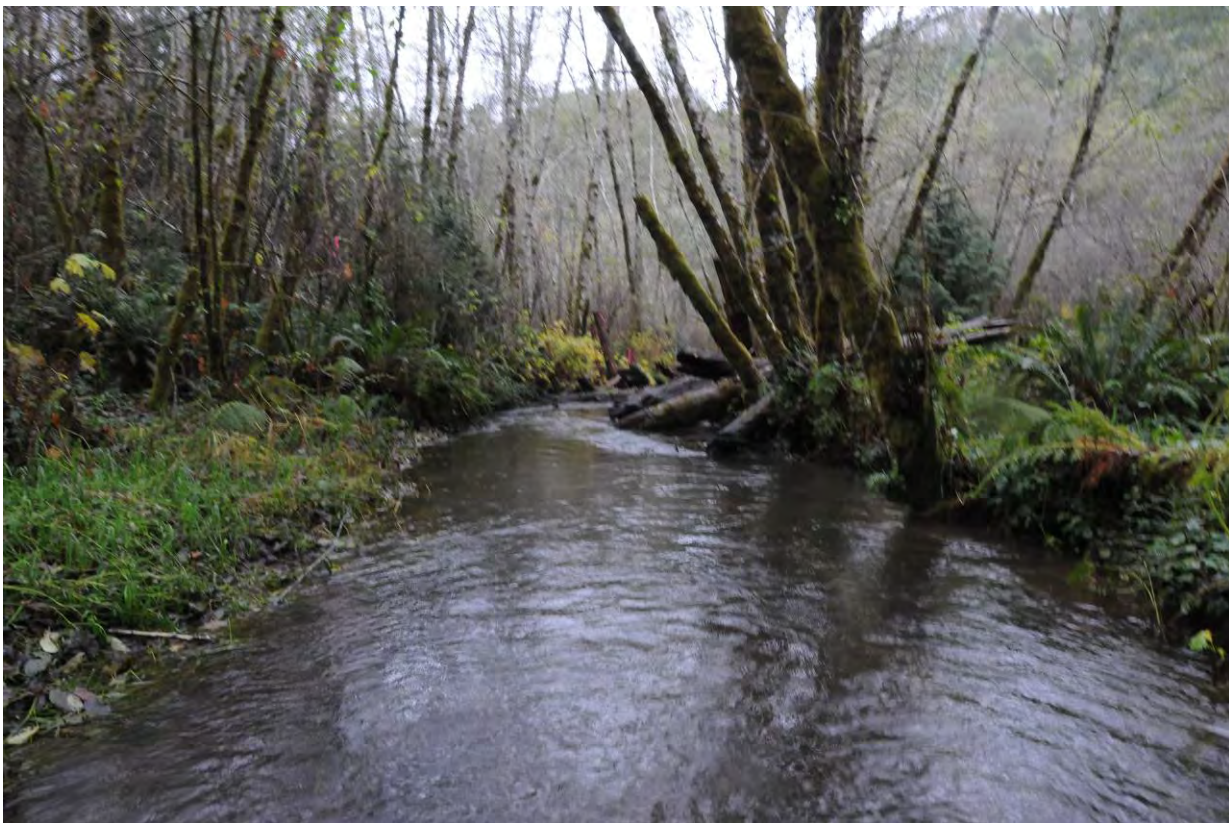
Figure 21. Paired before and after downstream views of Site 11. Image dates: top 9-30-2009, bottom 12-05-2010.

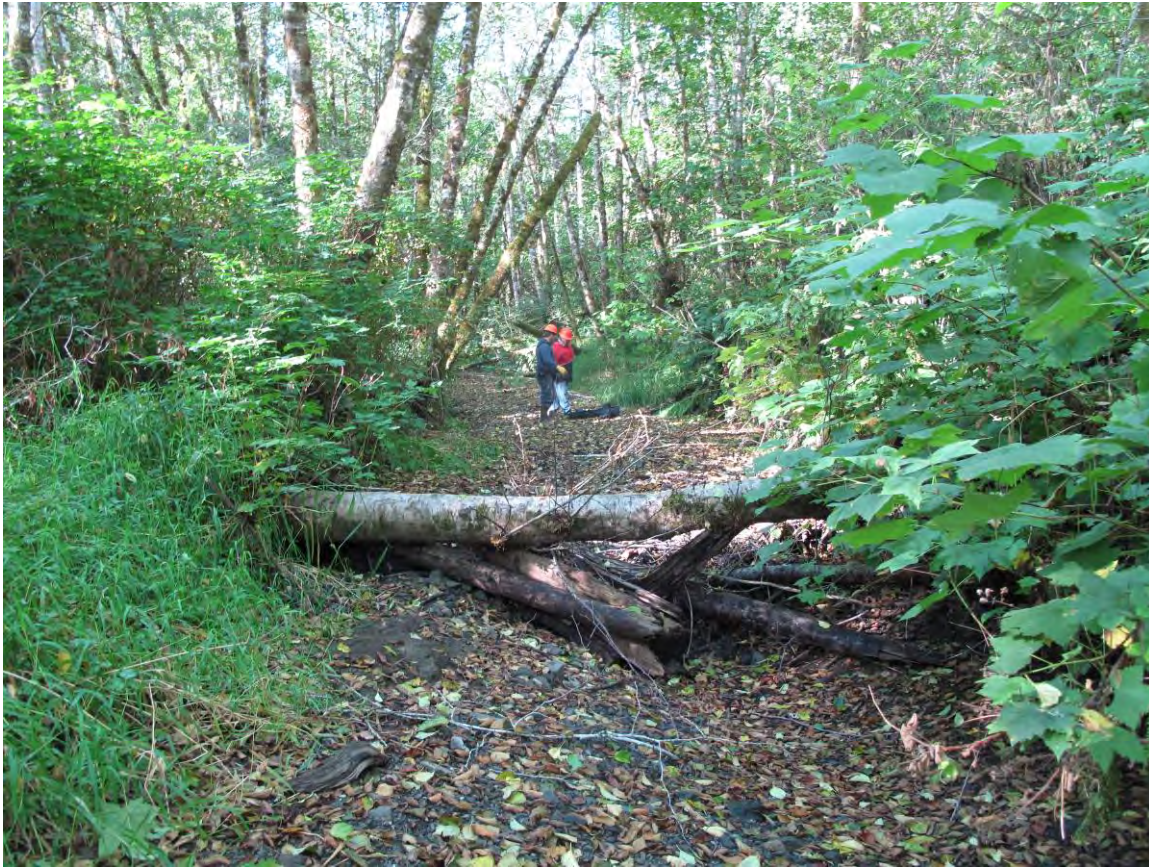
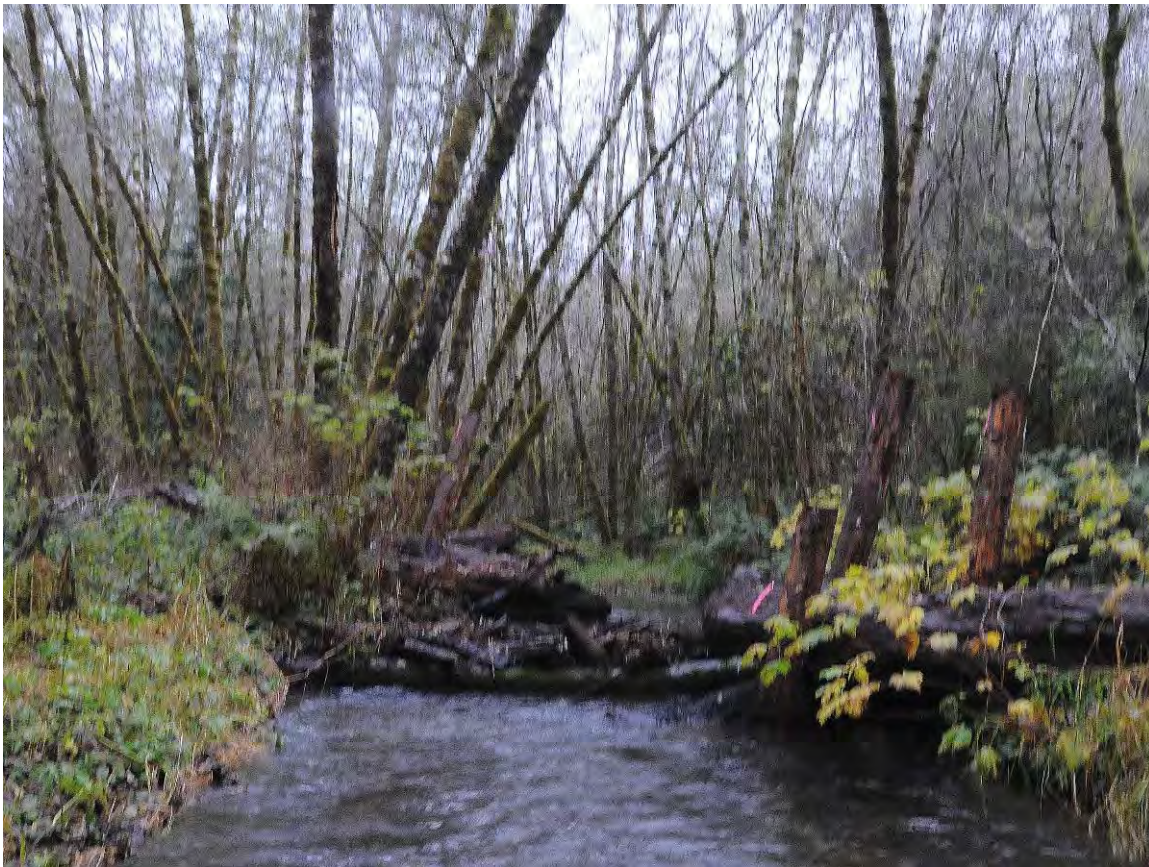
Figure 23. Paired before and after upstream views of Site 12. Image dates: top 9-29-2009, bottom 12-05-2010.

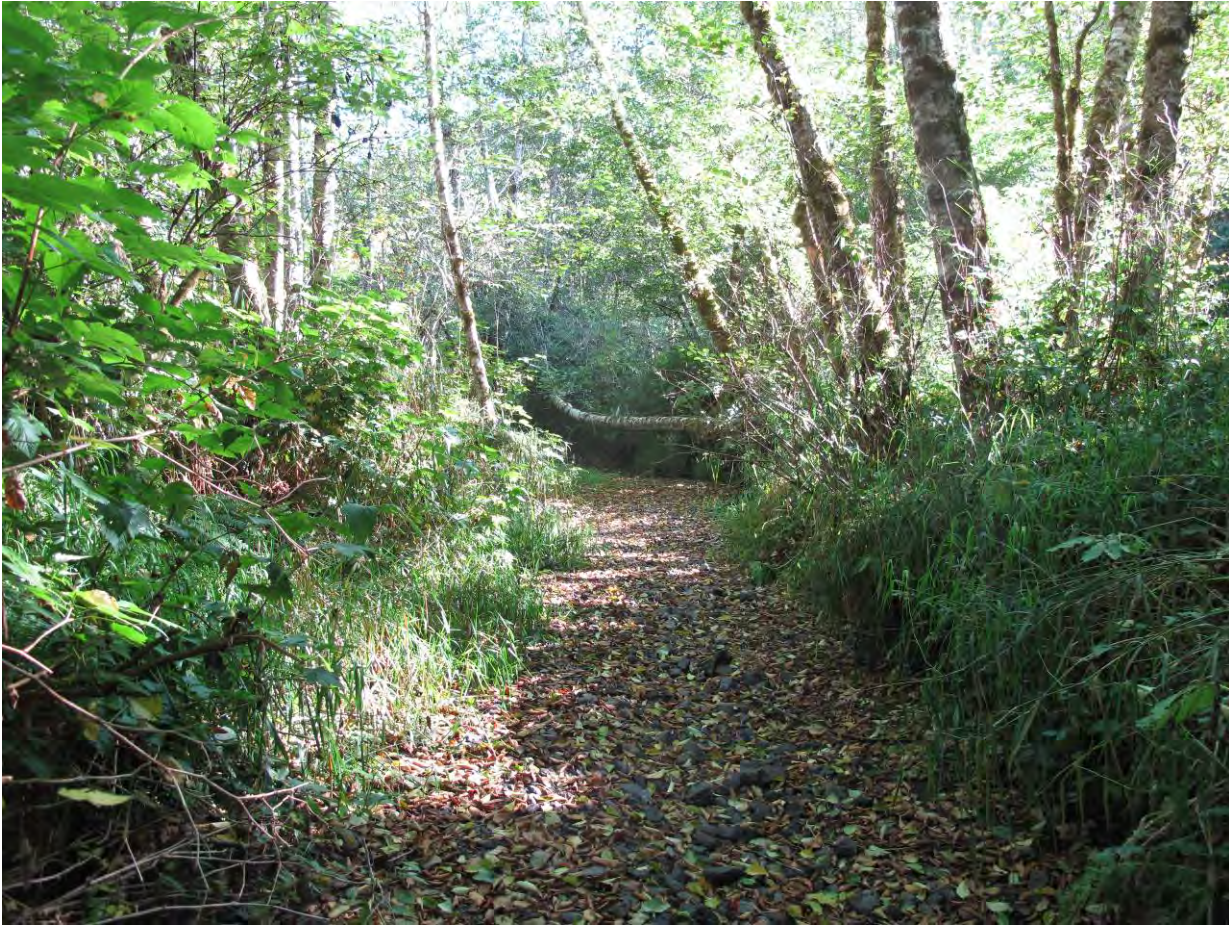
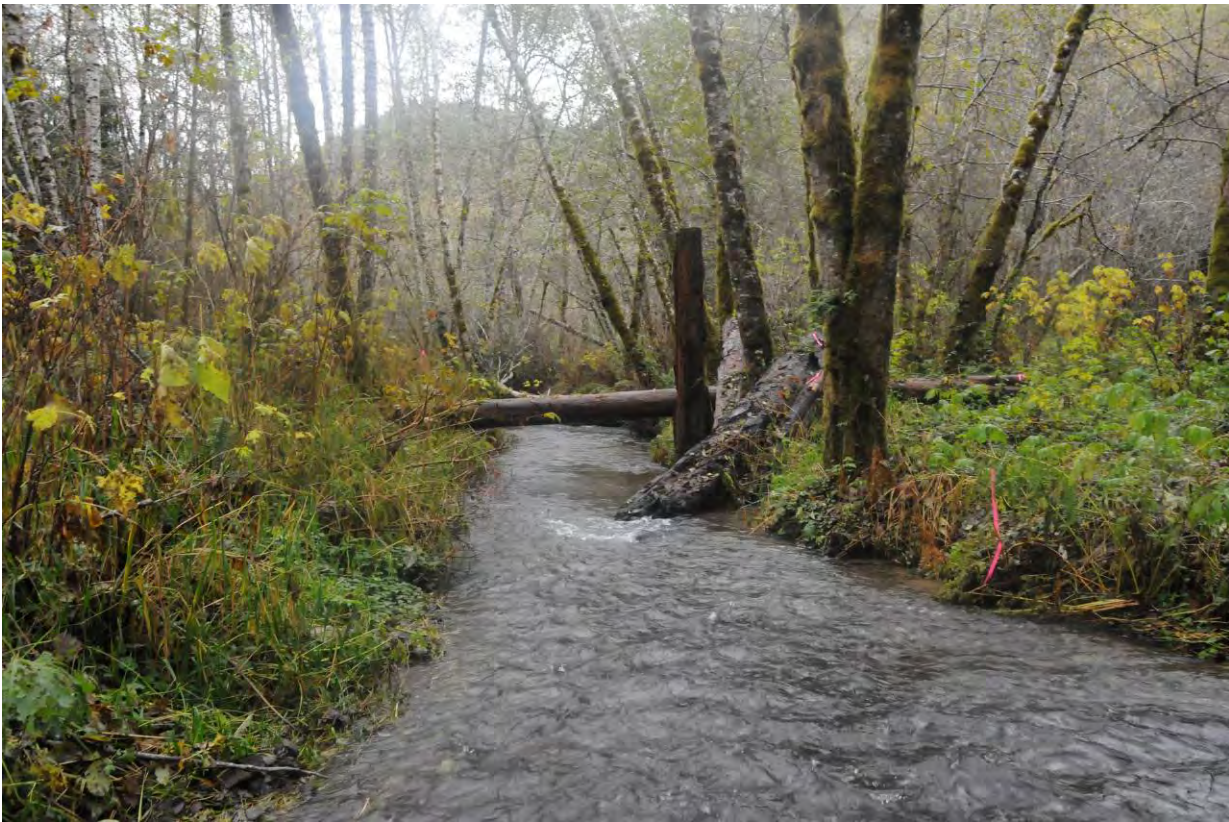
Figure 26. Paired before and after downstream views of Site 13. Image dates: top 9-30-2009, bottom 12-05-2010.
