**CAL TRANS (YURO 005)**

**YUROK TRIBE**

**SITE ASSESSMENT REPORT**

**SEPTEMBER 2010**

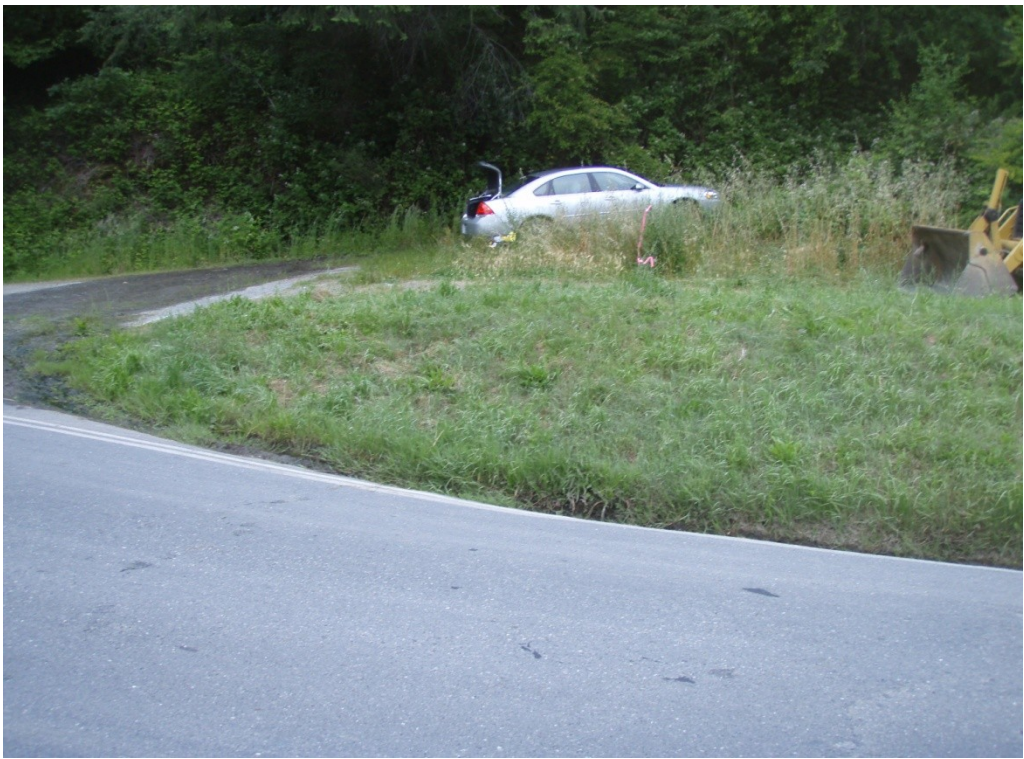
**Photo 01:** Cal Trans site prior to UST removal. Highway 169 is in the foreground.

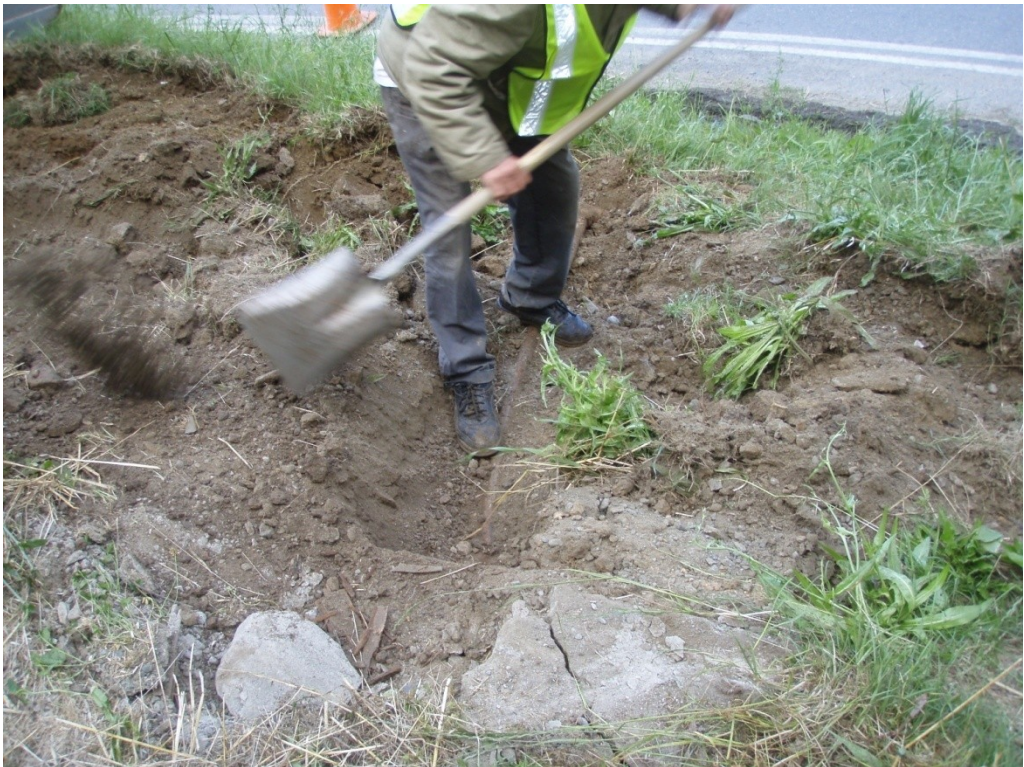
The two pipes were found at a depth of approximately 1.5 feet bgs. Both pipes originated at the dispenser island, were parallel and adjacent to each other, and approximately five feet in length. The vent pipe ended at the UST at a horizontal tee. The dispenser pipe was connected to a vertical pipe, which led into the UST. The top of the UST was approximately 2.5 feet bgs, and the bottom of the UST was approximately 6.5 feet bgs. The length of the UST measured at 46 inches, and the diameter measured at 72 inches. The volume of the UST was calculated to be 500 gallons.

**Photo 02:** Uncovering the piping that connected the UST to the dispenser island (foreground).

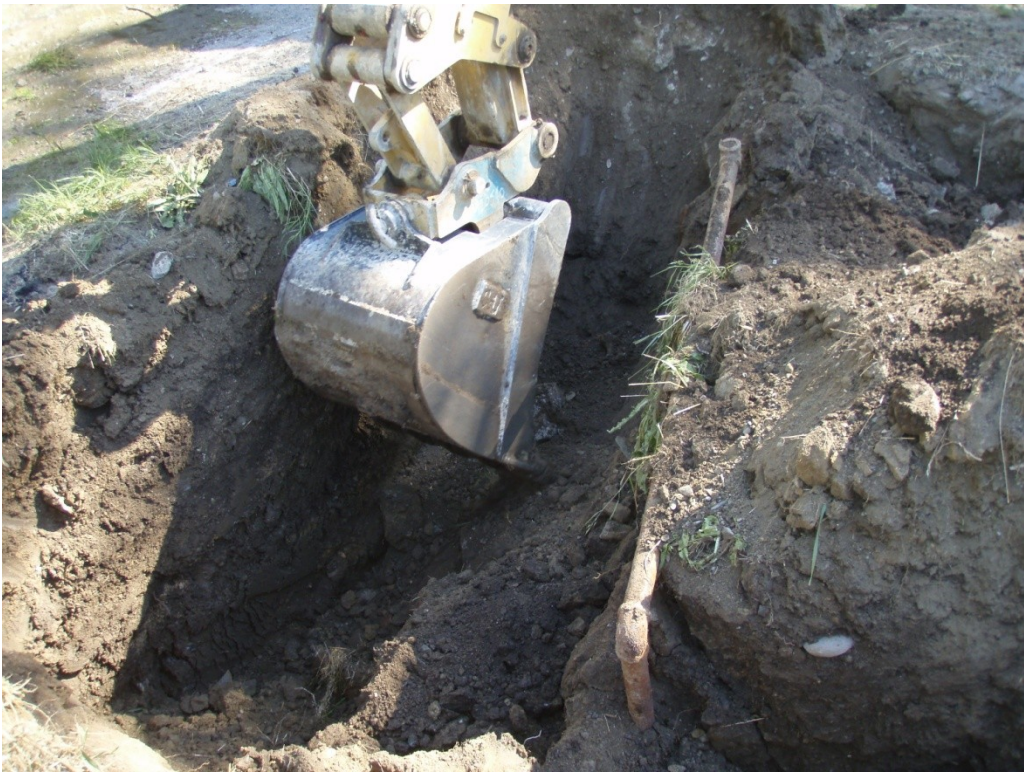
**Photo 03:** Removing soil from the northwest side of the UST. Note the far end of the pipe where the dispenser island was located.  
**Direction:** North

After the interior of the UST had been cleaned, a backhoe was used to remove the soil from both sides as well as the northeast end of the UST so that the UST could be removed from the ground. The soil was temporarily stockpiled on site to be used later for backfill. The soil was screened using a photoionization detector (PID) as it was removed from the excavation and no contamination was detected. Because of the deteriorated condition of the UST, it could not be transported whole on a trailer. Instead, the backhoe bucket was used to crush the UST on site, and the UST was placed in the back of a flatbed truck, along with the piping and other IDW.

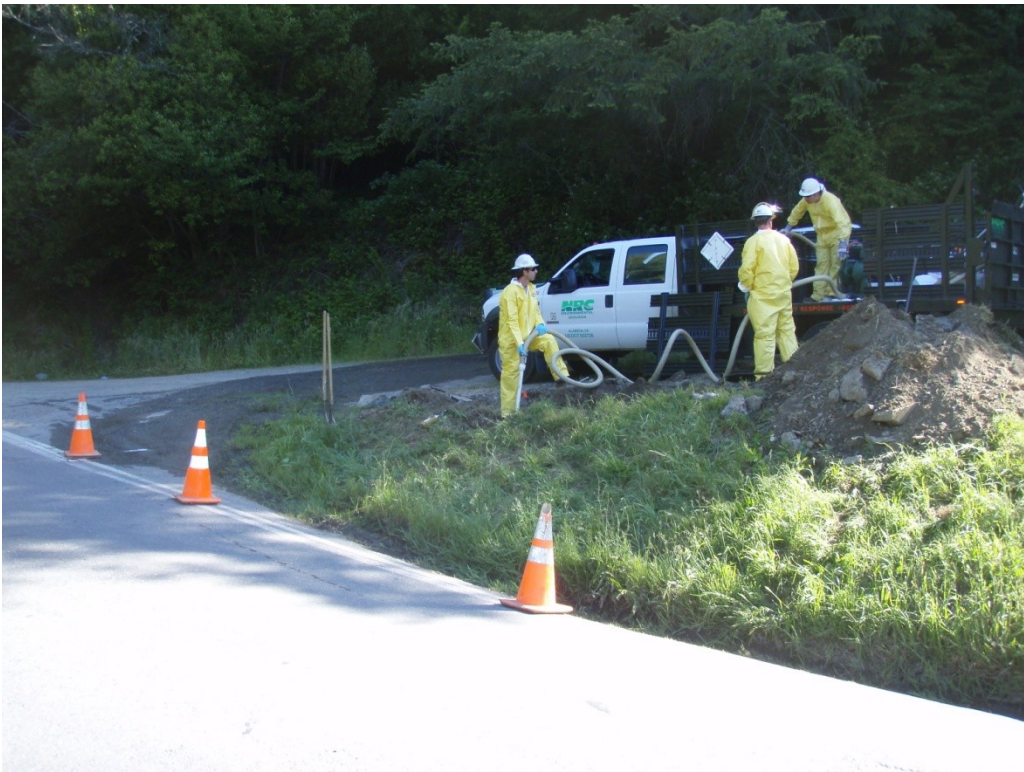
The UST was found to be severely corroded and very thin. A hole, resulting from corrosion or possibly from a backhoe bucket tooth, was present in the top of the UST. A liquid having the slight odor of weathered gasoline or possibly diesel, was detected in the UST.

Approximately 180 gallons of liquid having a brownish color was pumped from the UST and transferred to 55-gallon drums for transport and disposal. There was no indication of the presence of product or sheen on the liquid that was removed from the UST.

**Photo 04:** Removing contents of the UST. Followed by triple rinsing and final pumping.  
**Direction:** North

Following removal of the liquid, the inside of the UST was rinsed with a power washer three times and pumped after each rinsing. The rinse water was transferred to 55-gallon drums for transport and disposal. Following the final pumping, oxygen (O<sub>2</sub>) and lower explosive limit (LEL) were measured at various depths in the UST to ensure that no combustible vapors were present before the UST was removed from the ground. The oxygen concentration was found to be 19.9 percent and the LEL was found to be 2 percent. The readings were within the acceptable ranges specified in the work plan.

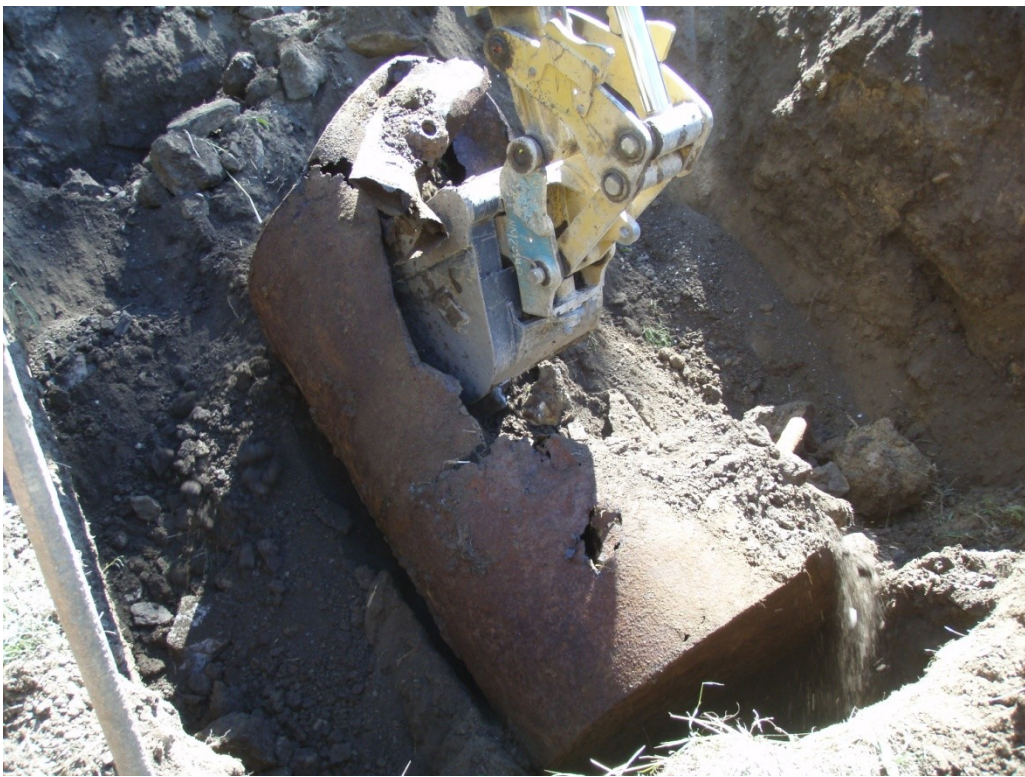
**Photo 05:** Removing the empty, badly deteriorated UST following removal of contents and triple rinsing.  
**Direction:** Northeast

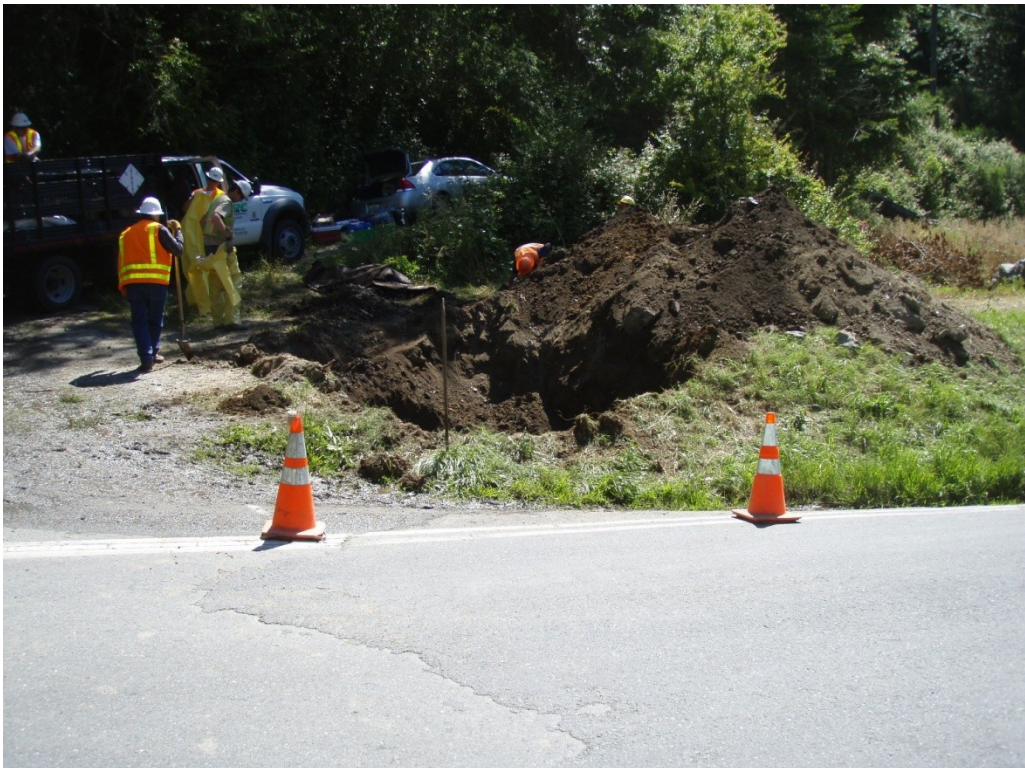
Beneath the northeast end of the UST, which is the end of the UST where both pipes from the dispenser island terminated, a possible stained area was observed in the soil. As a precaution, a minimal amount of soil was removed and disposed of along with the UST contents. The sample (Yurok3) collected in this area was collected from approximately two feet beneath the potentially stained area.

**Photo 06:** UST excavation after UST removal and prior to backfilling.  
**Direction:** Northeast

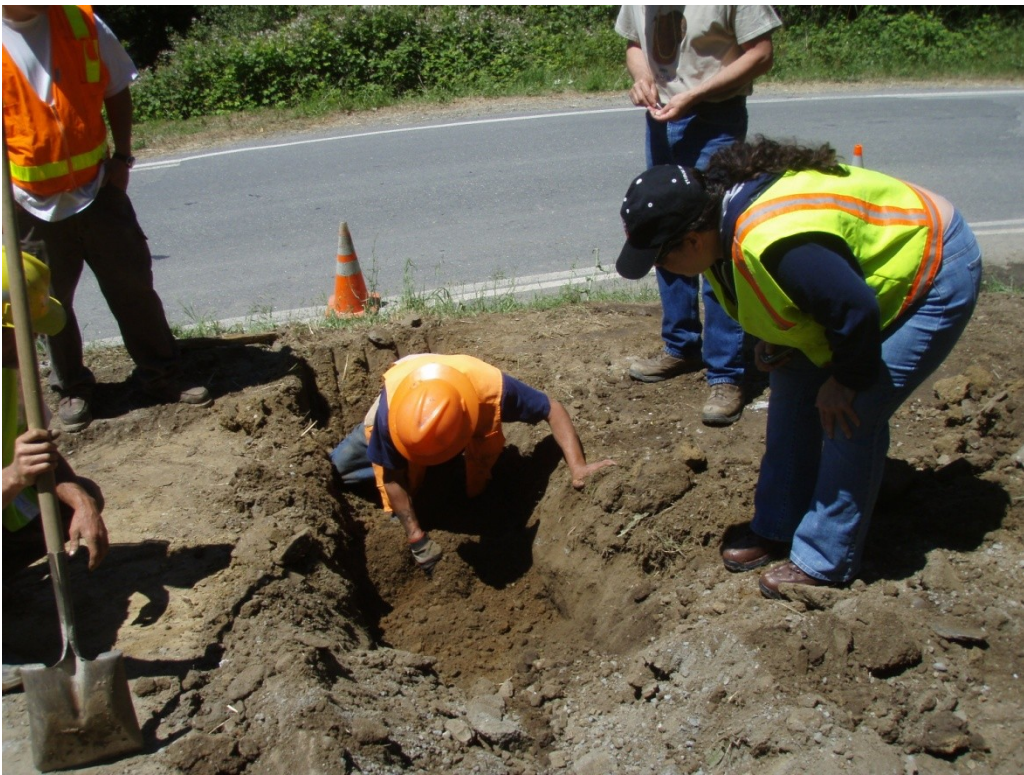
Bristol thoroughly scanned the Anomaly B area for metal using the magnetic locator. There were no indications of metallic objects in the area. A test trench, approximately 18 feet long, two feet deep, and two feet wide, was dug between the Anomaly A and Anomaly B areas to ensure that there were no dispenser pipes running from the dispenser island to the southeast to a potential UST in the Anomaly B area. No pipes, USTs, or other metallic objects were found during trenching activities. The trench was then backfilled with the soil that had been excavated.

**Photo 07:** Checking for artifacts in the test trench.  
**Direction:** Southwest

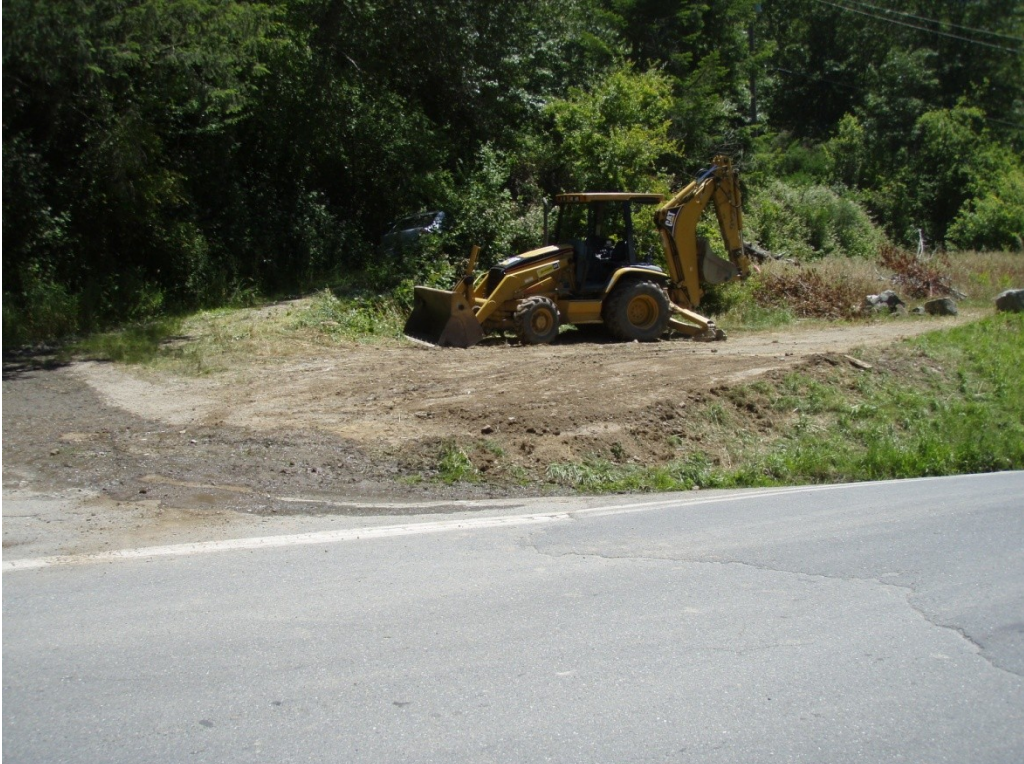
**Photo 08:** Site following assessment activities and final grading.  
**Direction:** Northeast

Based on the data gathered at the site and analytical results from soil samples collected at the site, all COCs in soils remaining on the site were below RSLs. It is recommended that no further action be taken at the site at this time.
