## **High Priority Tasks for Salt Creek**

## **Hunter Creek**

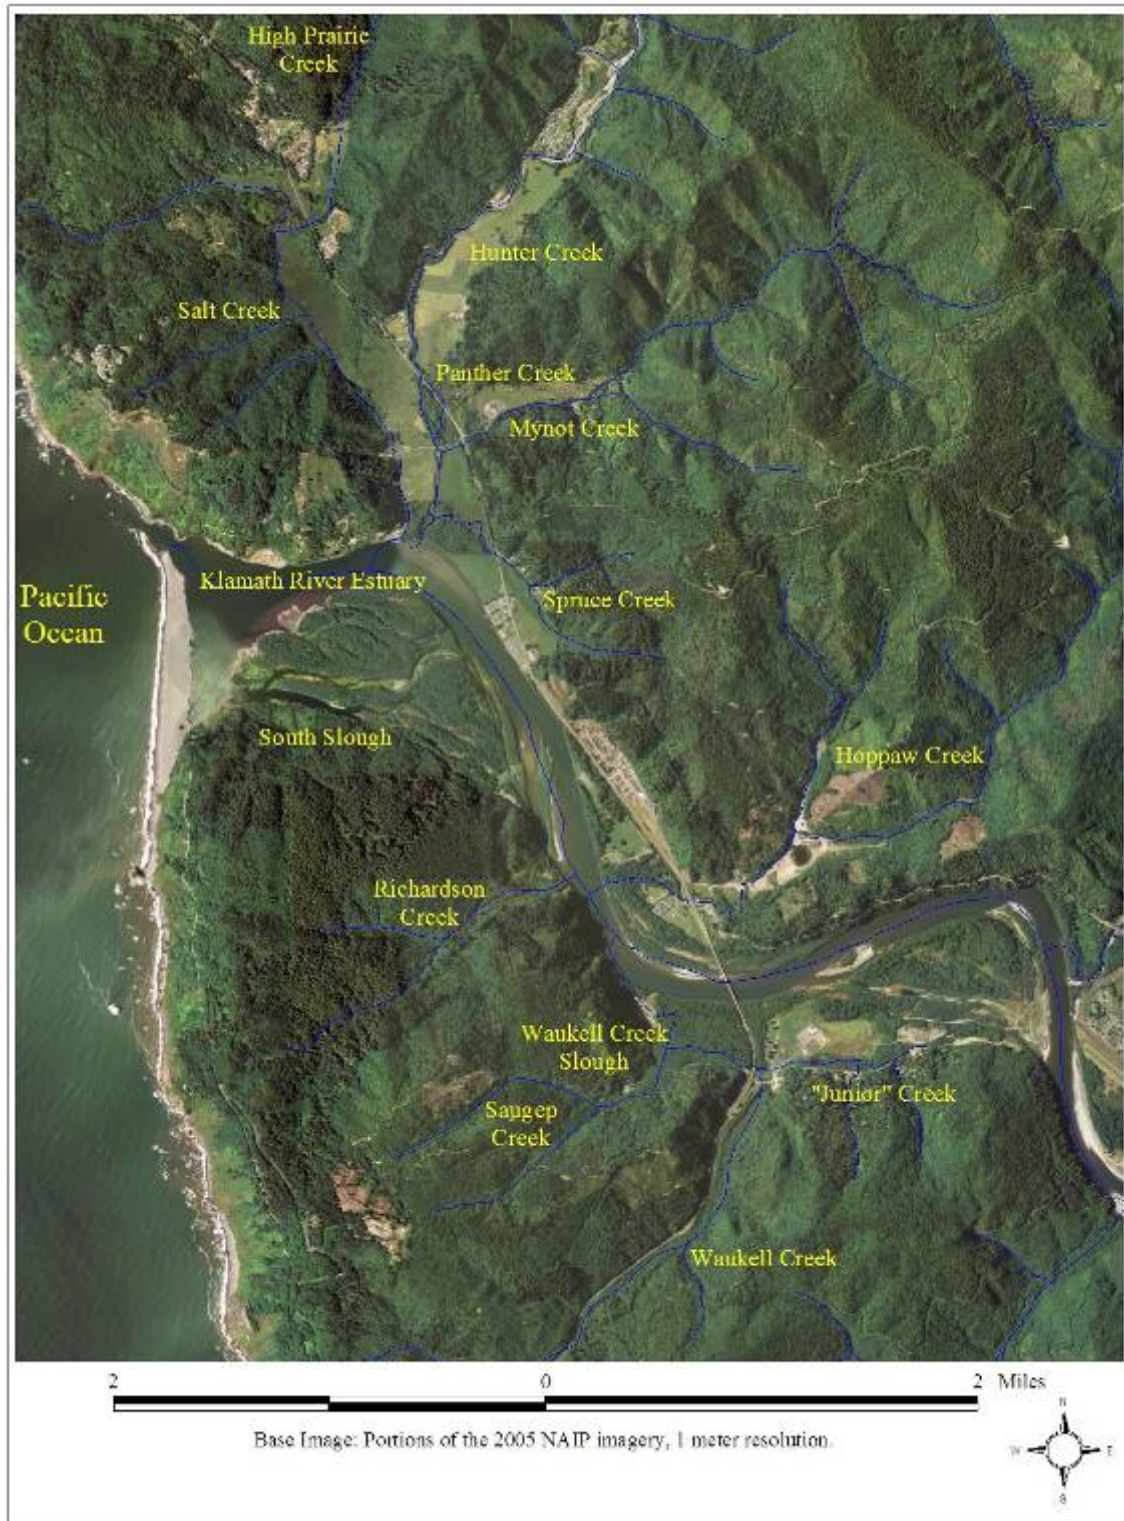
Figure 17. Map of the Klamath River Estuary and associated off-estuary tributaries, Lower Klamath River Sub-basin, California (Base image: portions of the 2005 NAIP imagery, 1 meter resolution).

Mynot Creek, and Panther Creek; Hoppaw Creek; Richardson Creek; and Waukell Creek (Figure 17). Recent fisheries investigations conducted in these tributaries suggest that significant numbers of natal and non-natal salmonids use off-estuary habitats during the year, especially during winter – spring (Figure 18) (Beesley and Fiori 2004; YTFP In Progress).

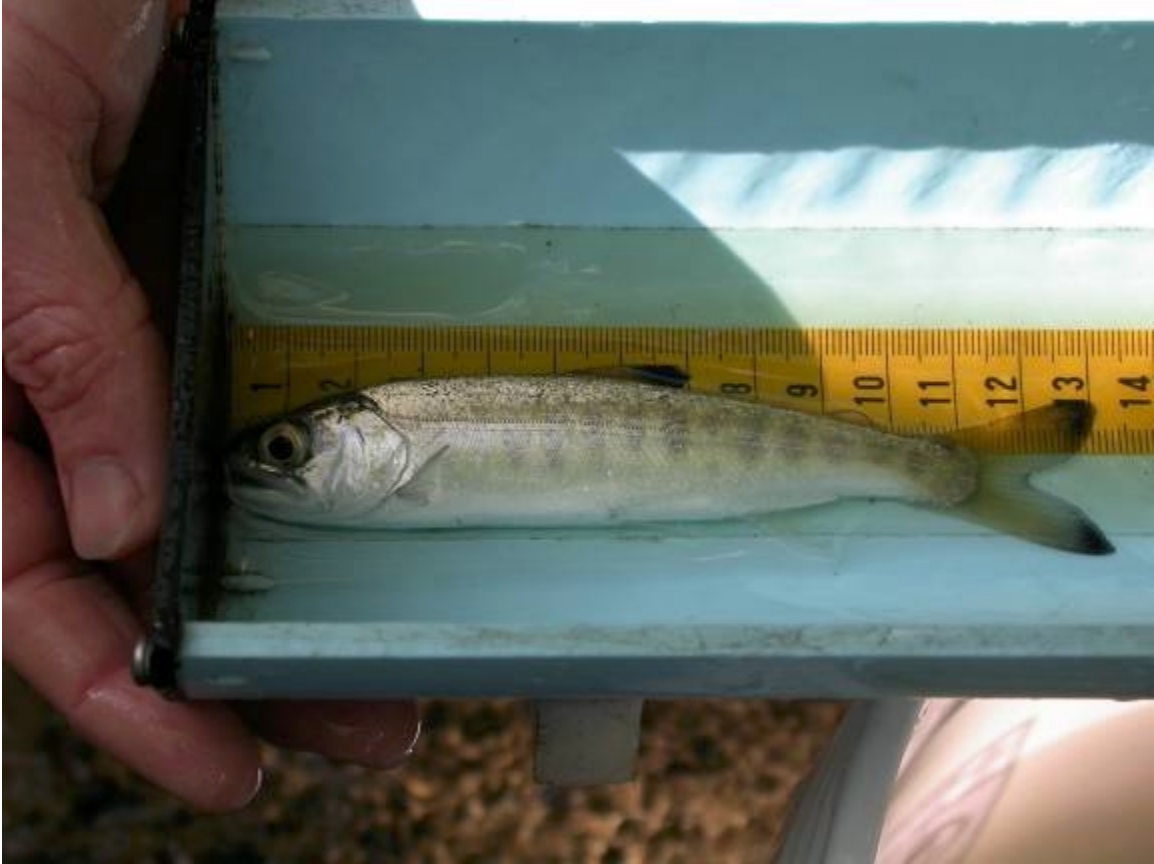
Figure 18. A juvenile coho salmon (120 mm fork length) captured in a migrant trap located in lower Salt Creek, Lower Klamath River Sub-basin, California (April 2003).

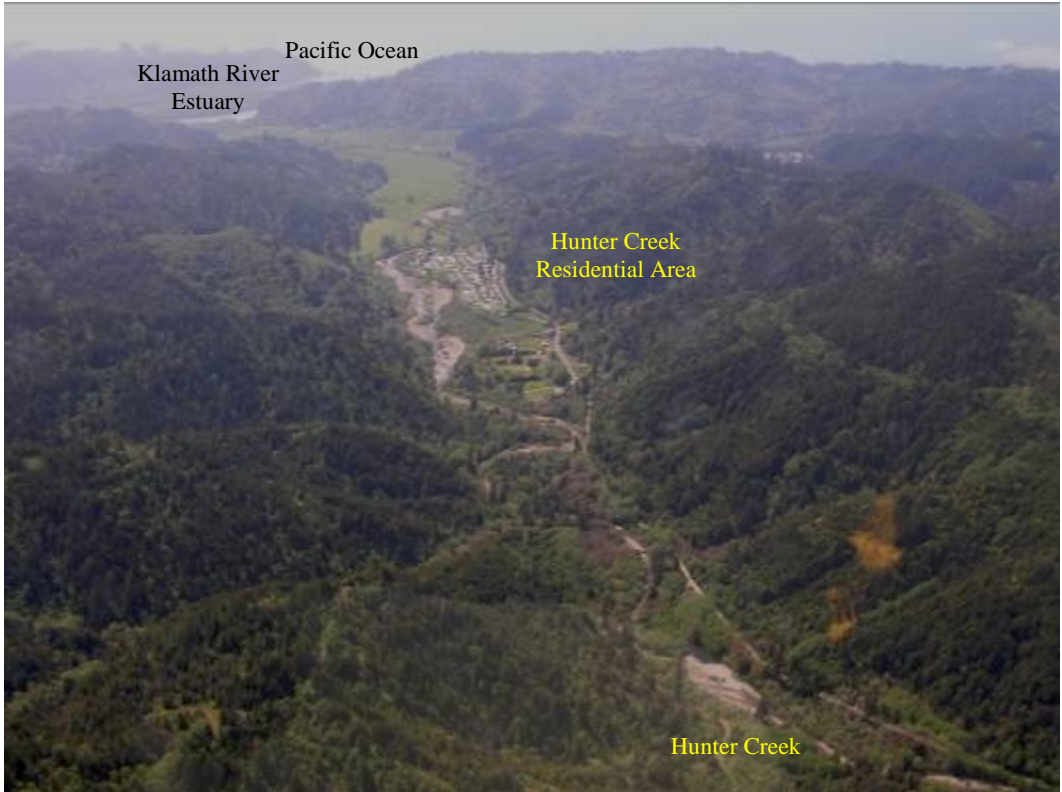
Figure 19. Oblique aerial photograph of lower Hunter Creek obtained from a small airplane, Lower Klamath River Sub-basin, California (April 2005).

Channel aggradation in lower Hunter Creek has also resulted in damage to private property in a residential housing community located in the watershed (Figures 19 – 20). In 2004, channel instability occurring in the vicinity of the residential community prompted a concerned landowner to obtain an emergency gravel extraction permit to excavate a new channel away from the housing development (Figures 20 – 21). The excavation was conducted by a local dairy business in October 2004 and with minimal guidance and no regulatory oversight. Although there were several storms and high flow events during winter 2004 – 2005; the residential community sustained minimal damage (Figure 22). However, poor channel design resulted in substantial bank erosion and loss of riparian vegetation (primarily willow, alder, and shrubs) throughout the treatment reach.

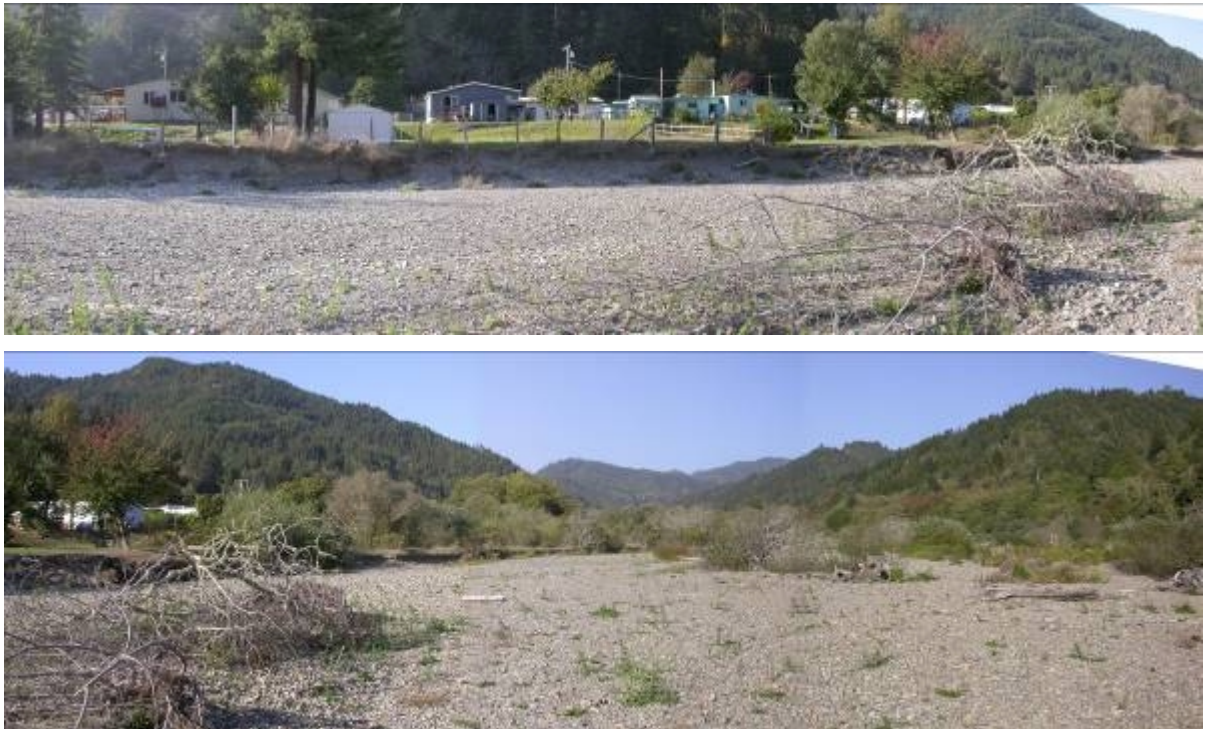
Figure 20. Photographs of the fluvial corridor of Hunter Creek and the housing development, Lower Klamath River Sub-basin, California (October 2004).

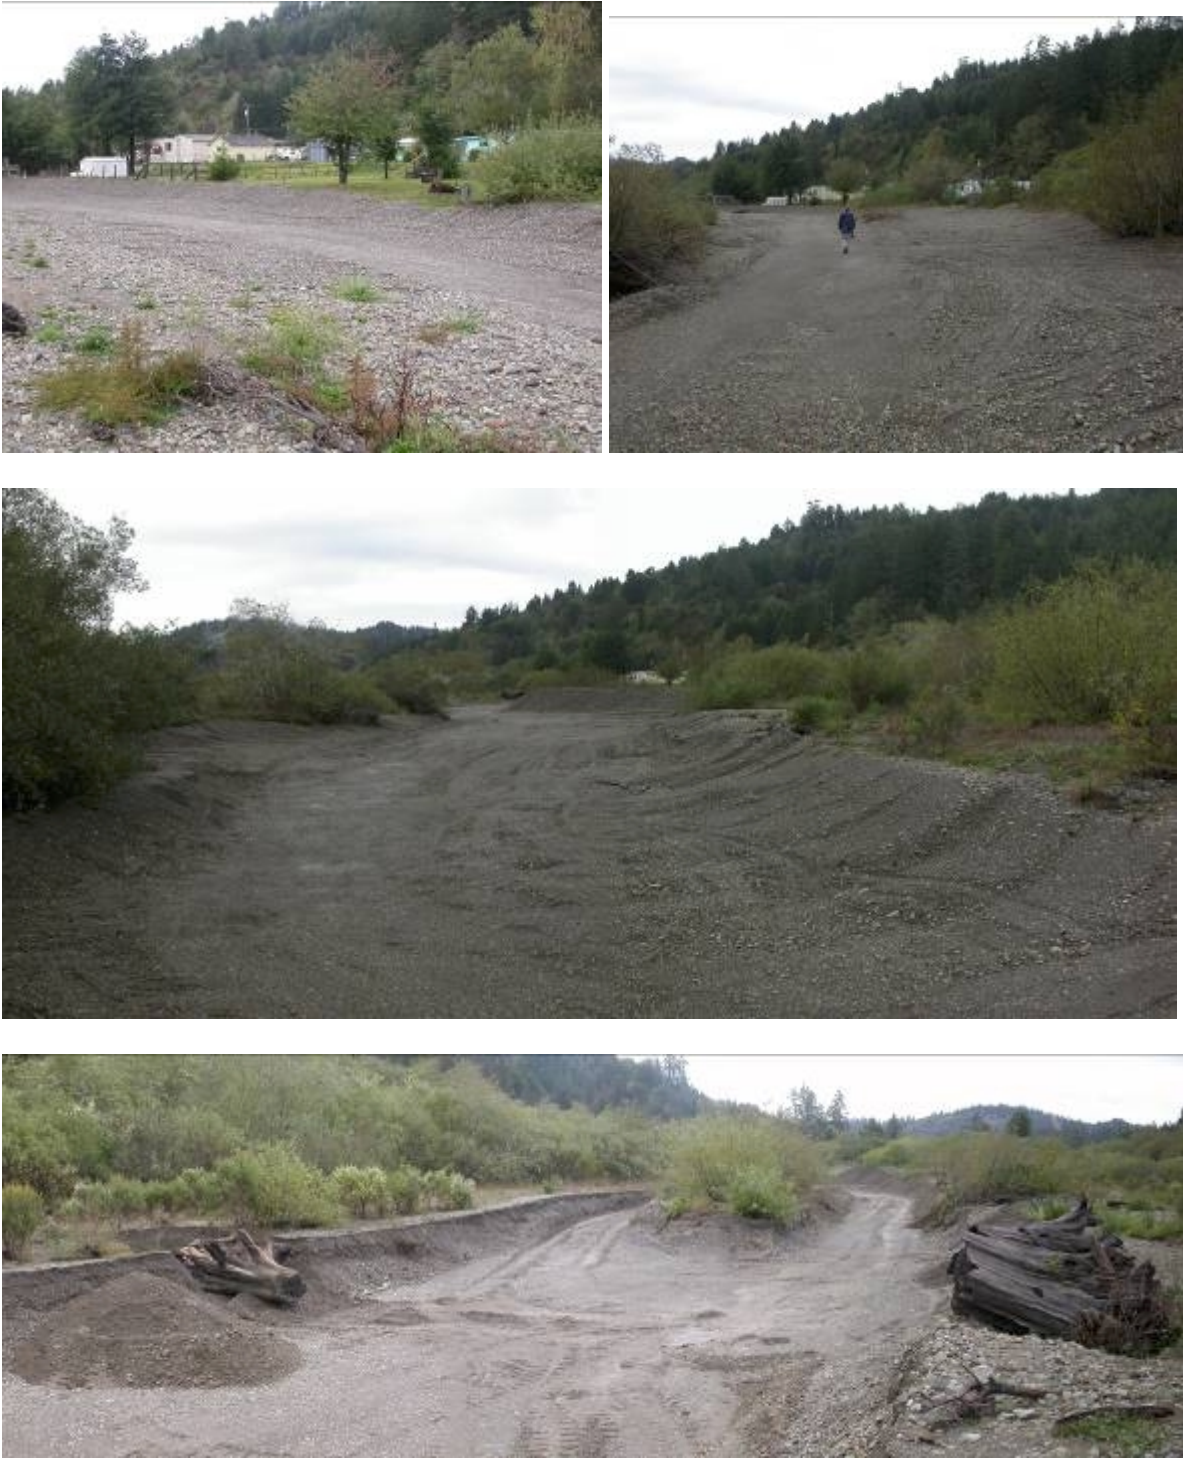
Figure 21. Photographs of the fluvial corridor of Hunter Creek during channel excavation operations, Lower Klamath River Sub-basin, California (Late October 2004) (Note the white house located in the top three photographs).

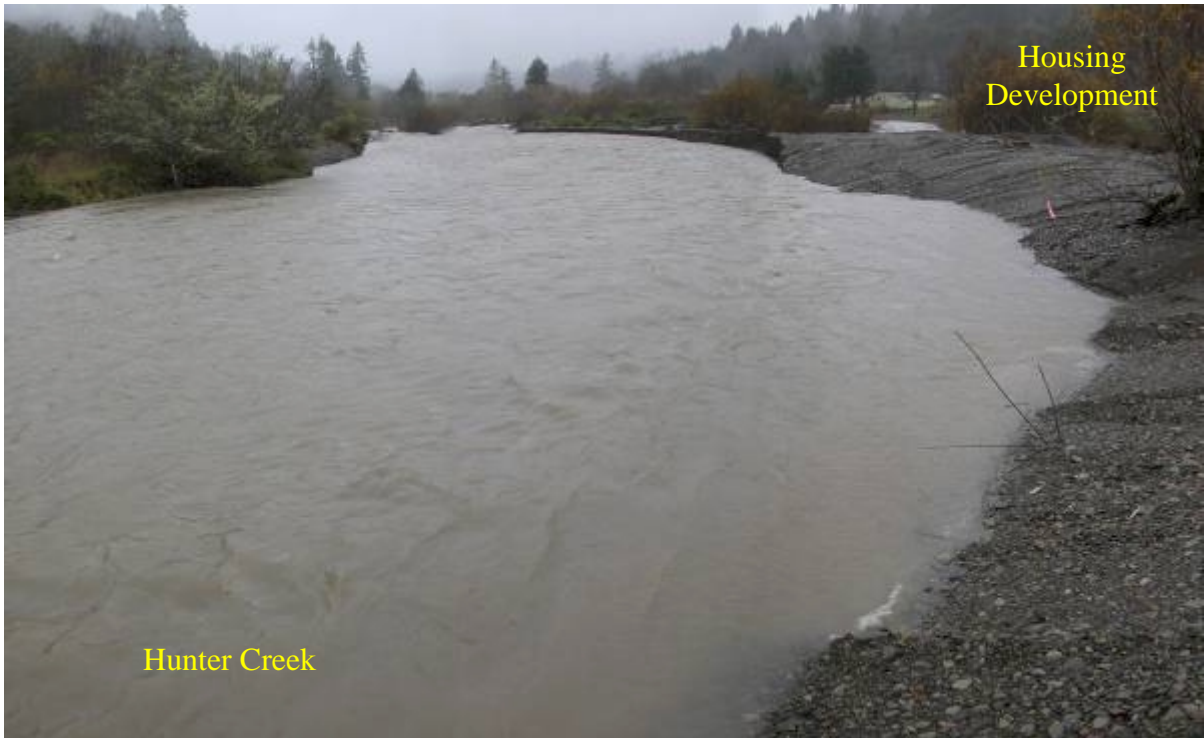
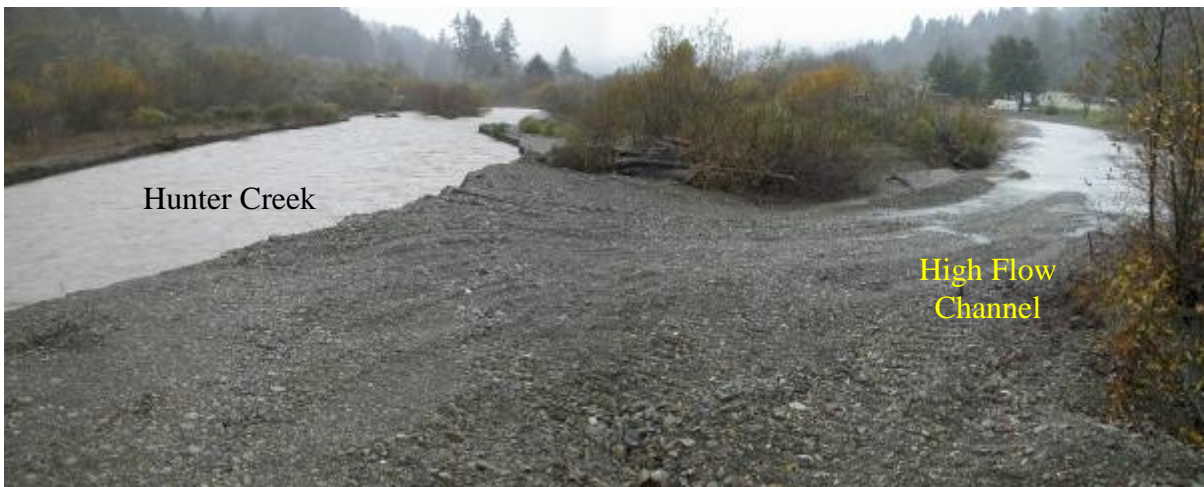
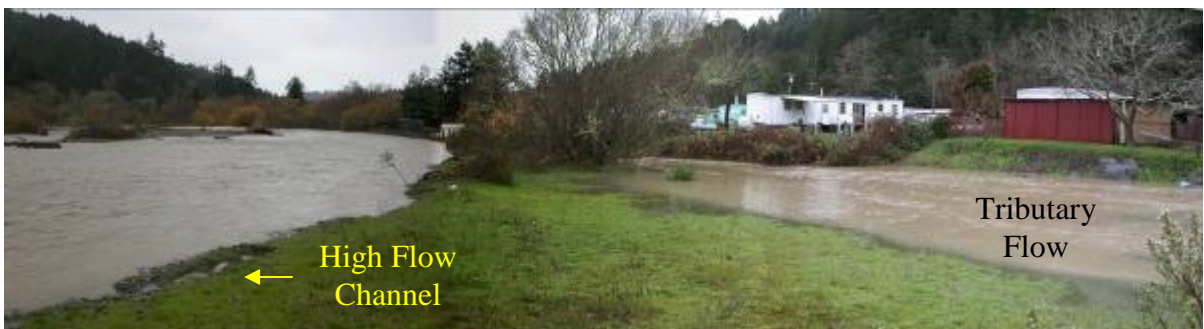
Figure 22. Hunter Creek in the vicinity of the housing development during a high flow event in December 2004, Lower Klamath River Sub-basin, California.

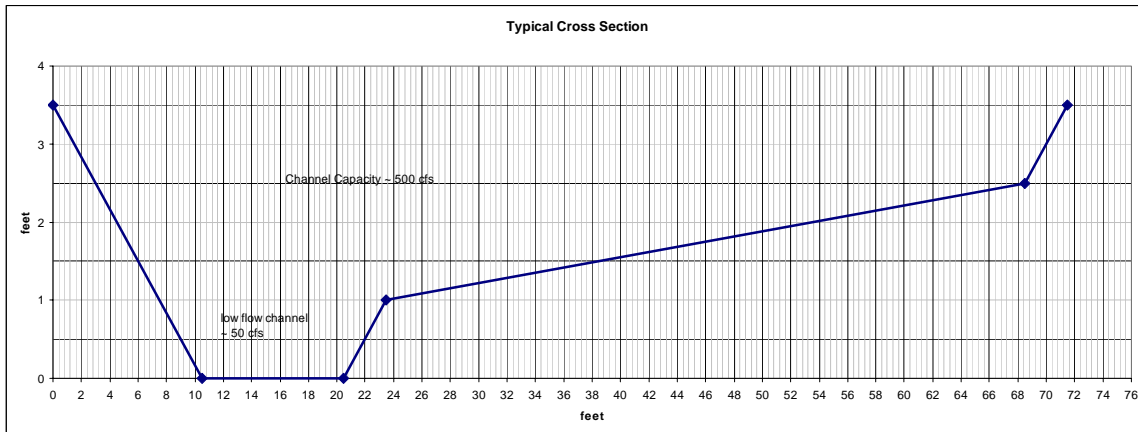
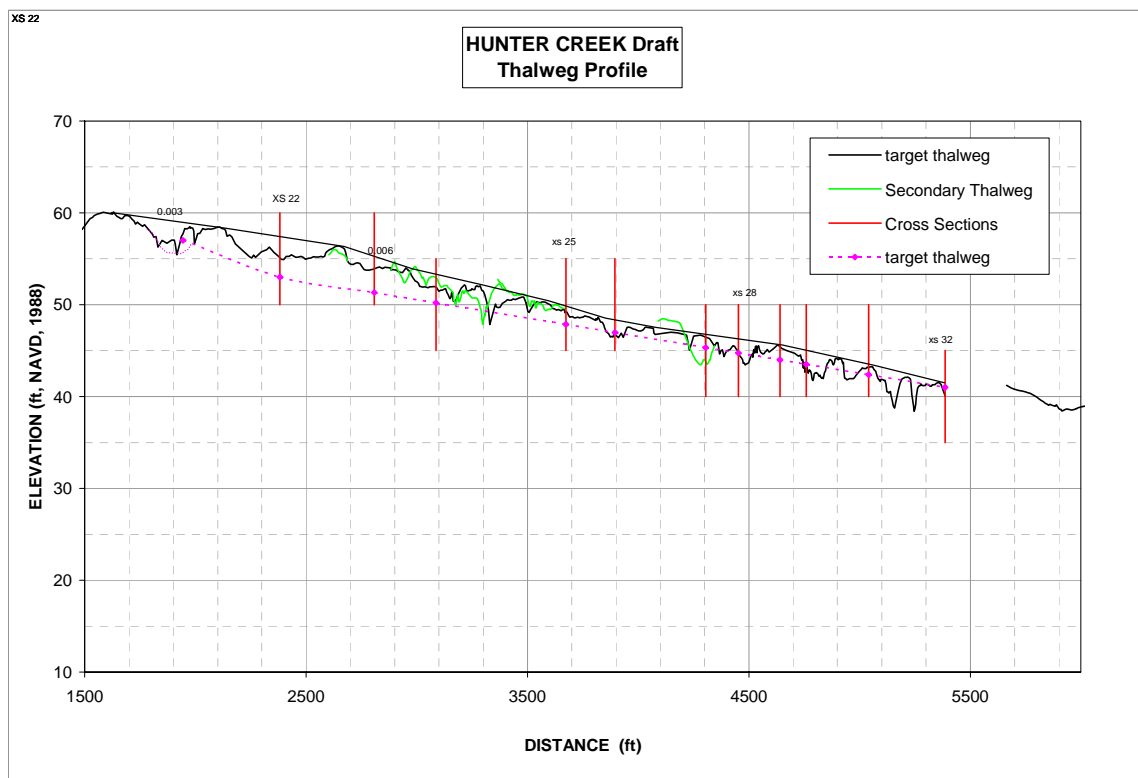
Figure 23. Example of a typical cross section design (top image) and thalweg profile (bottom image) provided by the National Oceanic and Atmospheric Administration for Hunter Creek, Lower Klamath River Sub-basin, California.

In fall 2005, the operators from the previous year took over the emergency permit and worked with NOAA to design and excavate a new channel through the reach (Figure 23). However, the operation was once again carried out with minimal technical guidance and no regulatory oversight. The result was construction of an oversized channel with nearly vertical banks (Figure 24). The residential community did not suffer flood damage that winter but the implemented design resulted in significant bank erosion and further loss of riparian plants. Throughout the two year extraction process, YTFP and FGS worked hard to coordinate with the initial permit holder, the operators, the U.S. Army Corps of Engineers, and NOAA to ensure resource protection for Tribal Trust fish and wildlife. Unfortunately, gravel was extracted in a manner that resulted in a substantial loss of fisheries and wildlife habitat due to a lack of regulatory oversight prior and during the two year project. YTFP and FGS continue to work with the landowners to develop a mitigation strategy for the site and to design a properly functioning channel through the reach to reduce flooding impacts to local residents and improve conditions for Tribal Trust fish and wildlife.

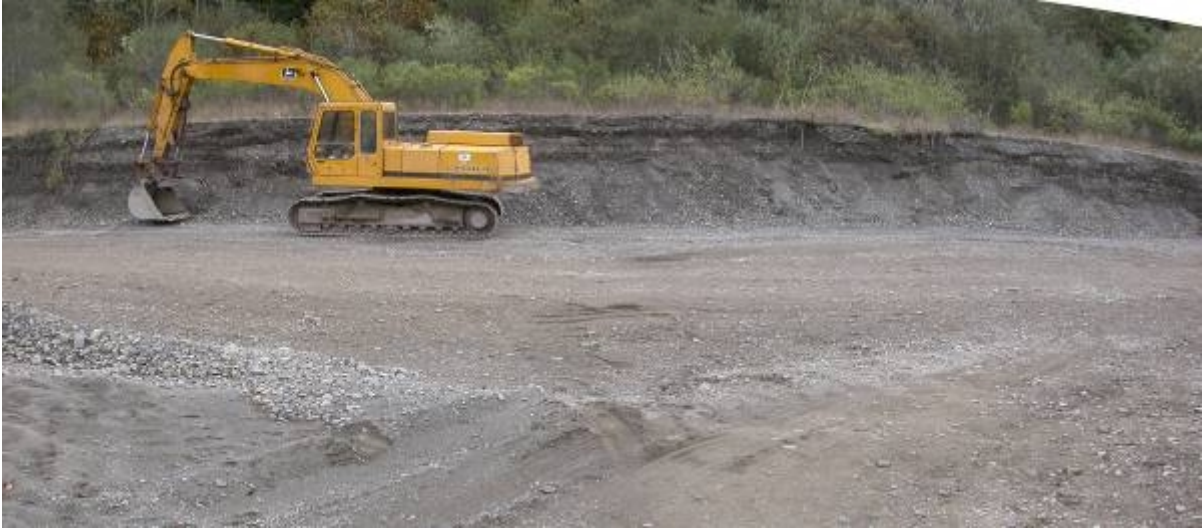
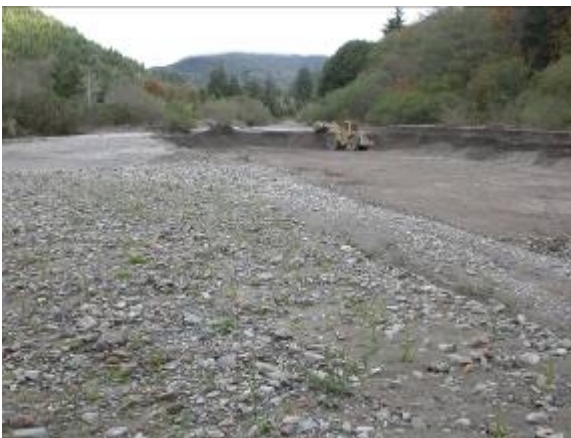
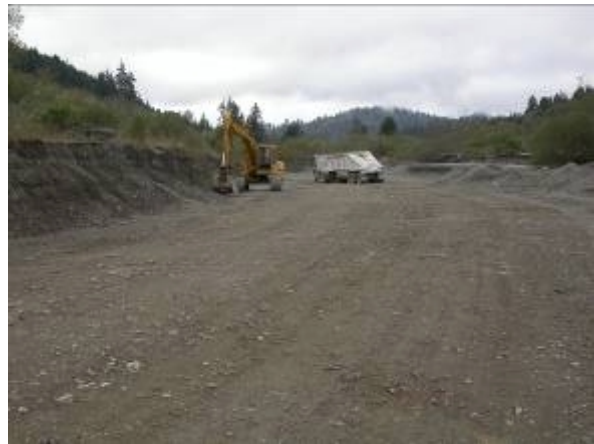
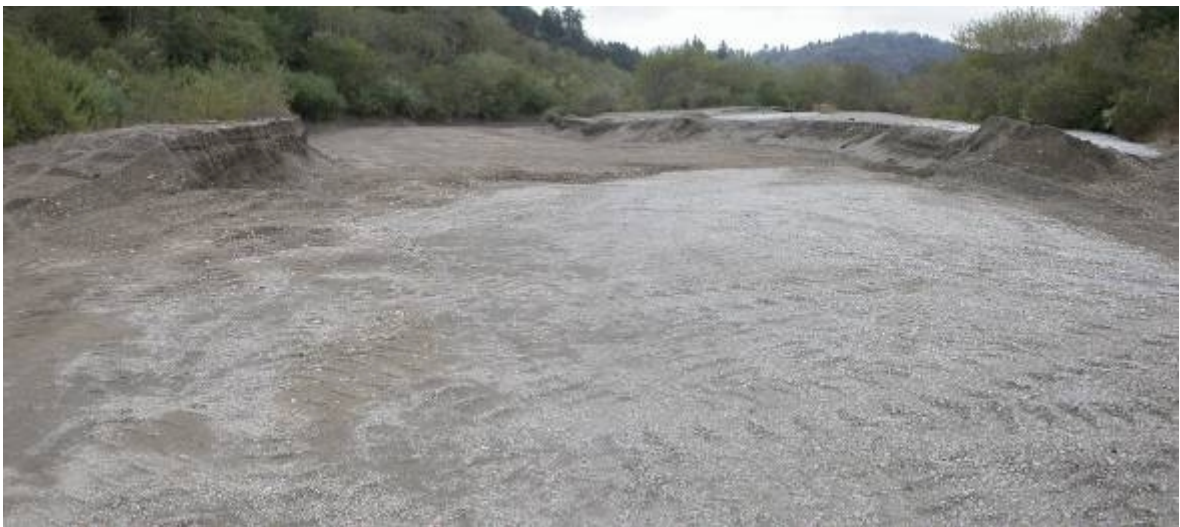
Figure 24. Photographs of the fluvial corridor of Hunter Creek during the second year of channel excavation operations, Lower Klamath River Sub-basin, California (October 2005).

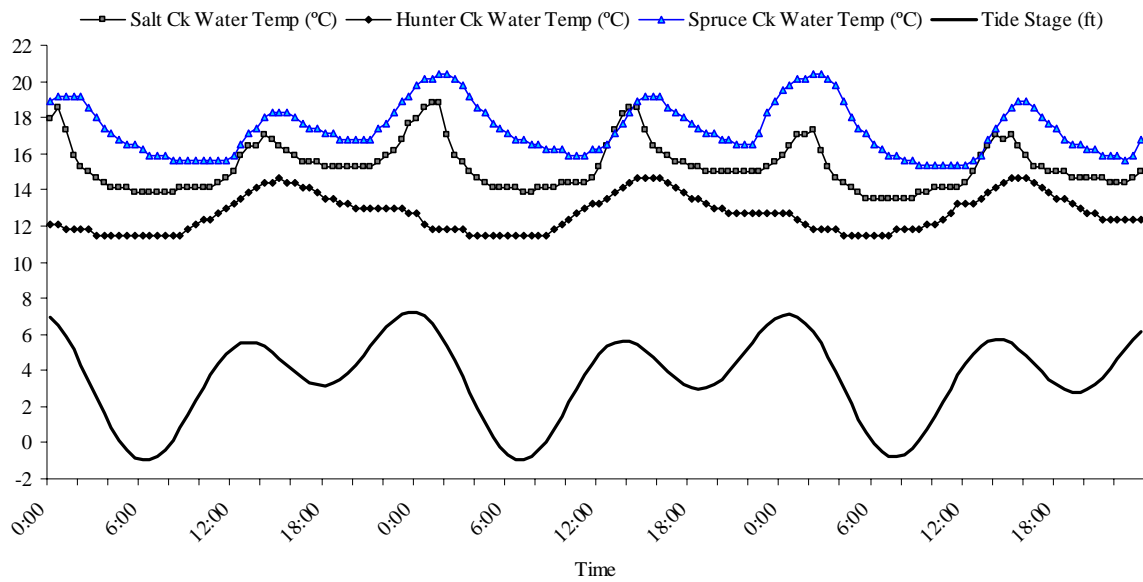
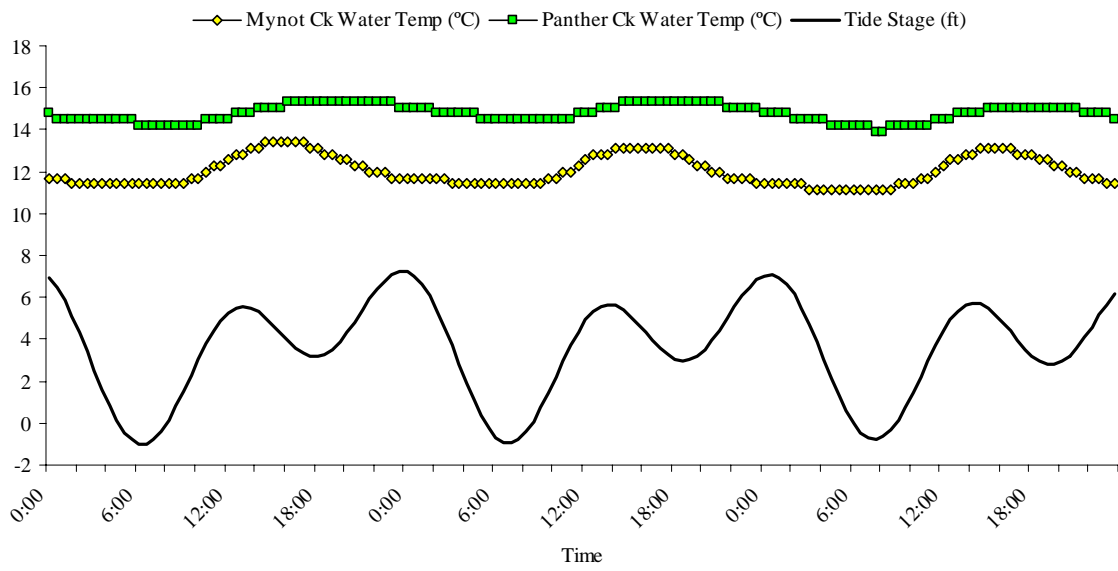
Figure 29. Water temperature recorded at several stations located in tributaries of the Klamath River estuary and predicted tide stage from the National Oceanic and Atmospheric Administration for Crescent City, California, for the period 24 – 26 July 2006.

Data collected in the Hunter-Salt valley since 2000 has revealed that water quality in the lower reaches of Salt Creek, Hunter Creek, and Spruce Creek were greatly influenced by Klamath River flows and tide cycles during most of the year (Figure 29). Water quality at the unnamed tributary, Mynot Creek, and Panther Creek appeared less influenced by tide cycles or mainstem river conditions, especially from spring – fall (Figure 29). Off-estuary water quality conditions on the north side of the Klamath River appeared favorable to adult and juvenile salmonids from winter through early summer. However, dissolved oxygen appeared to be limiting to salmonids in all of the creeks except Hunter Creek and Mynot Creek. Both Hunter Creek and Mynot Creek provide cold and highly oxygenated water over the entire year (Beesley and Fiori 2004; Hiner and Brown 2004; Beesley and Fiori 2007a). However, flow levels in lower Mynot Creek limit fish access and use during summer – fall. YTFP will continue monitoring water quality and quantity in the Klamath River estuary to improve our understanding of the conditions available to adult and juvenile salmonids and determine how best to enhance these areas to improve salmonid growth and survival.

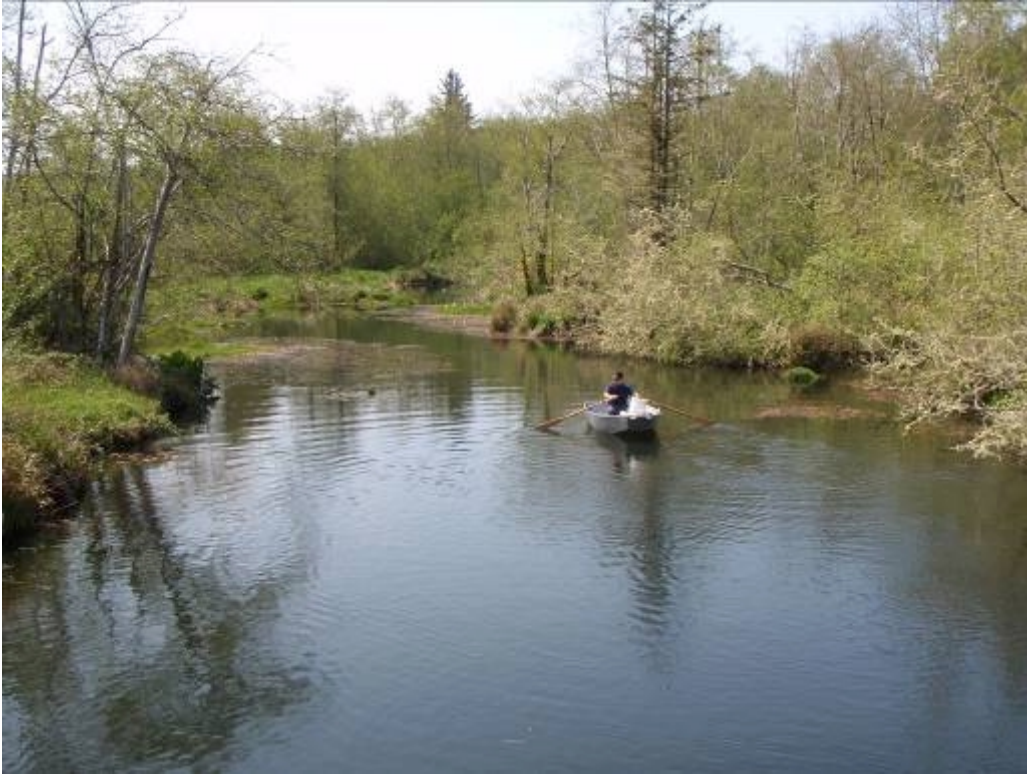
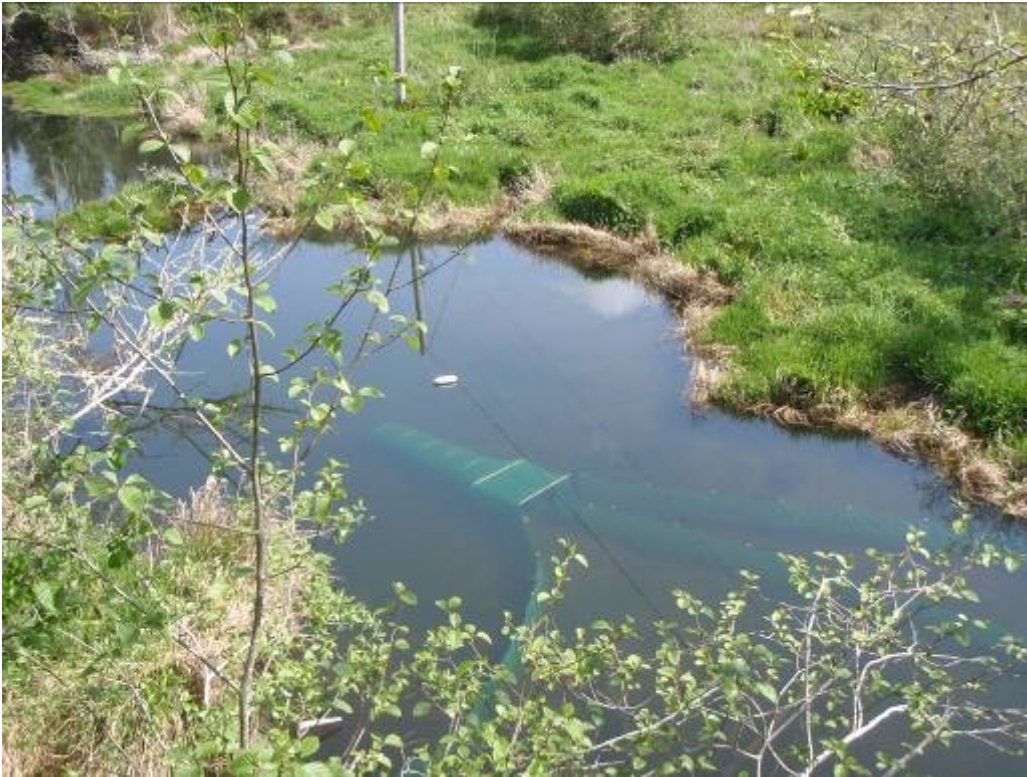
Figure 32. Yurok Tribal Fisheries Program crews monitoring salmonid populations in Panther Creek pond, Lower Klamath River Sub-basin, California (Spring 2008).

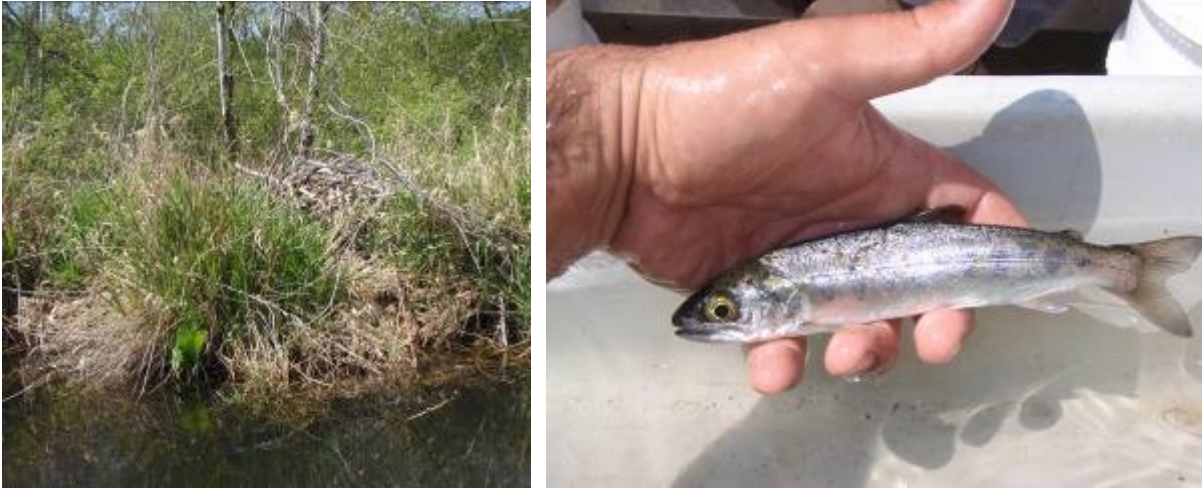
Figure 33. Photographs of a beaver hut in Panther Creek (left photograph) and a juvenile chinook salmon captured in a Panther Creek migrant trap (right photograph), Lower Klamath River Sub-basin, California (Spring 2008).
