Instream & Riparian Enhancement of Mainstem McGarvey Creek (Phase I)

Daniel B. Gale
Yurok Tribal Fisheries Program
P.O. Box 339
Klamath, CA 95548

March 01, 2009

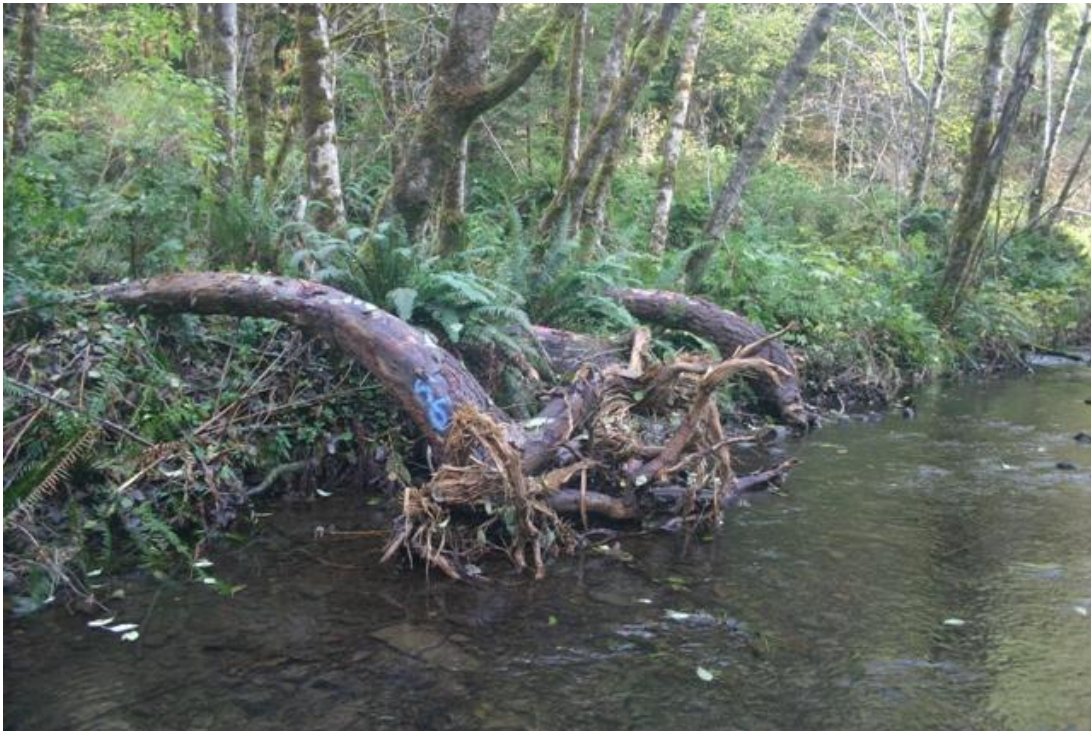
Figure 16. Shallow run at top of project reach following installation of structures #1, Mainstem McGarvey Creek, Lower Klamath River, California, September 2008.

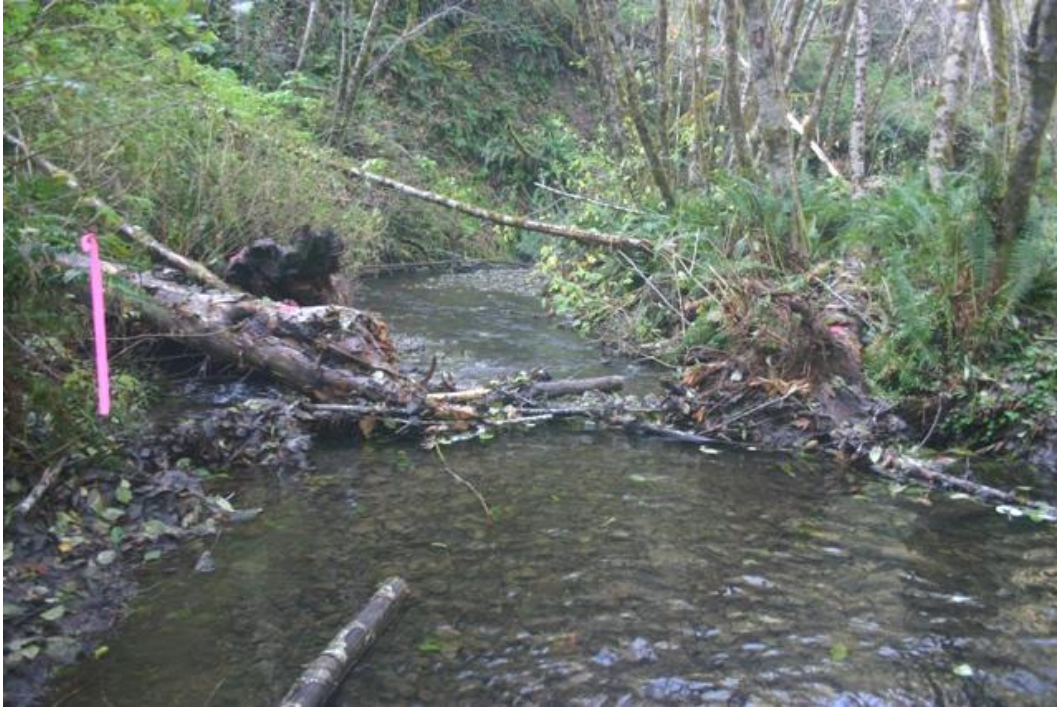
Figure 17. Shallow run at top of project reach following installation of structures #2, Mainstem McGarvey Creek, Lower Klamath River, California, September 2008.

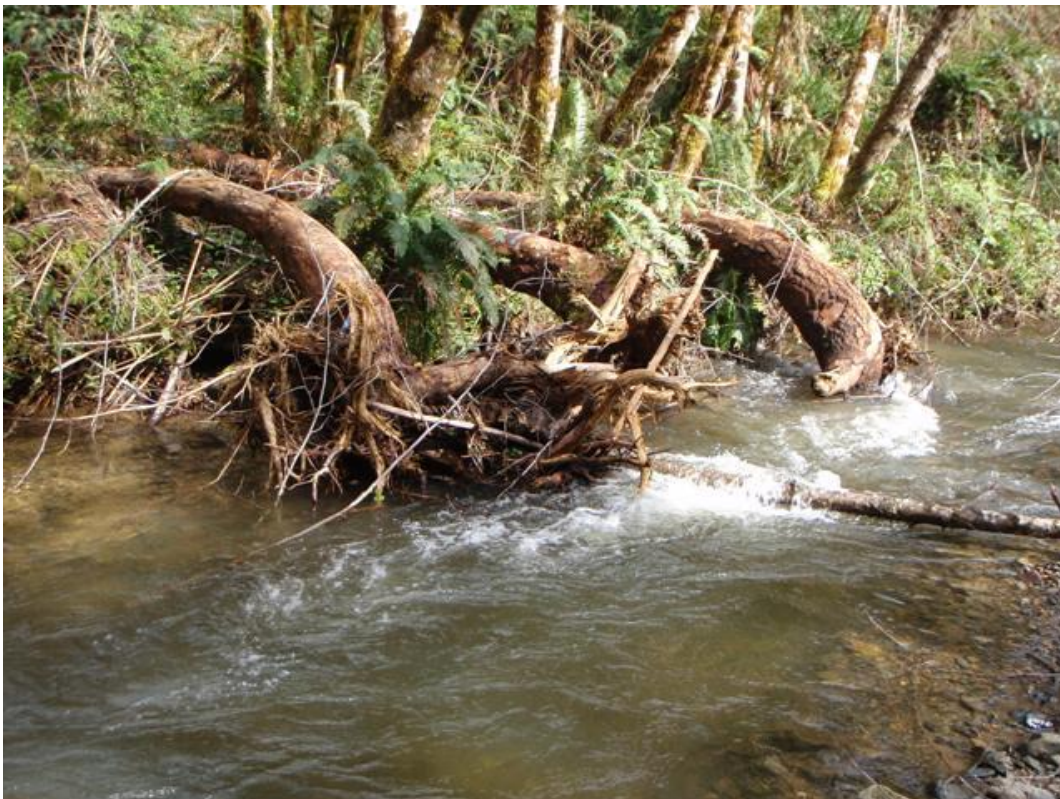
Figure 18. Structure #1 following high winter flows, Mainstem McGarvey Creek, Lower Klamath River, California, March 2009.

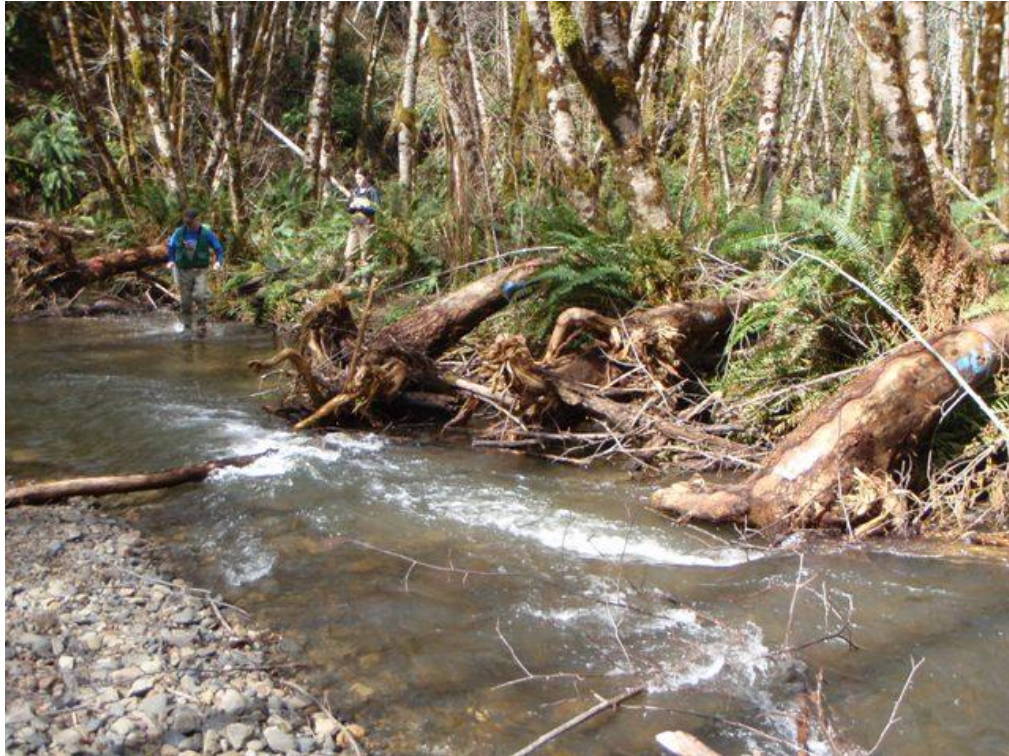
Figure 19. Structure #1 following high winter flows, Mainstem McGarvey Creek, Lower Klamath River, California, March 2009.

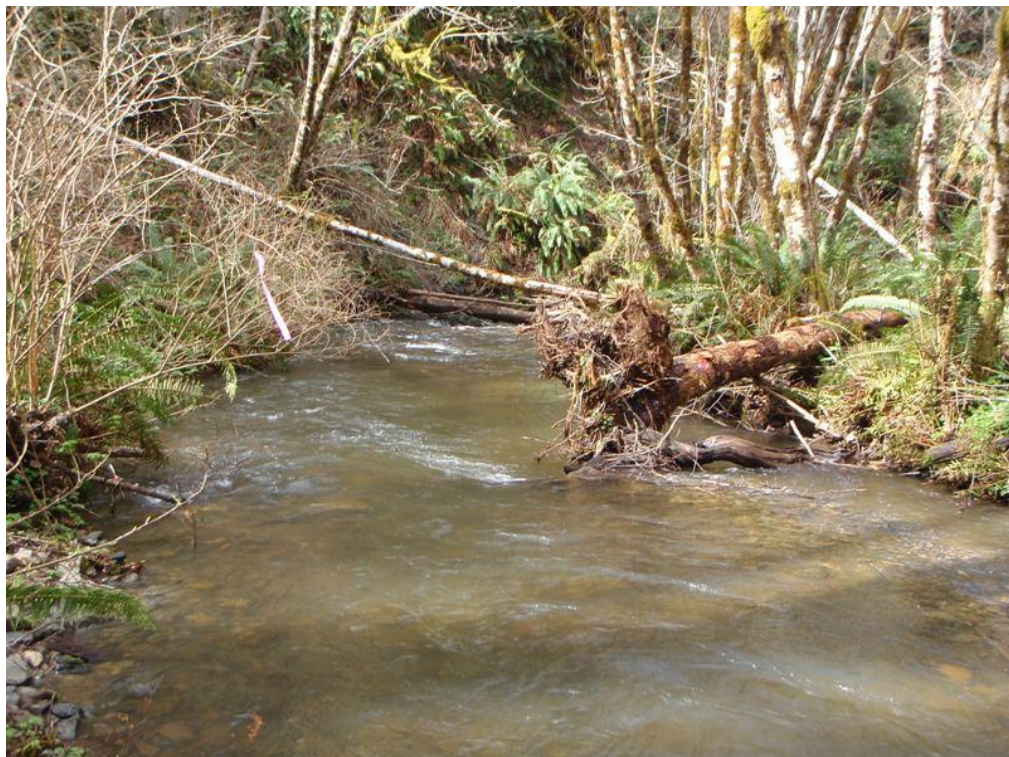
Figure 20. Structure #2 following high winter flows, Mainstem McGarvey Creek, Lower Klamath River, California, March 2009.

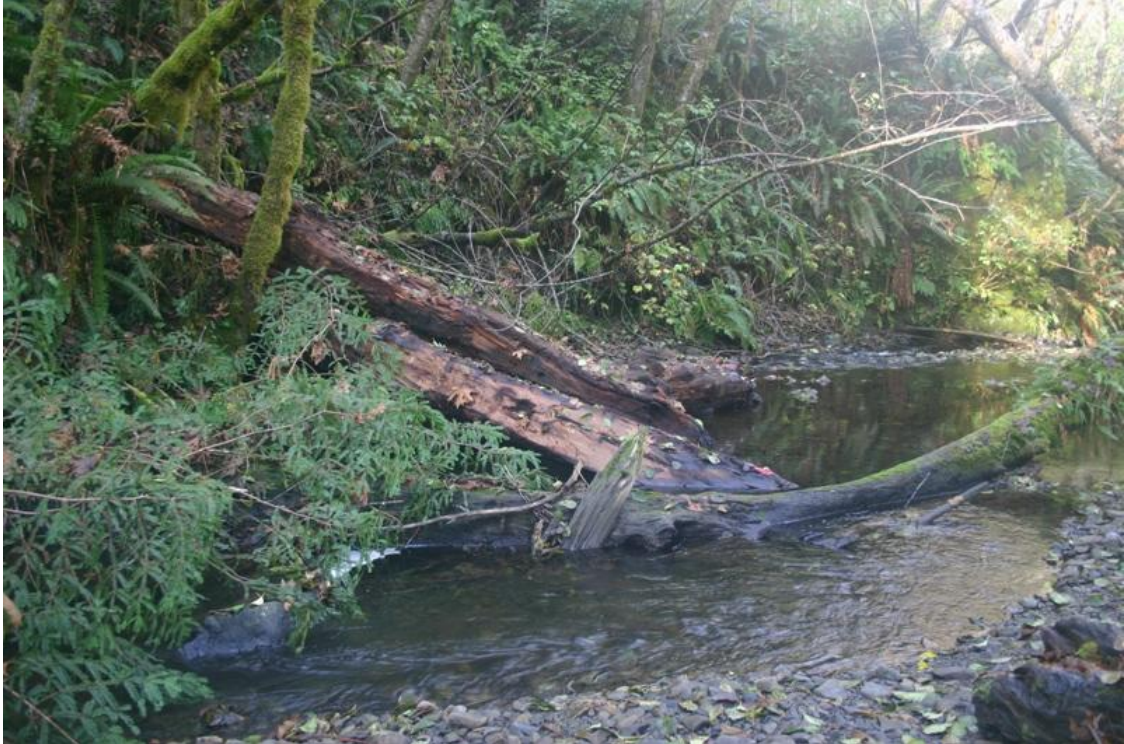
Figure 23. Shallow pool near top of project reach following installation of structure #3, Mainstem McGarvey Creek, Lower Klamath River, California, September 2008.

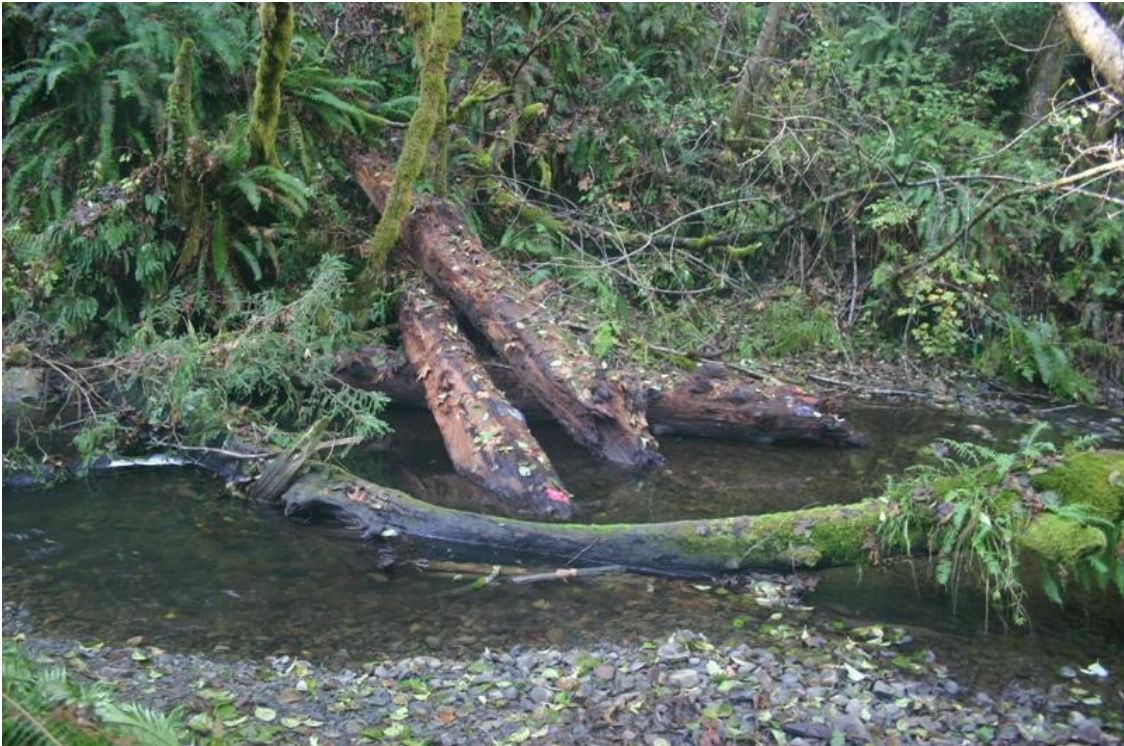
Figure 24. Shallow pool near top of project reach following installation of structure #3, Mainstem McGarvey Creek, Lower Klamath River, California, September 2008.

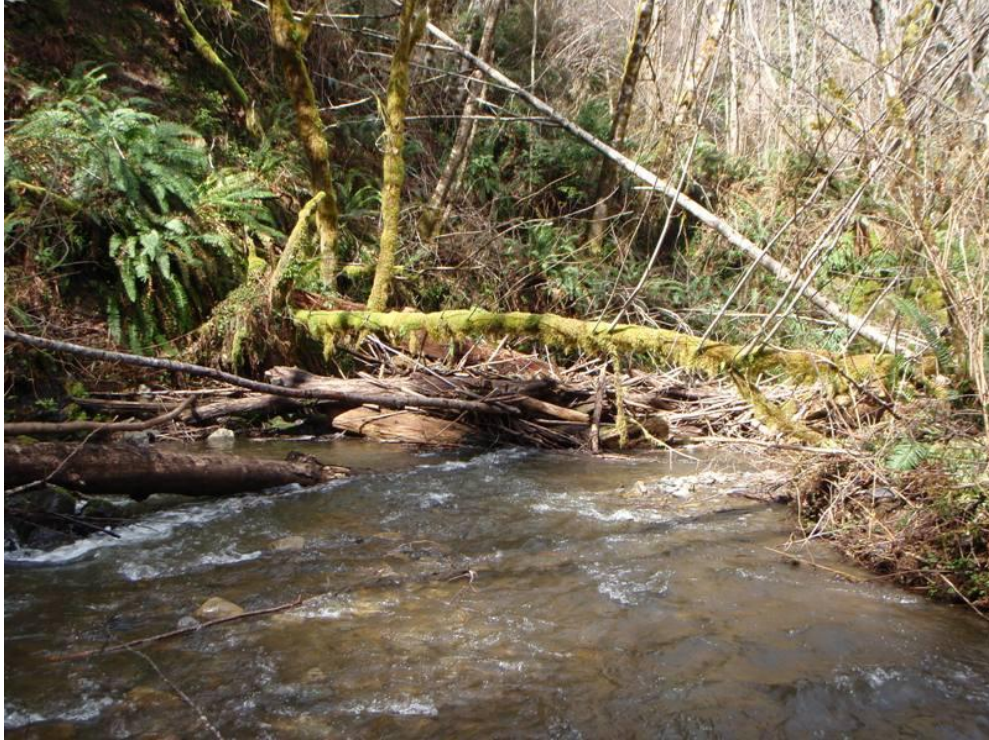
Figure 25. Structure #3 following high winter flows, Mainstem McGarvey Creek, Lower Klamath River, California, March 2009.

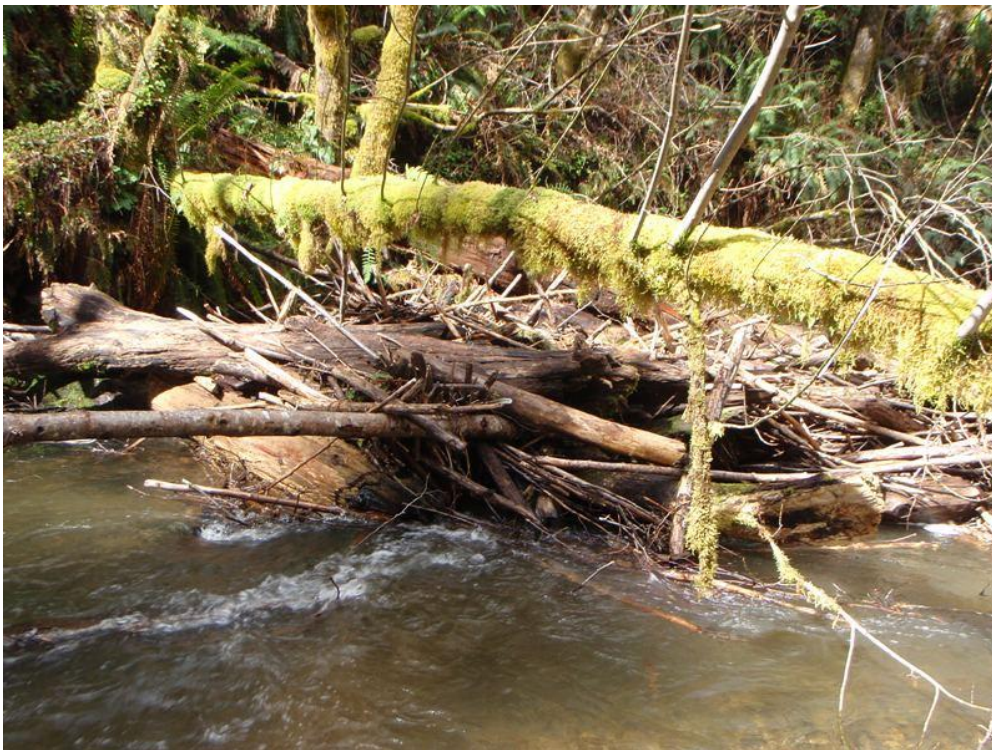
Figure 26. Structure #3 following high winter flows, Mainstem McGarvey Creek, Lower Klamath River, California, March 2009.

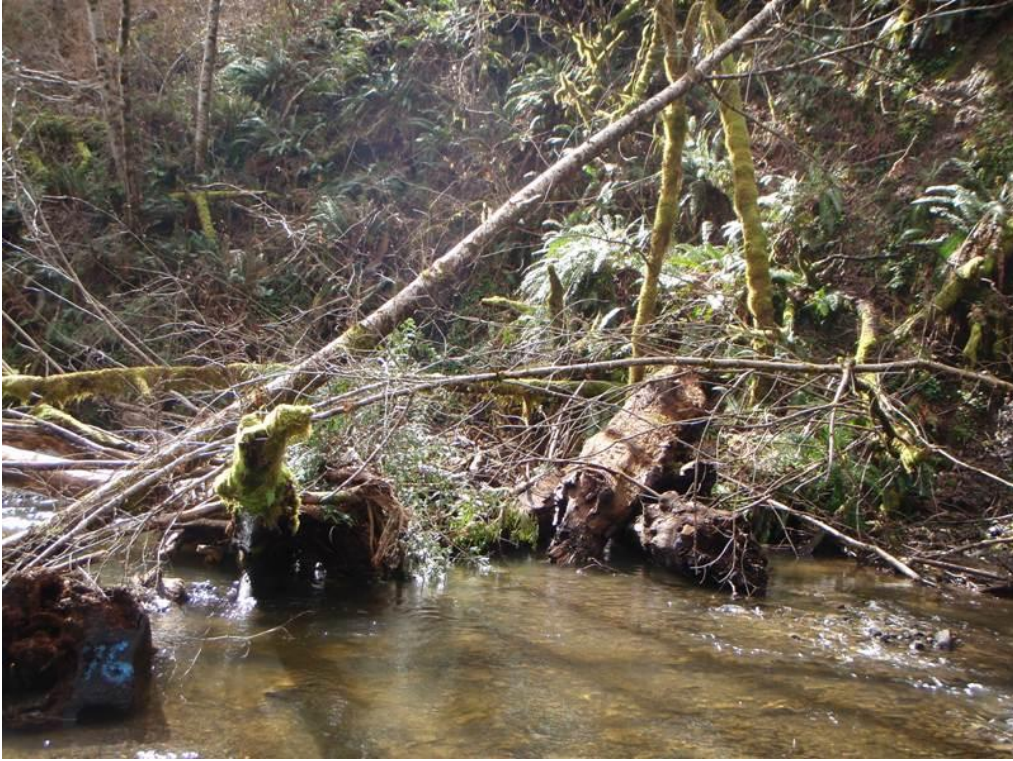
Figure 27. Structure #3 following high winter flows, Mainstem McGarvey Creek, Lower Klamath River, California, March 2009.

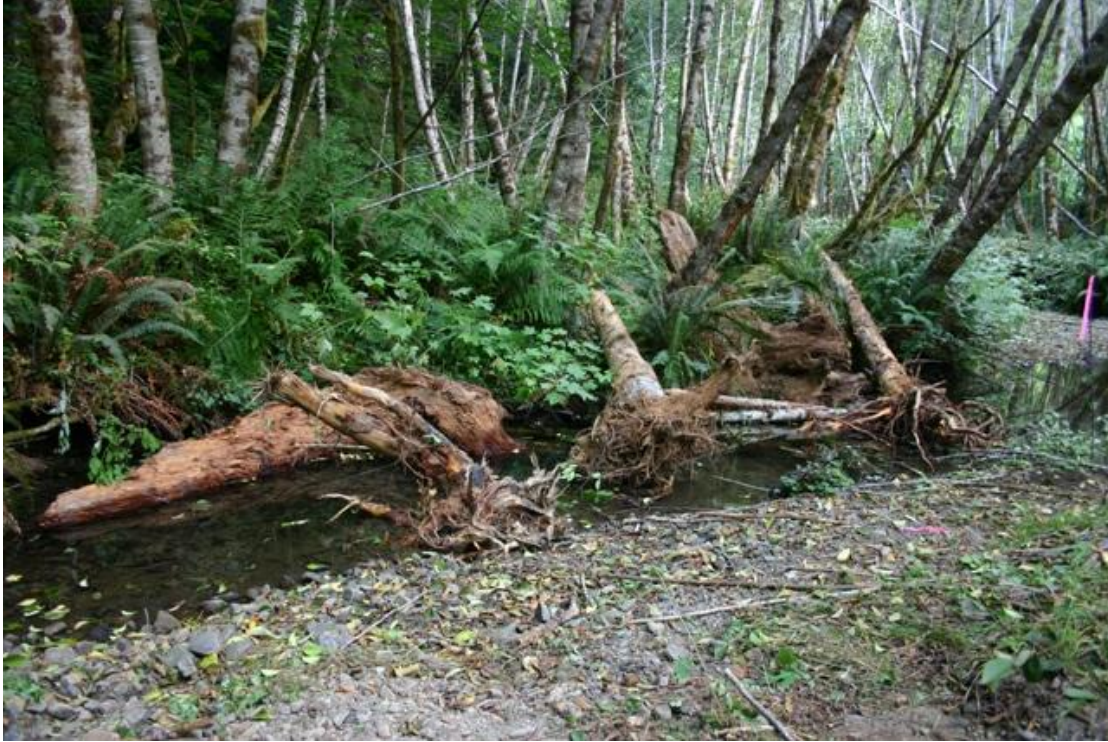
Figure 33. Shallow pool near top of project reach following installation of structure #4, Mainstem McGarvey Creek, Lower Klamath River, California, September 2008.

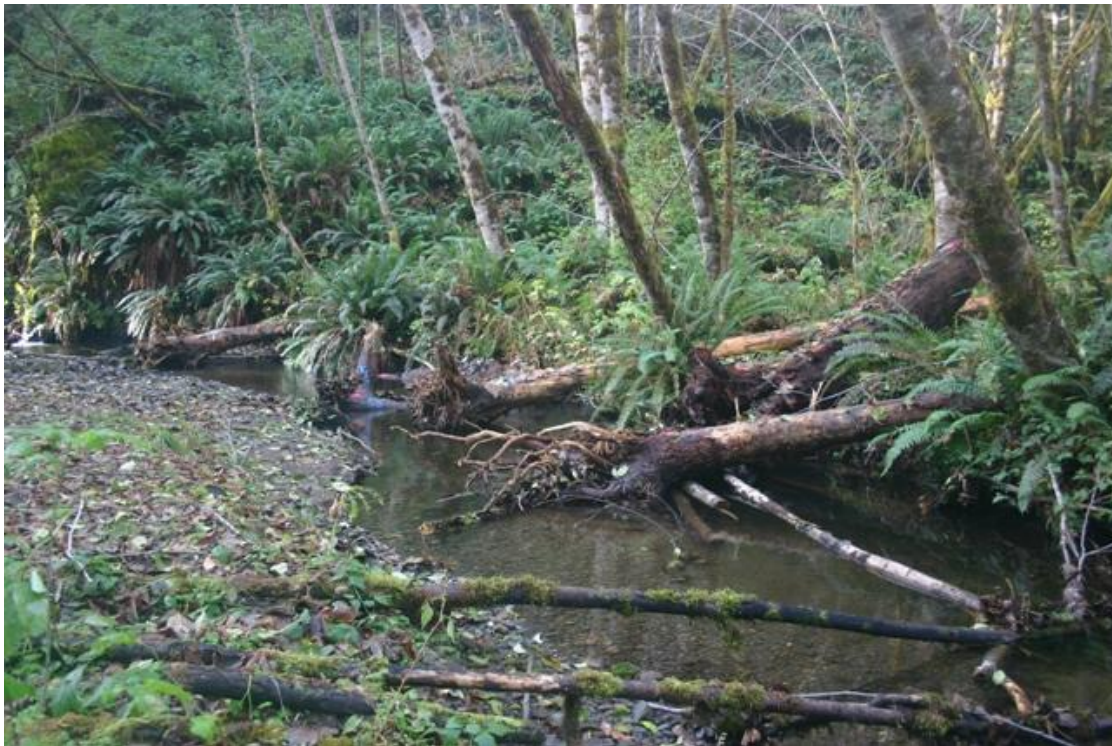
Figure 34. Shallow pool near top of project reach following installation of structure #4, Mainstem McGarvey Creek, Lower Klamath River, California, November 2008.

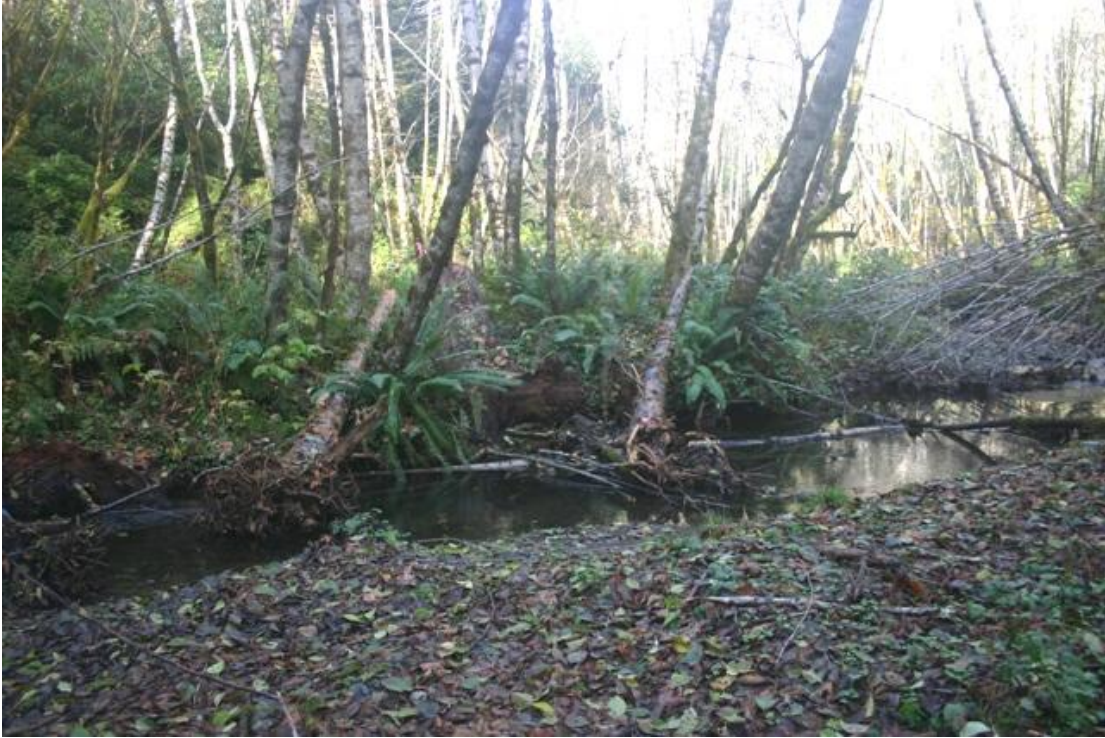
Figure 35. Shallow pool near top of project reach following installation of structure #4, Mainstem McGarvey Creek, Lower Klamath River, California, November 2008.

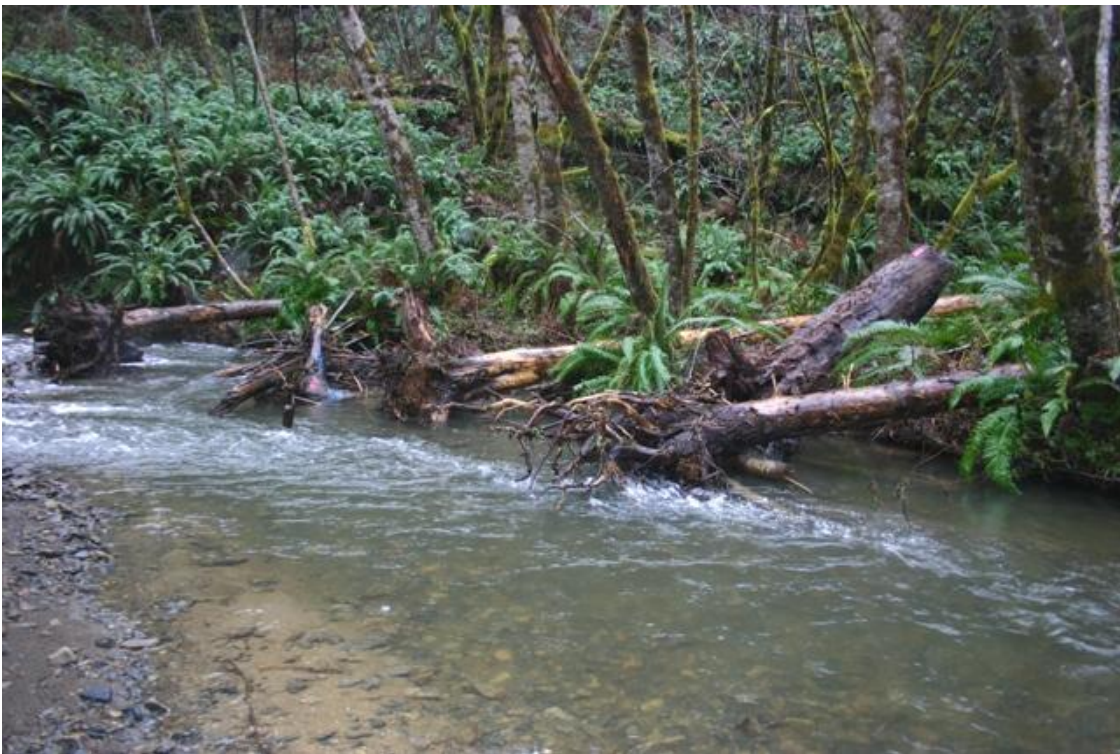
Figure 36. Structure #4 following high winter flows, Mainstem McGarvey Creek, Lower Klamath River, California, January 2009.

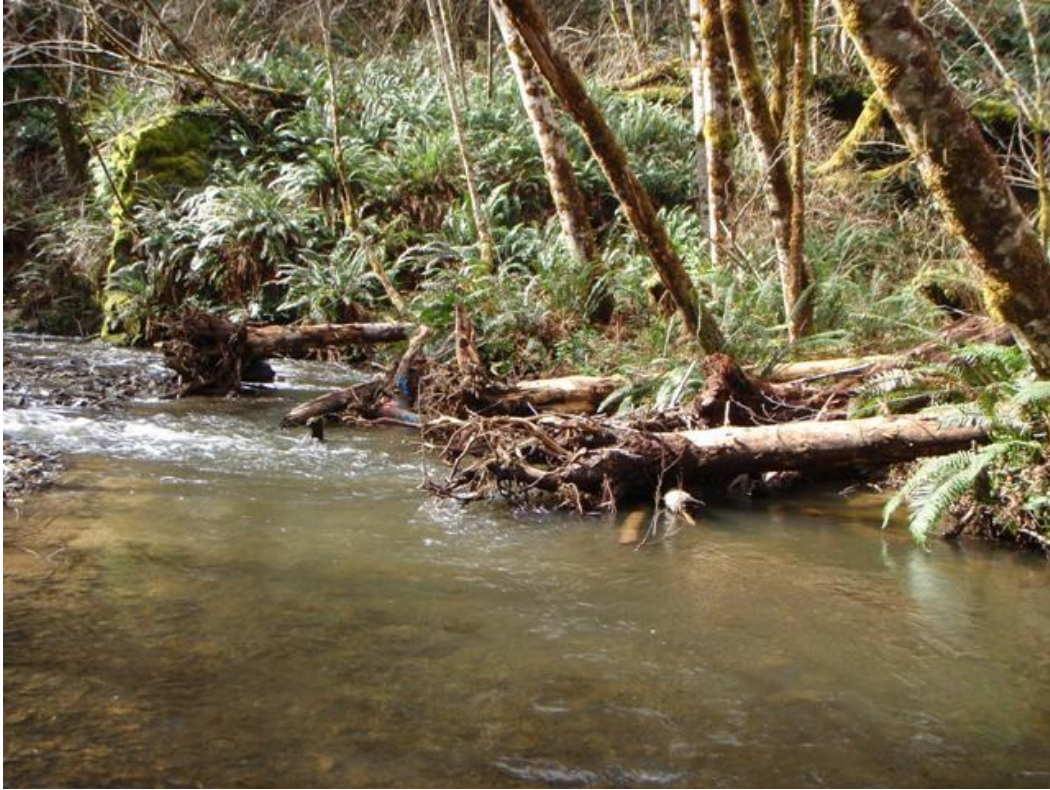
Figure 37. Structure #4 following high winter flows, Mainstem McGarvey Creek, Lower Klamath River, California, March 2009.

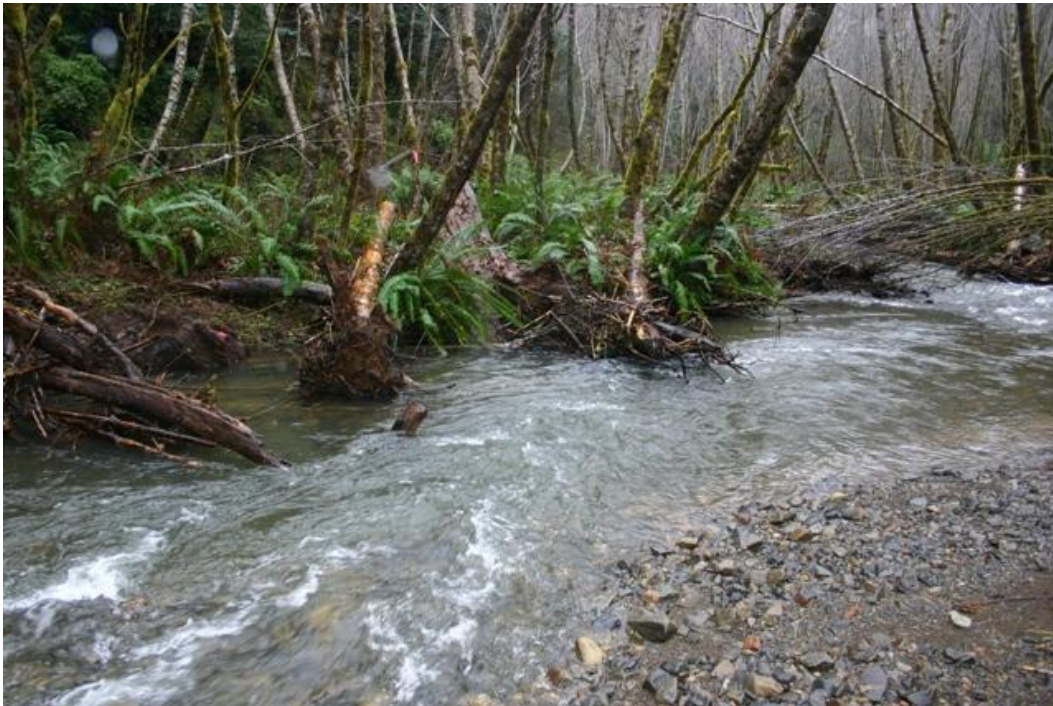
Figure 38. Structure #4 following high winter flows, Mainstem McGarvey Creek, Lower Klamath River, California, January 2009.

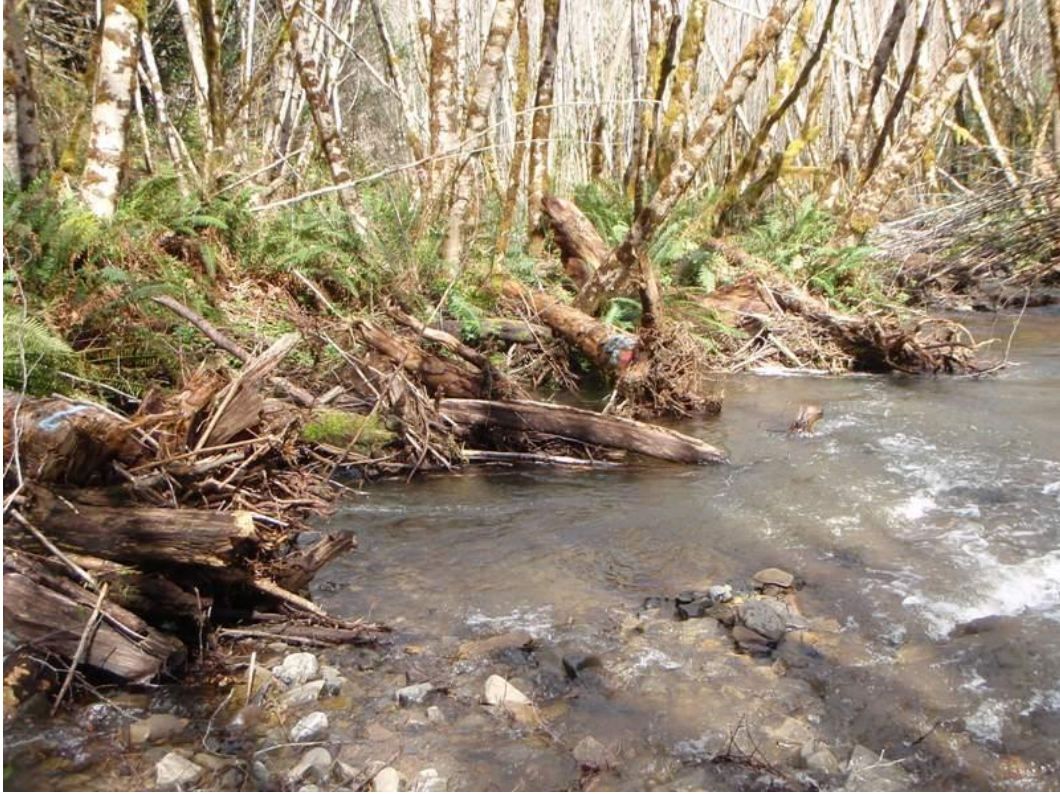
Figure 39. Structure #4 following high winter flows, Mainstem McGarvey Creek, Lower Klamath River, California, March 2009.

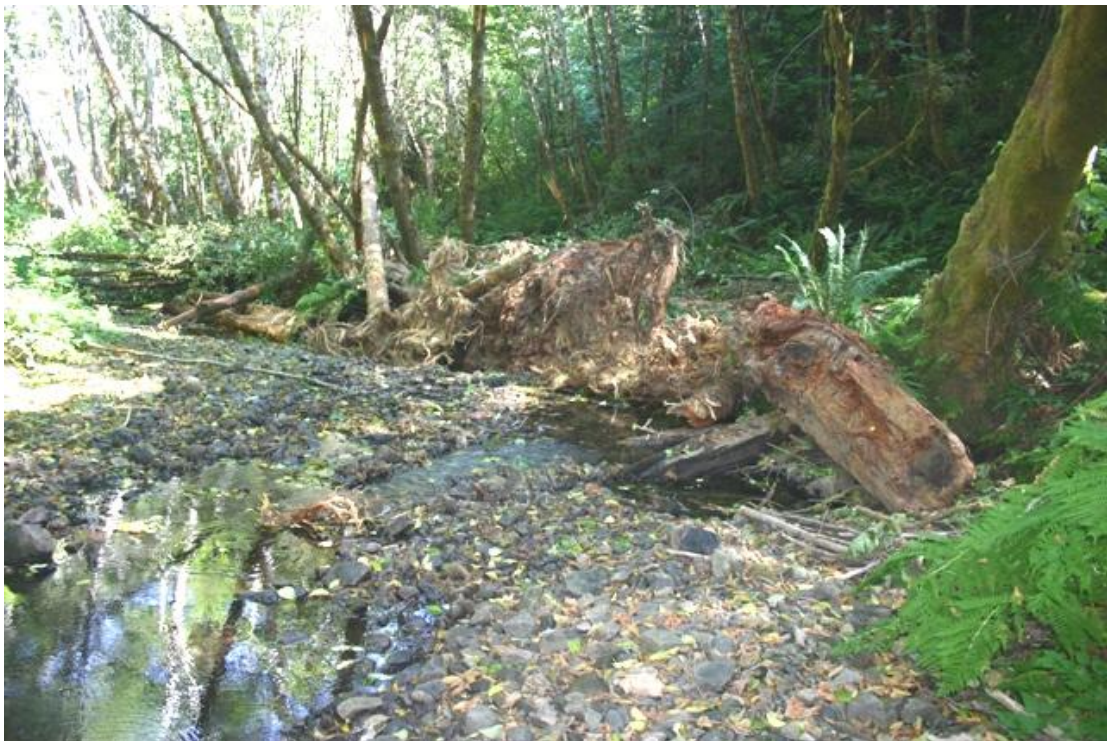
Figure 43. Shallow pool in upper portion of reach following installation of structure #5, Mainstem McGarvey Creek, Lower Klamath River, California, September 2008.

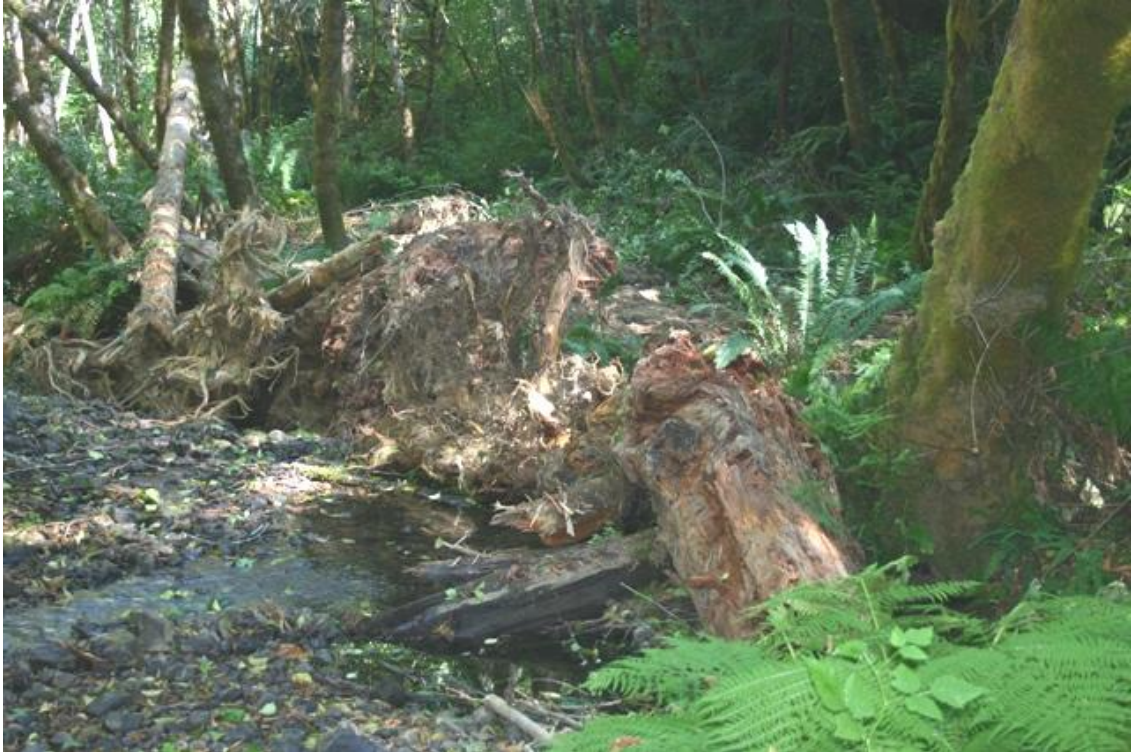
Figure 44. Shallow pool in upper portion of reach following installation of structure #5, Mainstem McGarvey Creek, Lower Klamath River, California, September 2008.

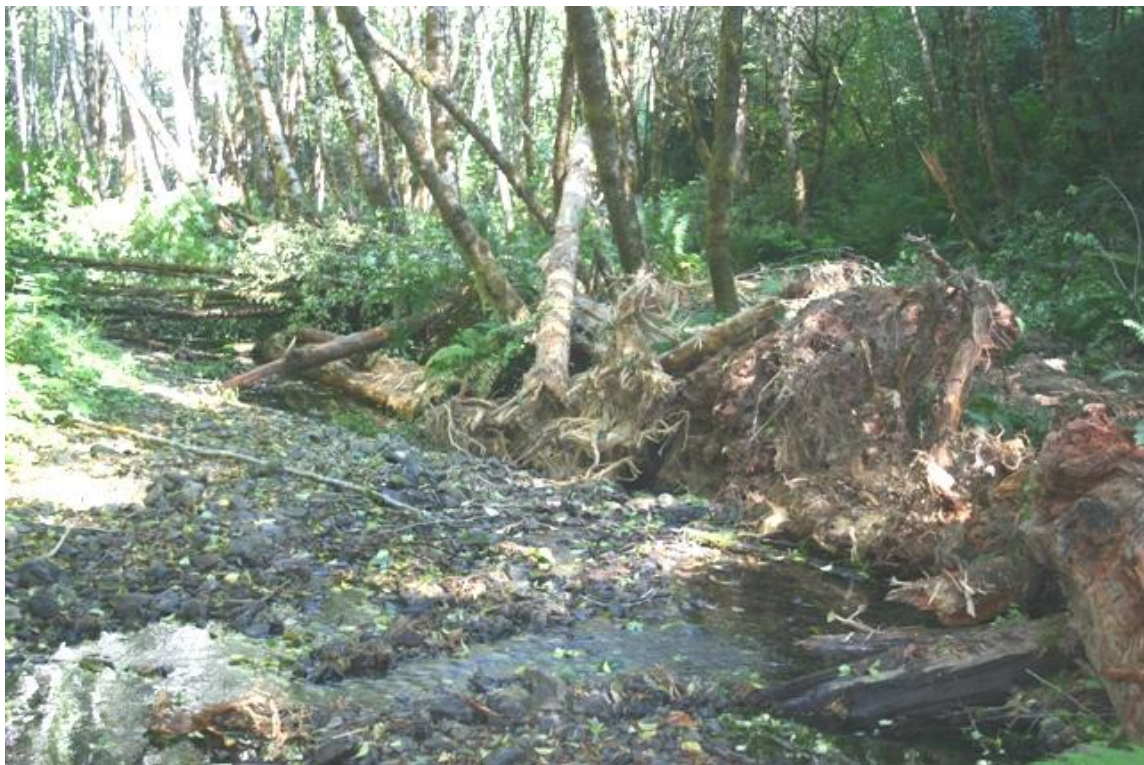
Figure 45. Shallow pool in upper portion of reach following installation of structure #5, Mainstem McGarvey Creek, Lower Klamath River, California, September 2008.

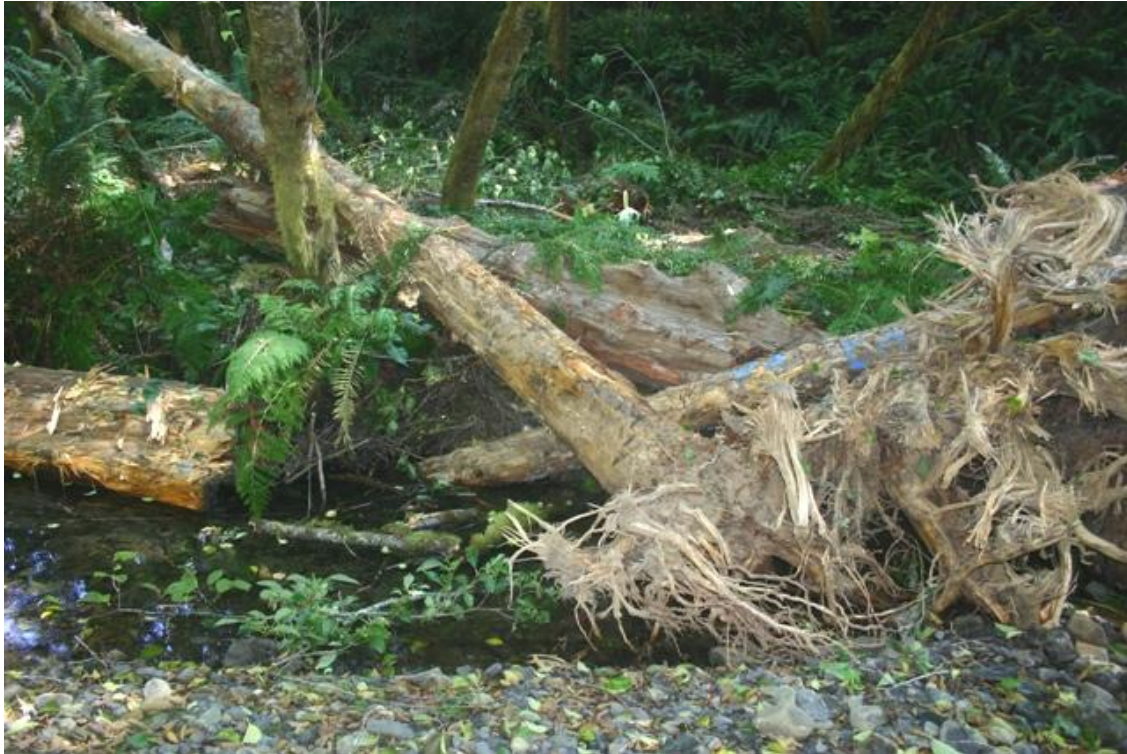
Figure 46. Shallow pool in upper portion of reach following installation of structure #5, Mainstem McGarvey Creek, Lower Klamath River, California, September 2008.

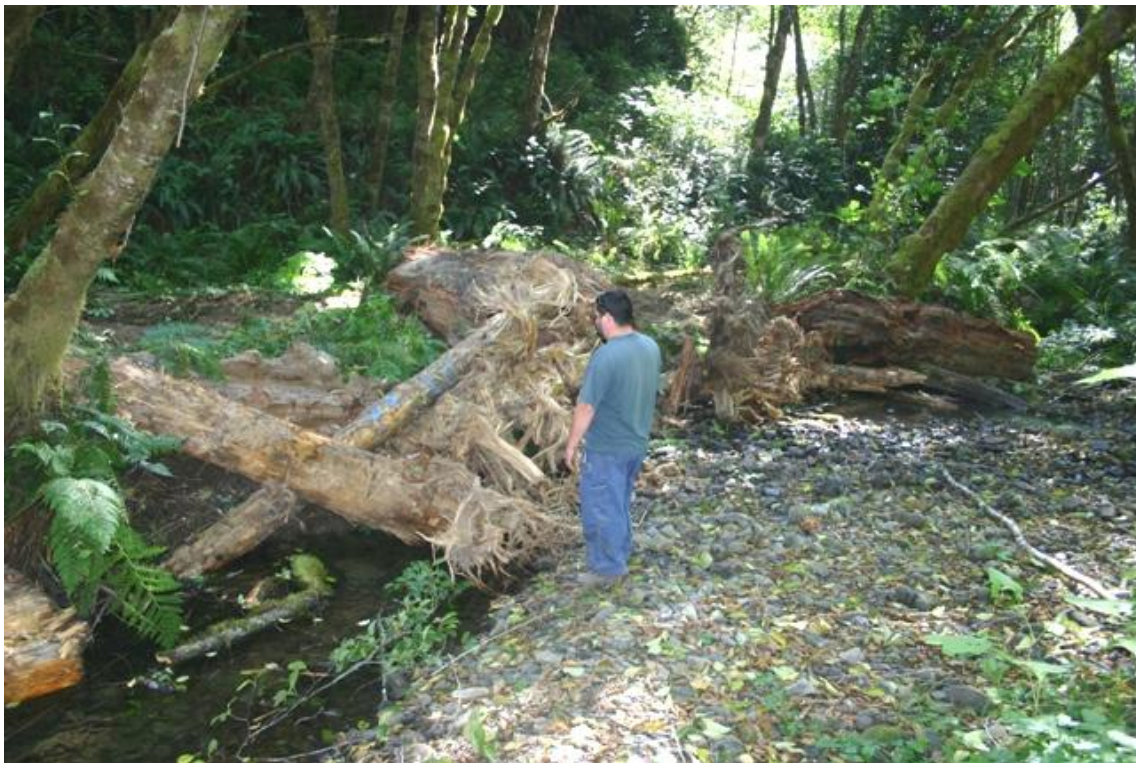
Figure 47. Shallow pool in upper portion of reach following installation of structure #5, Mainstem McGarvey Creek, Lower Klamath River, California, September 2008.

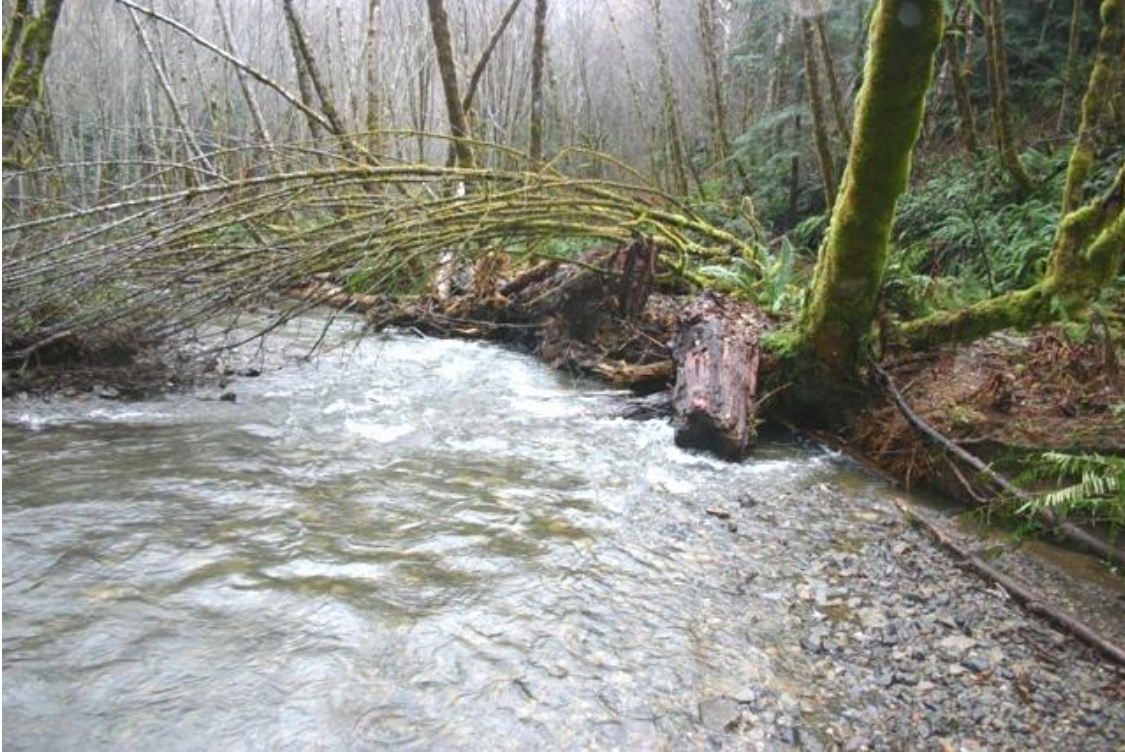
Figure 48. Structure #5 following high winter flows, Mainstem McGarvey Creek, Lower Klamath River, California, January 2009.

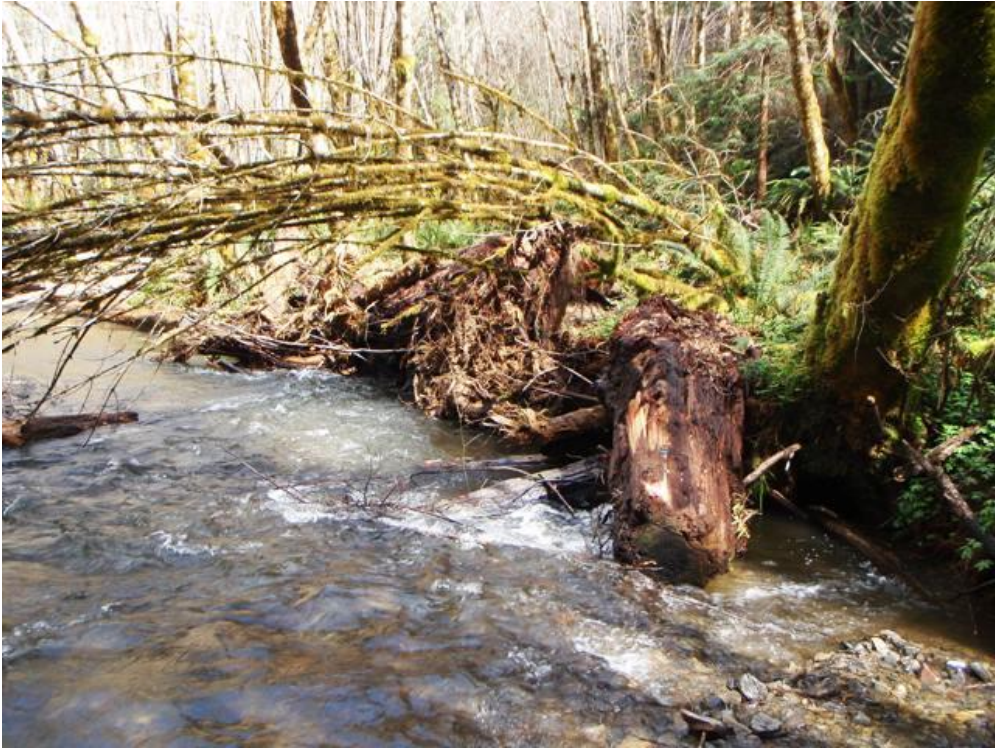
Figure 49. Structure #5 following high winter flows, Mainstem McGarvey Creek, Lower Klamath River, California, March 2009.

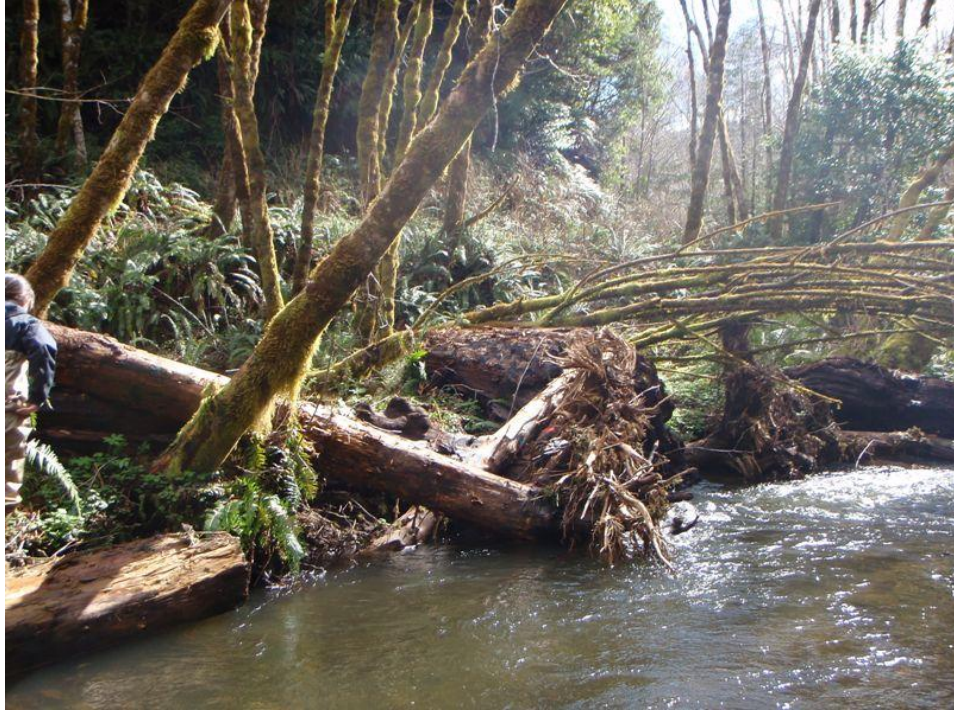
Figure 50. Structure #5 following high winter flows, Mainstem McGarvey Creek, Lower Klamath River, California, March 2009.

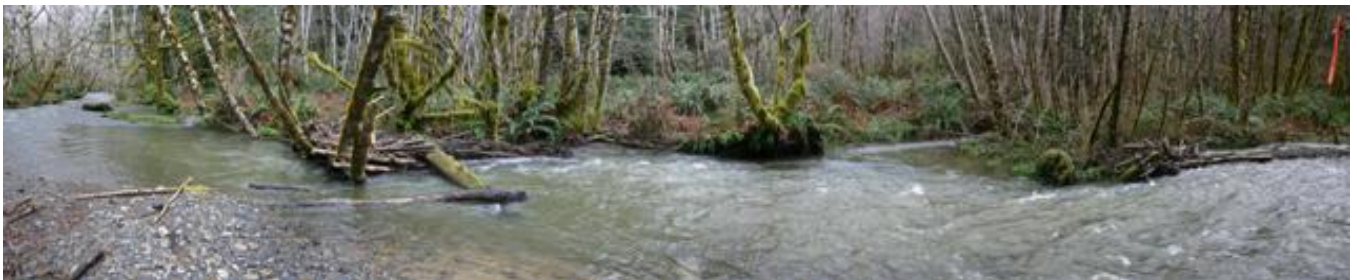
Figure 52. Channel confluence pool in upper portion of reach prior to installation of structure #6, Mainstem McGarvey Creek, Lower Klamath River, California, February 2007.

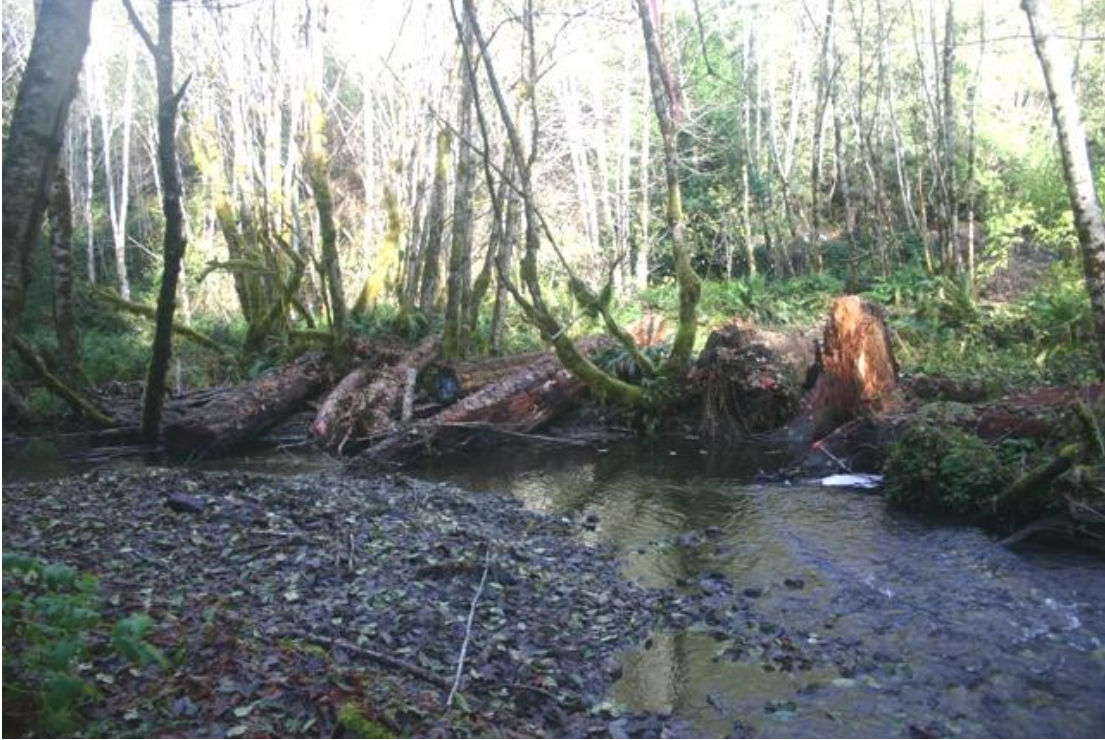
Figure 55. Confluence pool in upper portion of reach following installation of structure #6, Mainstem McGarvey Creek, Lower Klamath River, California, October 2008.

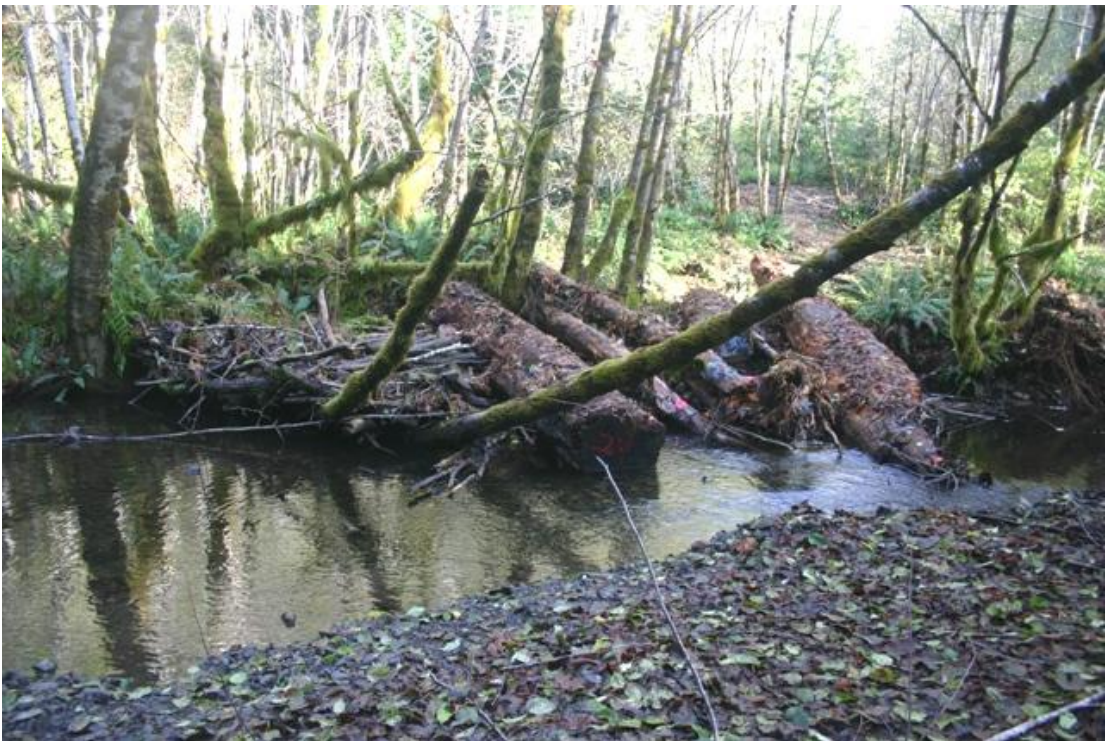
Figure 56. Confluence pool in upper portion of reach following installation of structure #6, Mainstem McGarvey Creek, Lower Klamath River, California, October 2008.
