Instream & Riparian Enhancement of Mainstem McGarvey Creek (Phase I)

Daniel B. Gale
Yurok Tribal Fisheries Program
P.O. Box 339
Klamath, CA 95548

March 01, 2009

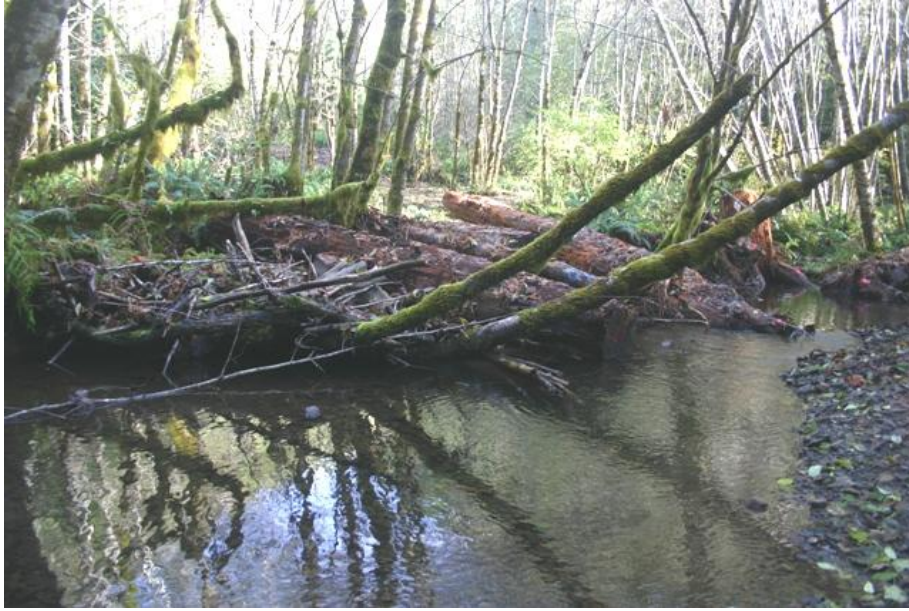
Figure 57. Confluence pool in upper portion of reach following installation of structure #6, Mainstem McGarvey Creek, Lower Klamath River, California, October 2008.

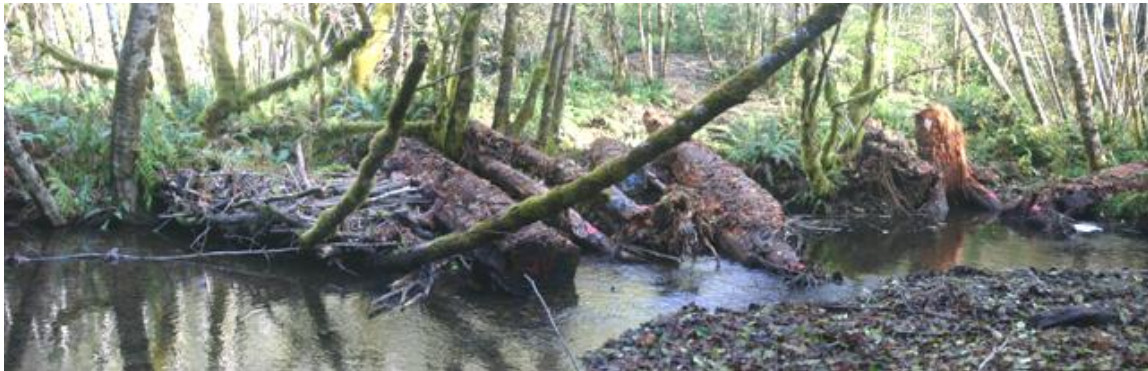
Figure 58. Confluence pool in upper portion of reach following installation of structure #6, Mainstem McGarvey Creek, Lower Klamath River, California, October 2008.

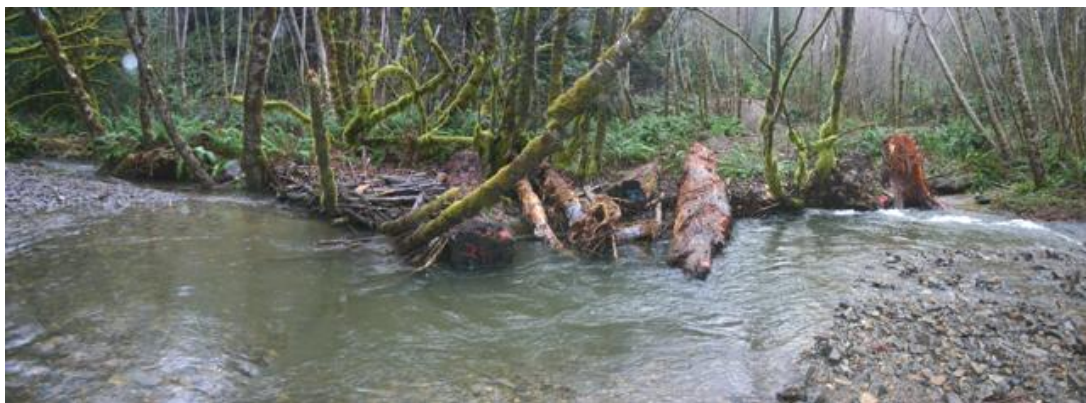
Figure 59. Structure #6 following high winter flows, Mainstem McGarvey Creek, Lower Klamath River, California, January 2009.

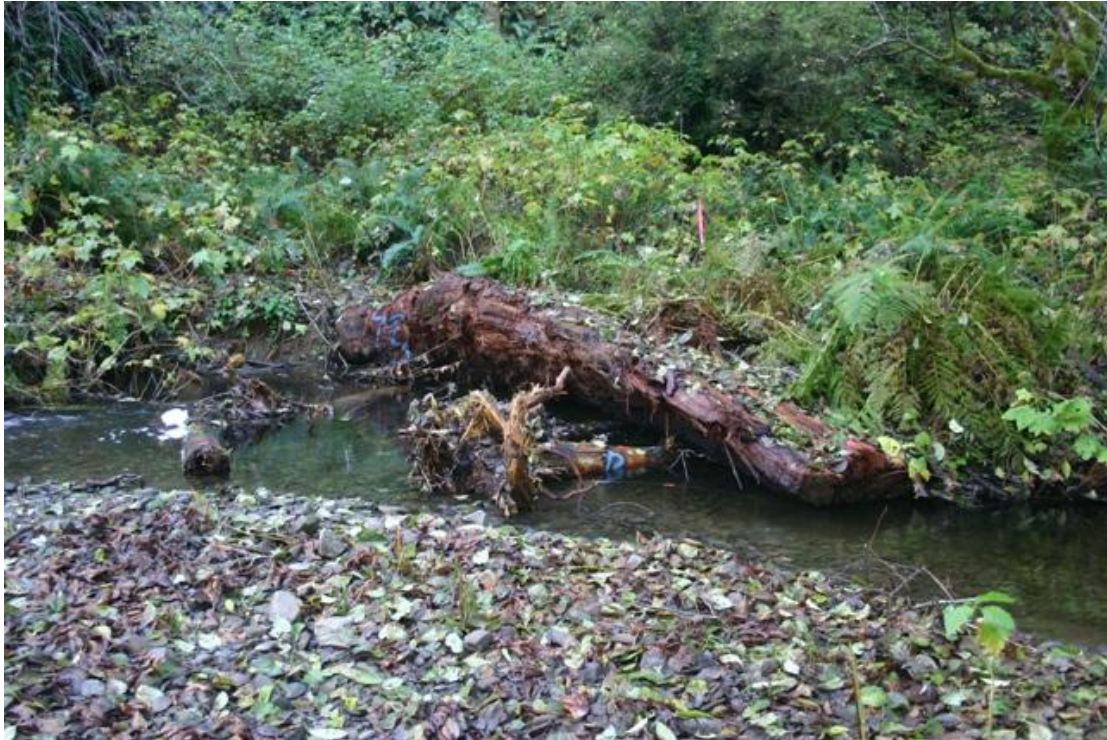
Figure 62. Backwater pool in upper portion of reach following installation of structure #7, Mainstem McGarvey Creek, Lower Klamath River, California, November 2008.

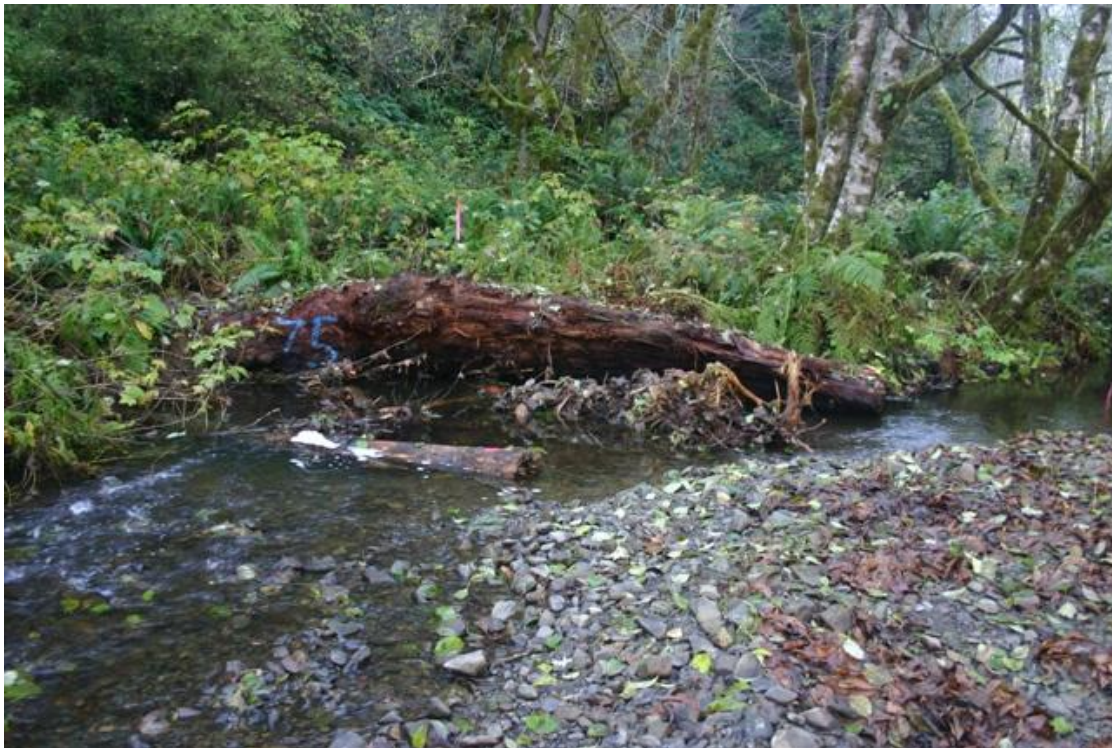
Figure 63. Backwater pool in upper portion of reach following installation of structure #7, Mainstem McGarvey Creek, Lower Klamath River, California, November 2008.

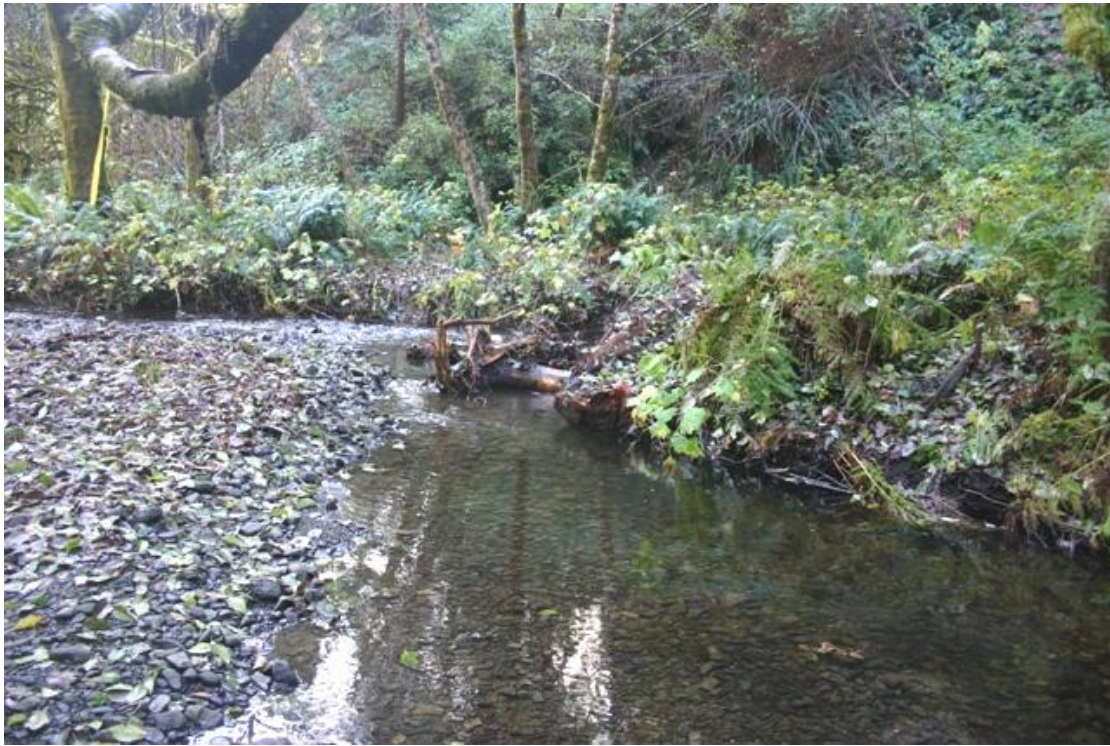
Figure 64. Backwater pool in upper portion of reach following installation of structure #7, Mainstem McGarvey Creek, Lower Klamath River, California, November 2008.

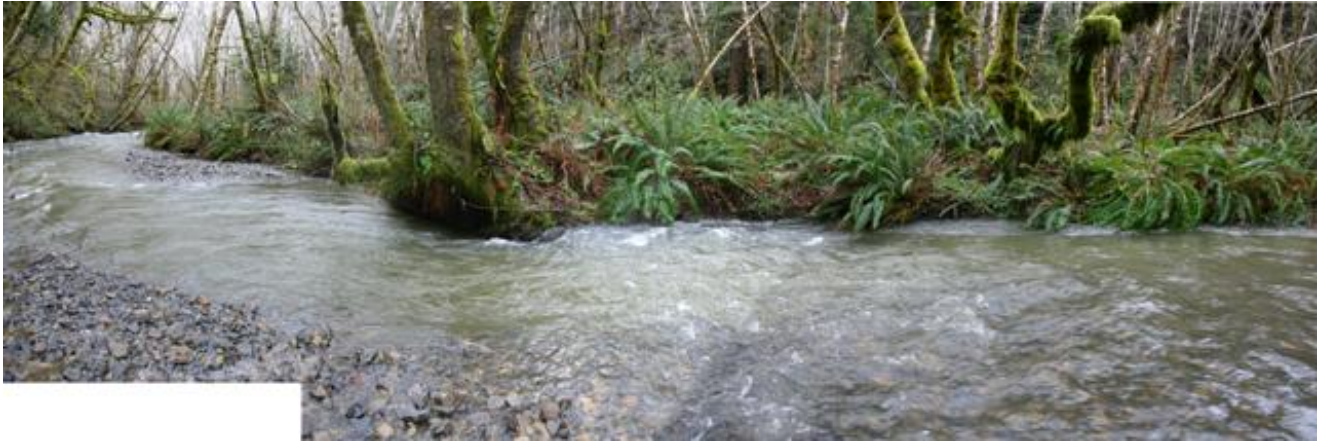
Figure 66. Lateral scour pool in middle portion of reach prior to installation of structures #8-9, Mainstem McGarvey Creek, Lower Klamath River, California, February 2007.

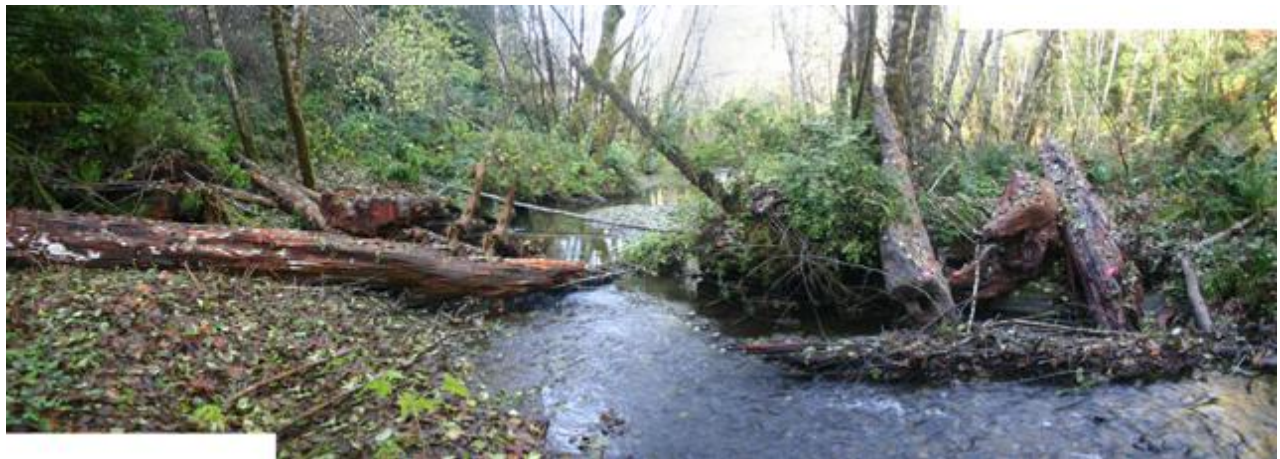
Figure 67. Scour pool in middle portion of reach following installation of structures #8-9, Mainstem McGarvey Creek, Lower Klamath River, California, November 2008.

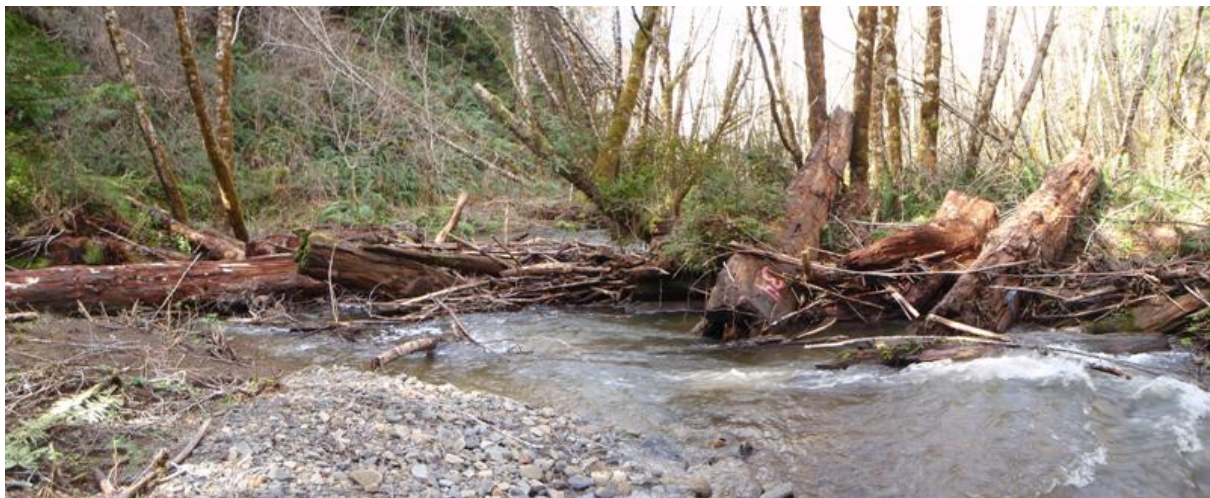
Figure 68. Structures #8-9 following high winter flows, Mainstem McGarvey Creek, Lower Klamath River, California, March 2009.

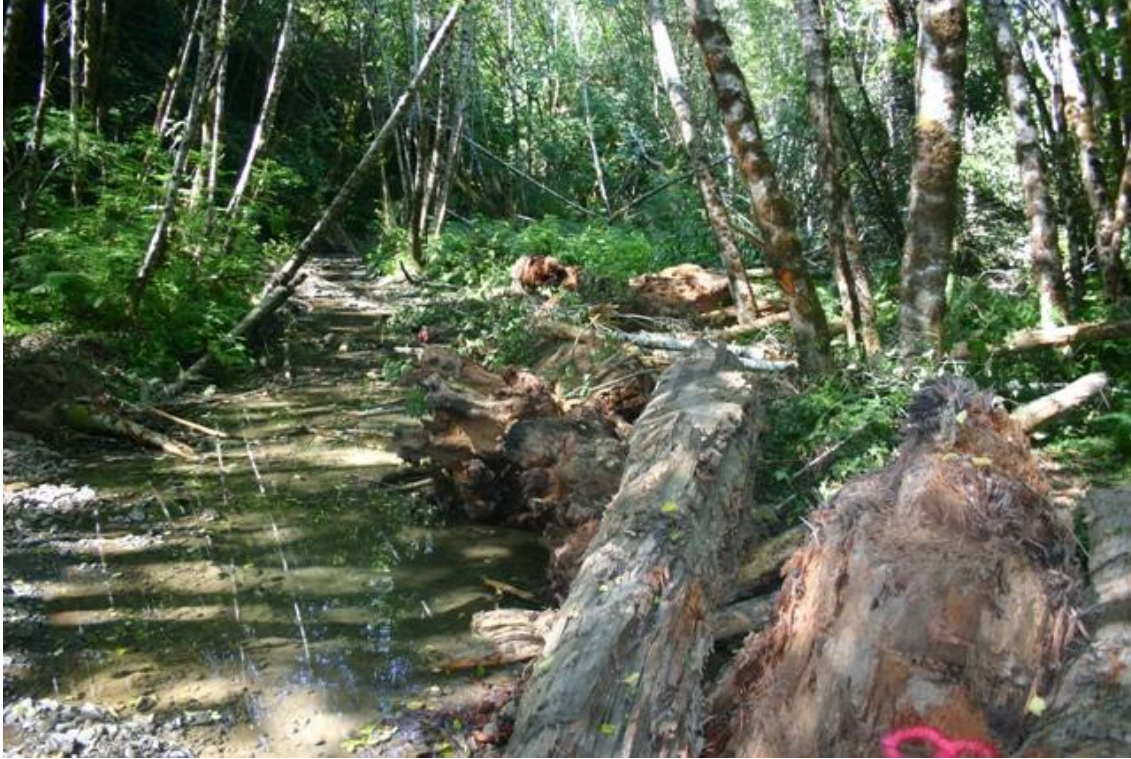
Figure 69. Step-run in middle portion of reach following installation of structures #10, Mainstem McGarvey Creek, Lower Klamath River, California, September 2008.

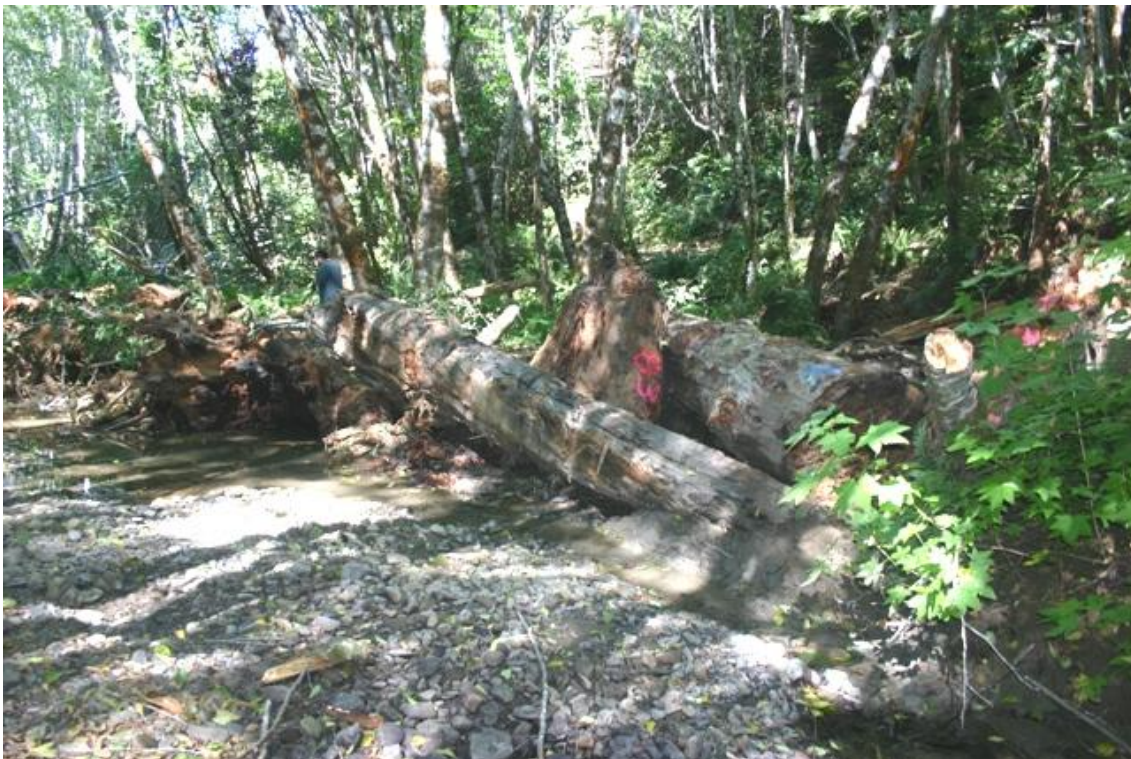
Figure 70. Step-run in middle portion of reach following installation of structures #10, Mainstem McGarvey Creek, Lower Klamath River, California, September 2008.

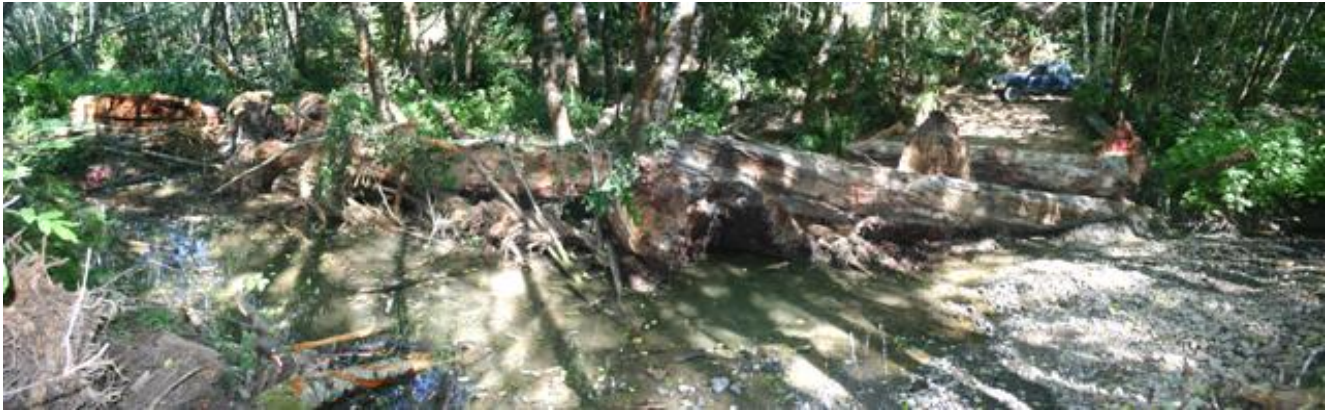
Figure 71. Step-run in middle portion of reach following installation of structures #10, Mainstem McGarvey Creek, Lower Klamath River, California, September 2008.

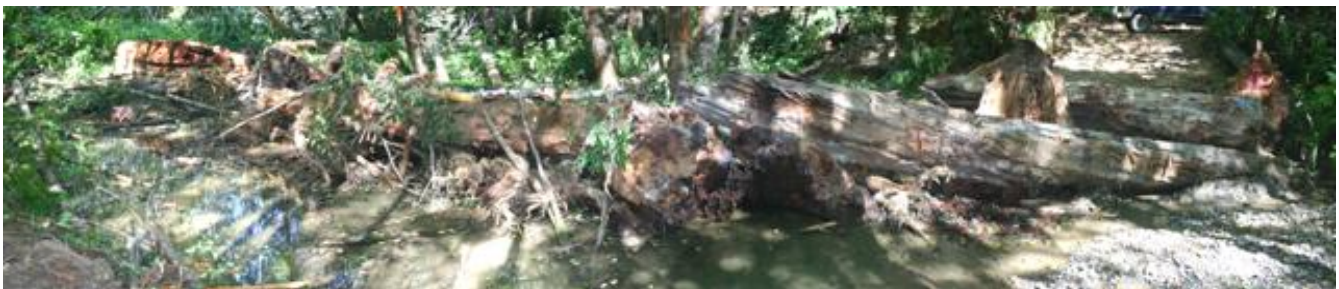
Figure 72. Step-run in middle portion of reach following installation of structures #10, Mainstem McGarvey Creek, Lower Klamath River, California, September 2008.

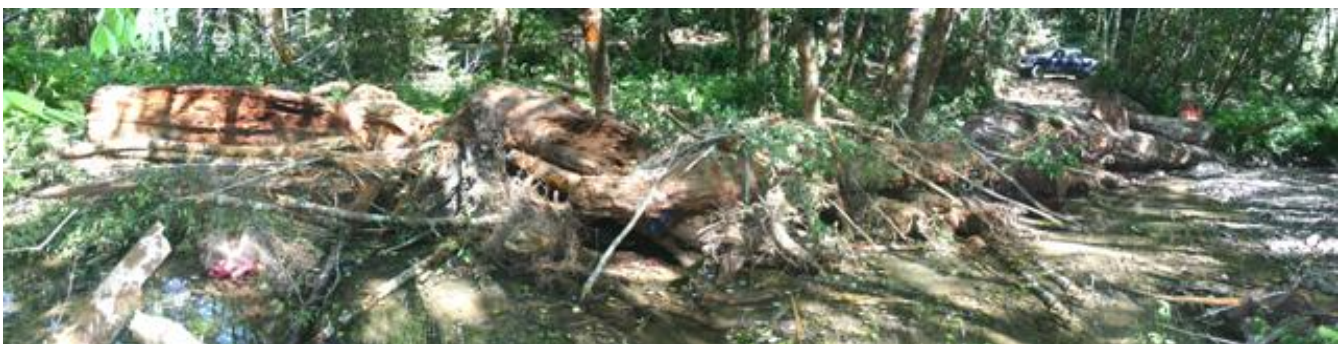
Figure 73. Step-run in middle portion of reach following installation of structures #10, Mainstem McGarvey Creek, Lower Klamath River, California, September 2008.

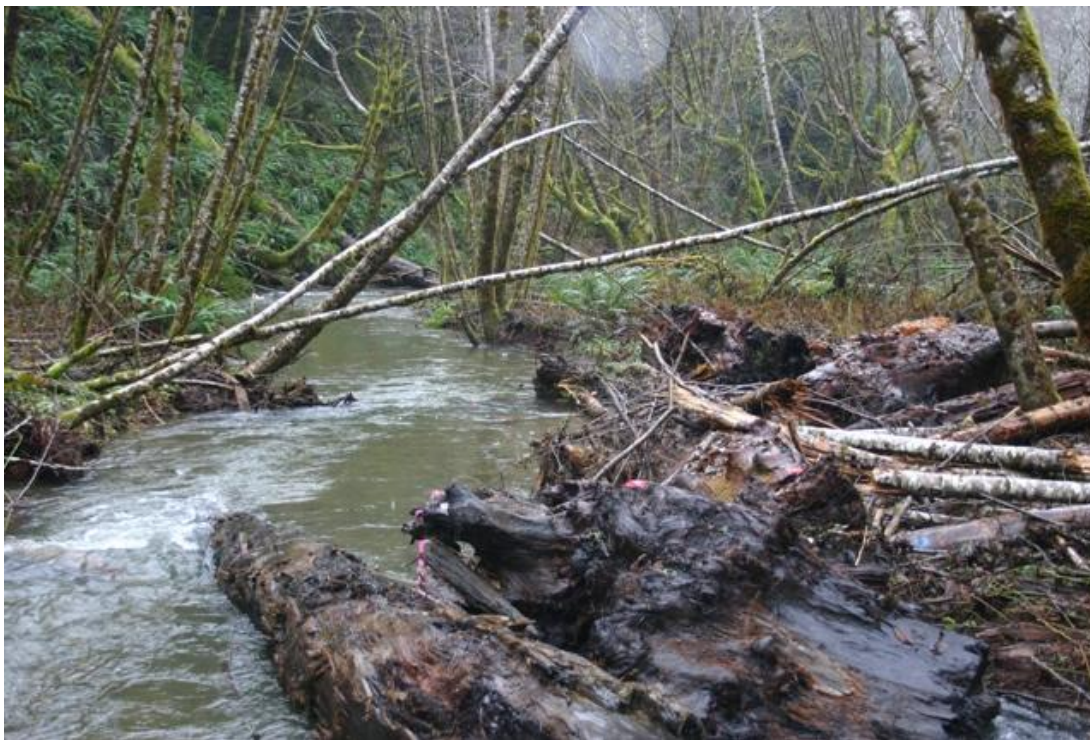
Figure 74. Structures #10-11 following high winter flows, Mainstem McGarvey Creek, Lower Klamath River, California, January 2009.

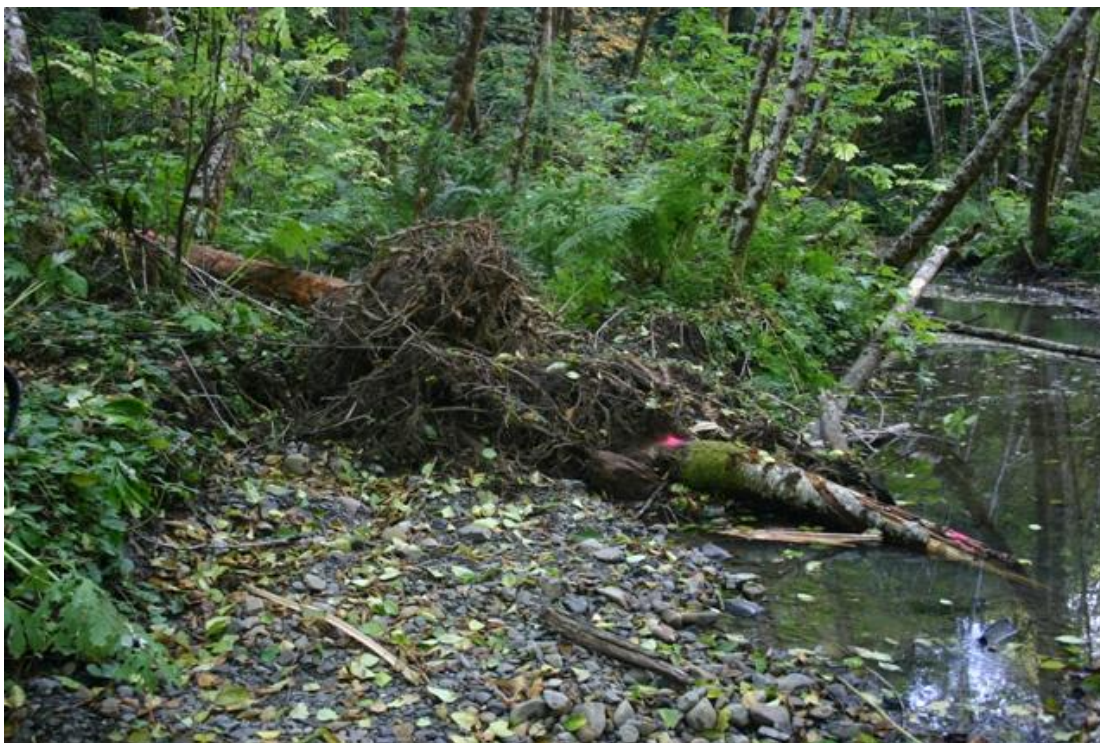
Figure 75. Structure #11 following high winter flows, Mainstem McGarvey Creek, Lower Klamath River, California, January 2009.

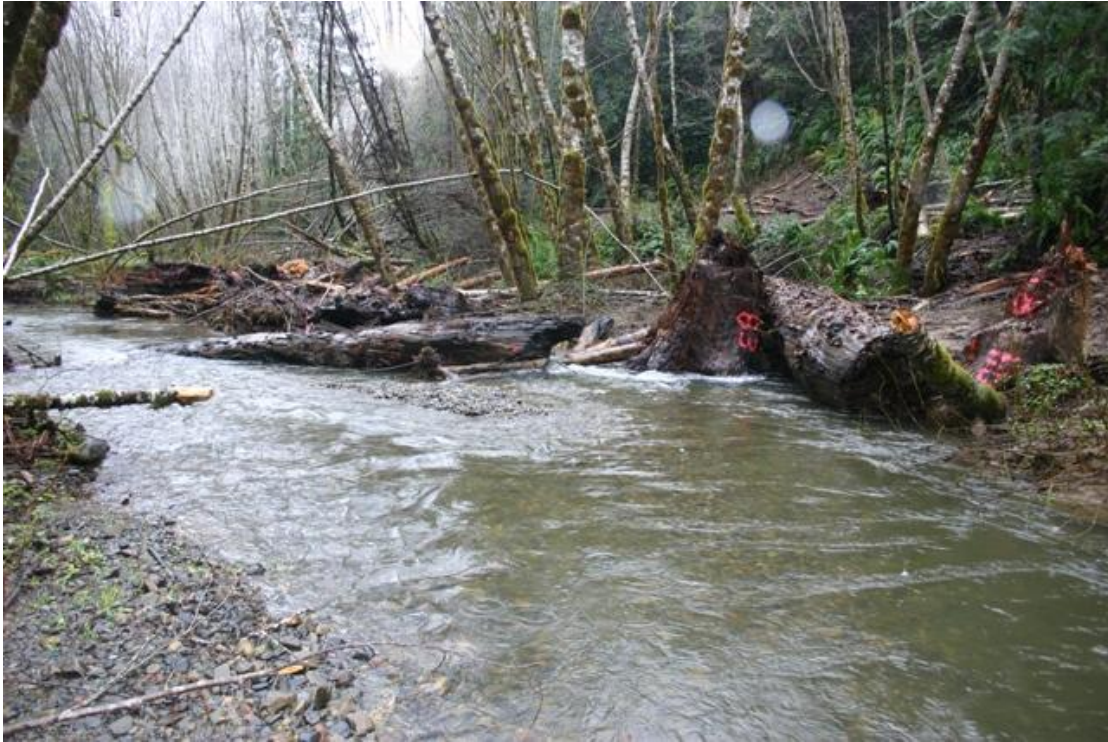
Figure 76. Structures #10-11 following high winter flows, Mainstem McGarvey Creek, Lower Klamath River, California, January 2009.

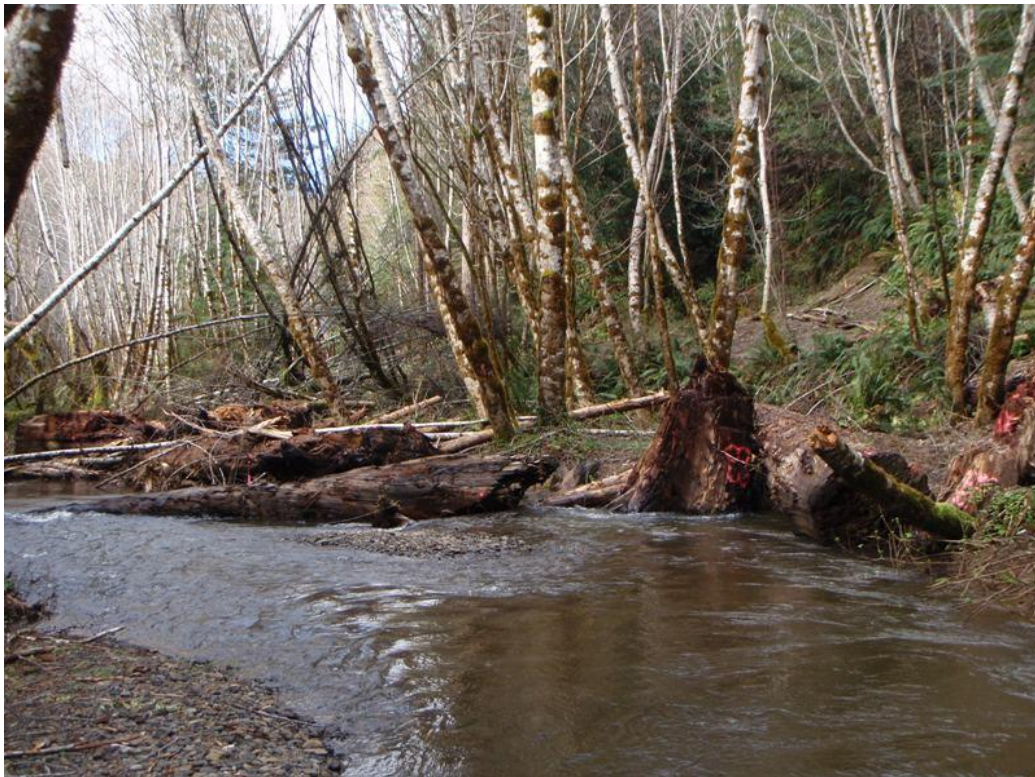
Figure 77. Structures #10-11 following high winter flows, Mainstem McGarvey Creek, Lower Klamath River, California, March 2009.
